Recent Investigations/Modifications on the ISS

LIGO internal note

November 27, 2008

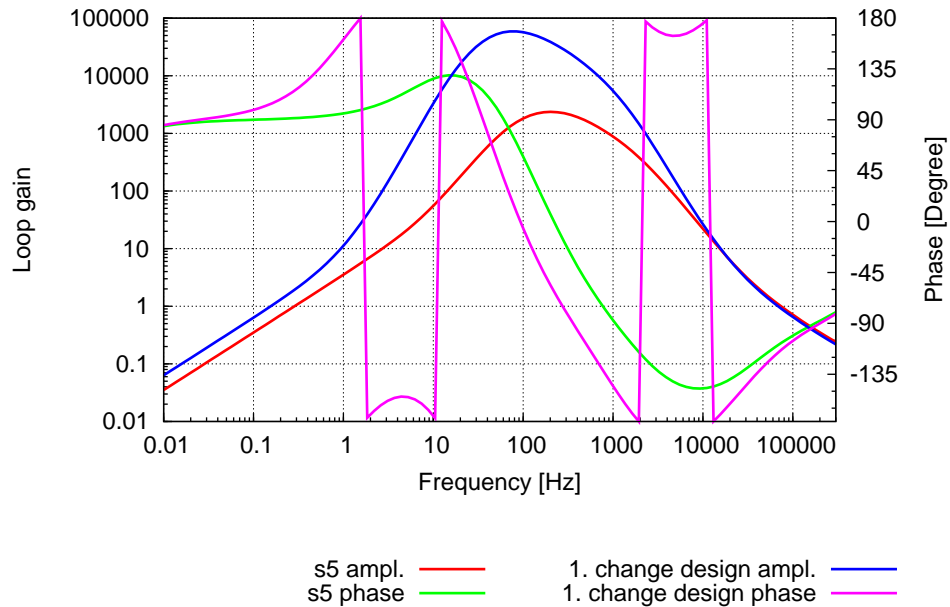
Figure 1: Initial ISS loop design and modifications from Aug/22/2008

At that time the open loop transfer function of the ISS was like shown in Figure 1, red and green trace (assuming a flat actuator response).

A bit later there was the implementation of somewhat more gain in the ISS servo loop in the 100 Hz region, to make sure that the loop would not be gain limited there. (Having in mind that the low-frequency laser power noise is particularly important for the DC readout. So certainly the noise should be sensor limited.) The blue/purple traces in Figure 1 show the modified servo, also not taking the actuator transfer function into account. This work was also done and documented by Stefan. Here is the excerpt of the LLO elog entry from Aug/22/2008, describing the electronics changes on SN#115:

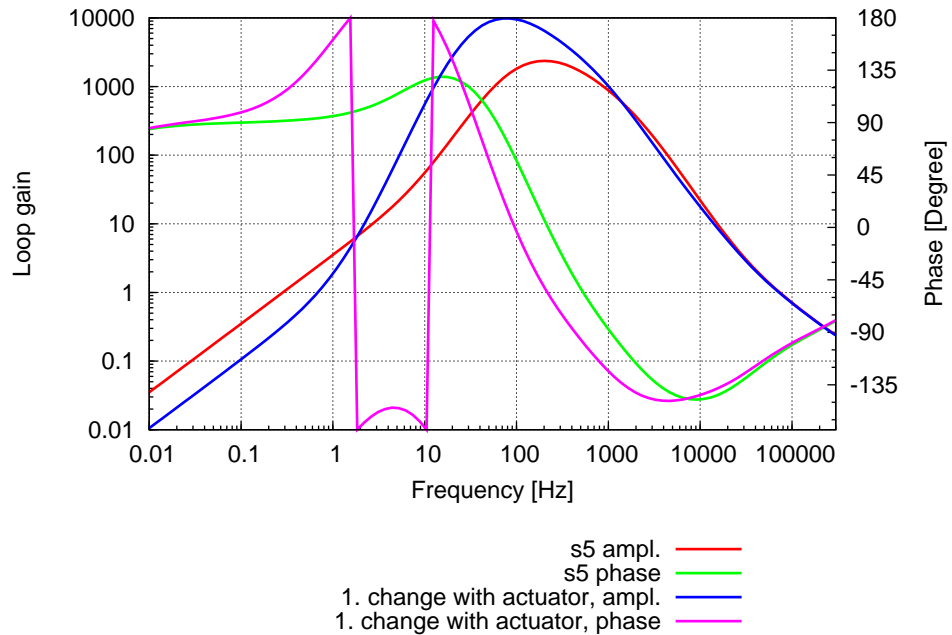
The ISS could not be recovered from the faulty state by any gain setting. Testing the actuator chain (RF drive input to laser power drop) showed no particular problem at the time. The DC laser power drop for 500 mV input to the RF drive, was around 3%. There was an intermittent state in time, on which the power drop seemed much less, but this state had somewhat disappeared the other day. (A month later we had this state again for 1-2 days. There is a spare AOM at LLO by now, such that this problem can be investigated a bit more relaxed, once this problem with the actuator shows up again. M. Zucker proposed to measure the RF-impedance of the AOM in its setup, yielding information to compare potential broken states from nominal ones.) However, even when the actuator seemed working fine again, there was a low-frequency oscillation around 2 Hz of the servo, which frequently saturated the loop. When taking into account that the AOM actuator chain has actually a frequency response containing a real zero at 2 kHz and a pole at 13 kHz, it looks reasonable that the loop tends to go unstable at the lower frequency end, for states with too low gain etc.

Figure 2 shows the loop shape of that time (before the fix), including the actuator response (blue and purple). The red and green trace are again the initial ISS design for comparison. The addition of the actuator responses made the loop unconditionally stable at the upper frequency end, but at the lower end, the gain rises rather steep, resulting in a higher UGF, and thus less phase margin.

Figure 2: Comparison of s5 loop shape with loop shape as of October 2008 (simulated). The AOM/YAG amplifier chain adds differentiation from 2 kHz to 13 kHz, which makes the servo rather shallow at this end. As a result, the overall gain cannot be increased sufficiently, to get good stability at the lower frequency end.

The modification we then implemented was to shift one of the zero-pole pairs at the lower frequency end from 0.8 and 30 Hz, to 4 and 150 Hz, respectively. This fixed the ISS at the time. Later one of the poles at 1 kHz was moved to 5 kHz, which in part compensates for the actuator response, while keeping increased phase margin at the upper end. It makes the gain shape more symmetric again such that the overall gain can be increased more, before running into oscillations at the upper frequency end. Both changes combined are shown in Figure 3, which is now implemented on both units at LLO (115 and 111).

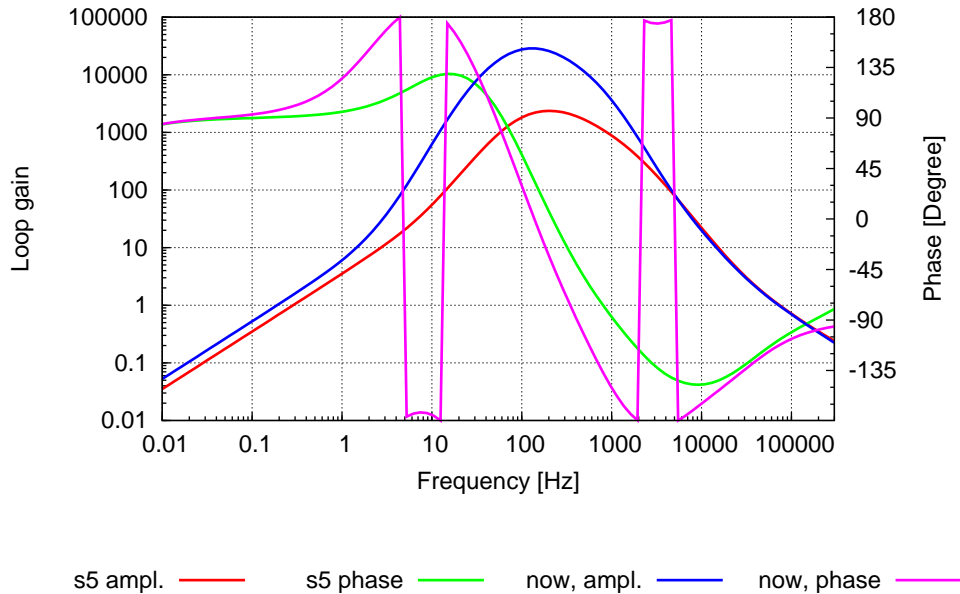
Figure 3: New (actual) loop shape of ISS 115 and 111 (including actuator response function), compared to s5 loop shape.

Also included in the new loop revision is the removal of the zero-pole pair at 0.8 MHz and 3 MHz, respectively. According to Rana, this was originally put in to compensate for a too high finesse of the PMC. With the recent move to a lower finesse, this is not needed any more, but also is its phase influence around 100 kHz rather small.

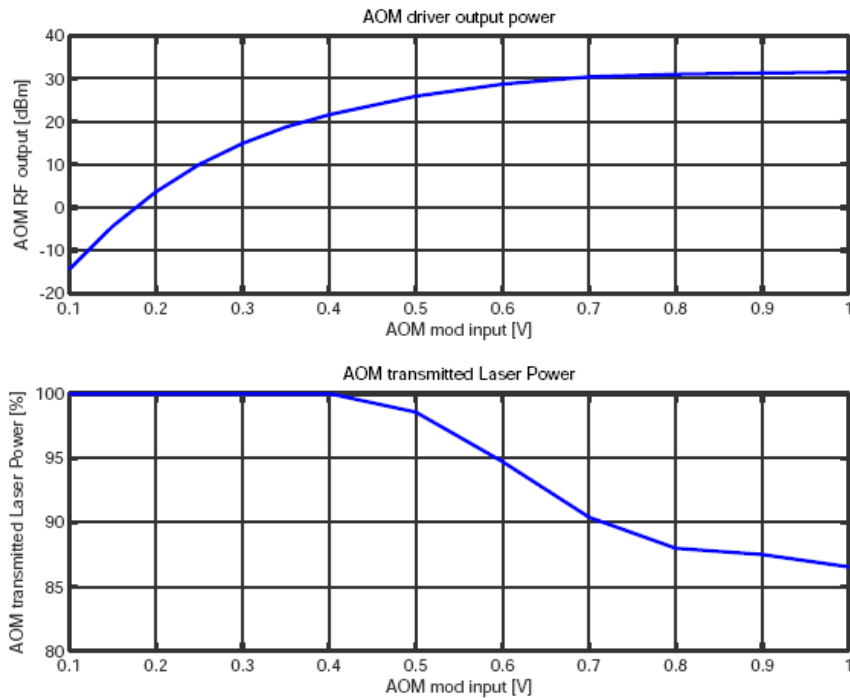
I set the biases to 500 mV on both units. (Compare to Stefans measurement of the actuator response in Figure 4). Recently we measured a power drop of 4 % for this setting. It might be that the Hanford RF driver has a different gain, however.

Figure 4: Transfer function from RF drive input to laser power drop (S.Ballmer)

An offset drift of the order 1 V in the circuit would have shifted the operating point from (say) 500 mV to 400 mV, thus significantly changing gain and range. However, this should not happen anymore now. If you wish to reduce the laser power drop, it might be the right thing (as Rana proposed) to attenuate the RF,

instead of lowering the bias. There might also be the possibility to adjust the gain of the RF driver just by a trimp pot. on the driver, which can be accessed from the front.
