Re: Failure Analysis of Aluminum Dumbbell  
LIGO Account No 5F518, SEAL Job No 1086

Two aluminum dumbbell assemblies which were glued to a glass surface were sent to SEAL Laboratories to determine why the adhesive failed.

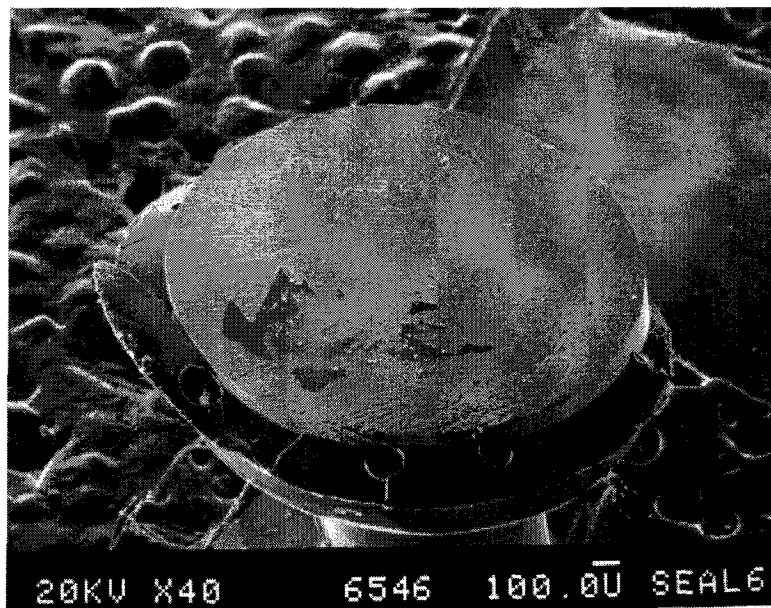
Figure 1. 40X SEM Image of Aluminum Dumbbell Bonding Surface

The above SEM images show nearly a complete adhesive failure. That is, the bond failed cleanly at the interface between the aluminum dumbbell and the adhesive. The 600X images of the aluminum dumbbell and the adhesive are mirrored, or replicate each other, showing that the adhesive cleanly failed at the interface with little bonding present.

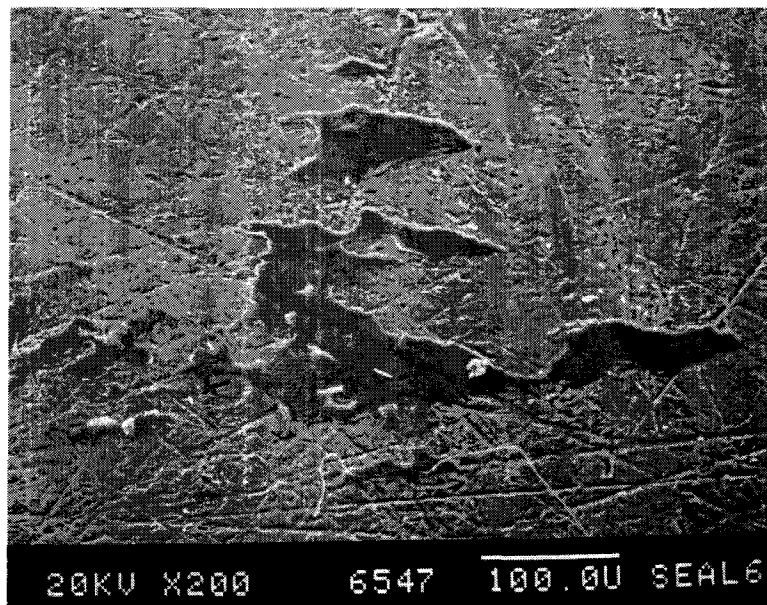
Figure 2. 200X SEM Image of Aluminum Dumbbell Bonding Surface

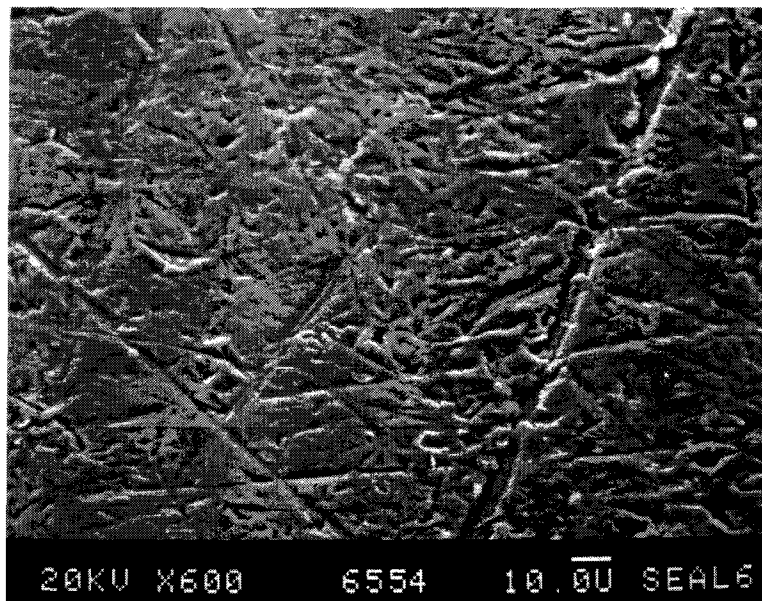
Figure 3. 600X SEM Image of Aluminum Dumbbell Bonding Surface

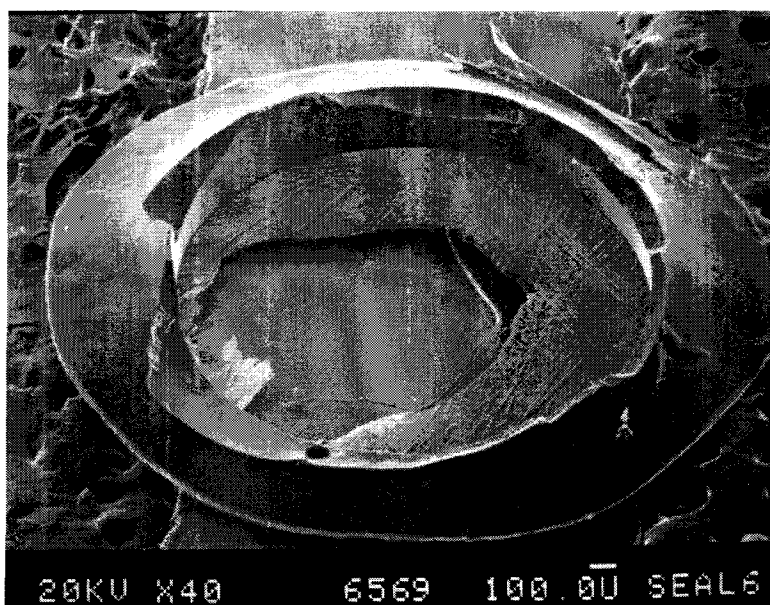
Figure 4. 40X SEM Image of Adhesive Bonding Surface

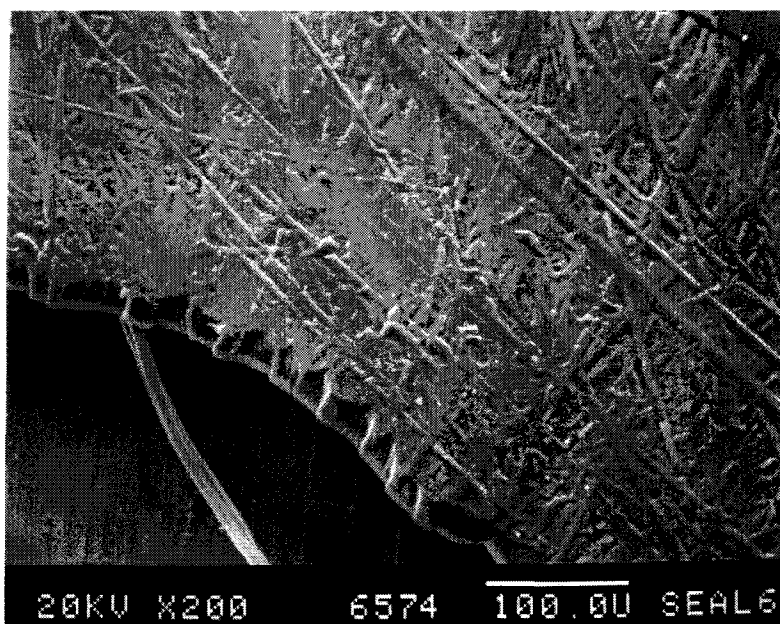
Figure 5. 200X SEM Image of Adhesive Bonding Surface

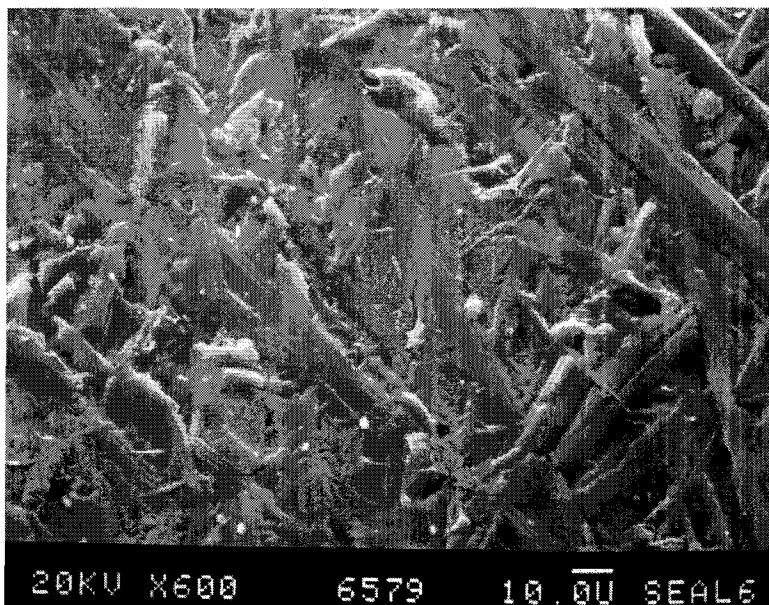
Figure 6. 600X SEM Image of Adhesive Bonding Surface
