LIGO-T070133-01-D

*Advanced LIGO*

07/19/2007

A Quick Test of Laser Safety Eyewear

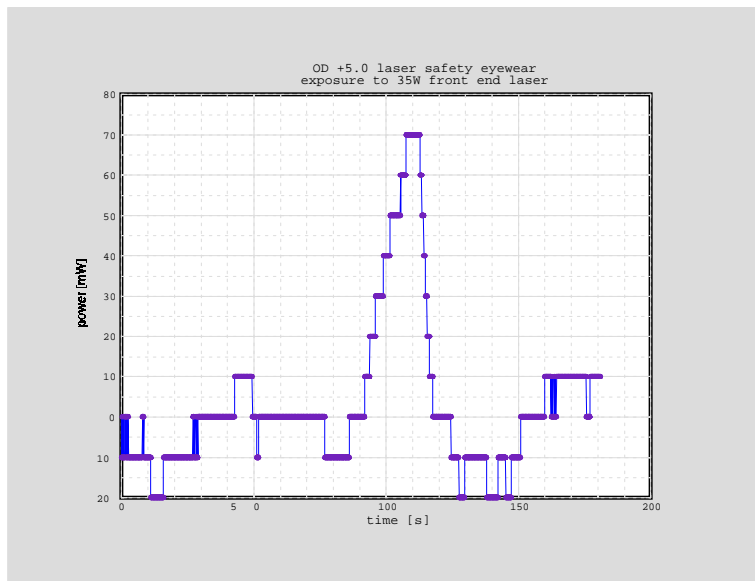
The maximum transmitted power measured was 70 mW. The video recording can be viewed [here for .mov players](#) or [here for .avi players](#). The streak present in the video is due to saturation of the CCD element and is not the laser beam.

In both cases, there was no transmitted power for a period of at least a few seconds. Unfortunately, a synchronized time resolved measurement was not possible but observing the calorimeter during the exposure period revealed no significant departures from zero during the early stages. After removing the beam, the damage to the glass is apparent, with a small crater being present with small cracks where the beam hit. As each lens cooled down the whole lens cracked.

My personal conclusion from seeing this test is that we should follow the CE standard and require a period of time where the laser safety eyewear can withstand a direct hit. It is doubtful that some of our polycarbonate-based laser safety eyewear would withstand the worst-case scenario of a direct hit. Even the small extra time afforded by CE certified laser safety eyewear would give a laser operator time to get out of harm's way. Frankly, after seeing the video, if a person couldn't tell that they were being hit by the laser then there are more immediate problems at hand.

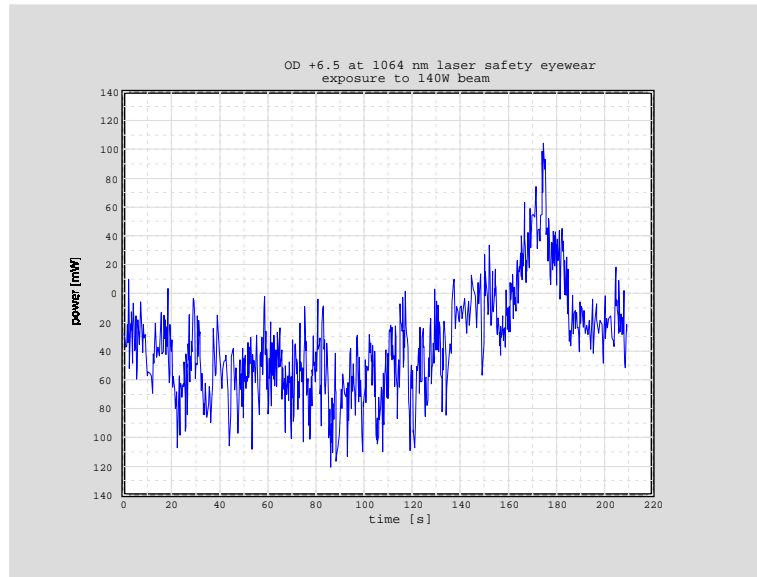
The maximum transmitted power measured was approximately 90 mW. The video recording can be viewed [here for .mov players](#) or [here for .avi players](#).

In the case of KG5, a hole was made through the glass. There is evidence that the beam melted the glass material.
