LIGO-T070133-02-D

*Advanced LIGO*

04/14/2008

A Quick Test of Laser Safety Eyewear

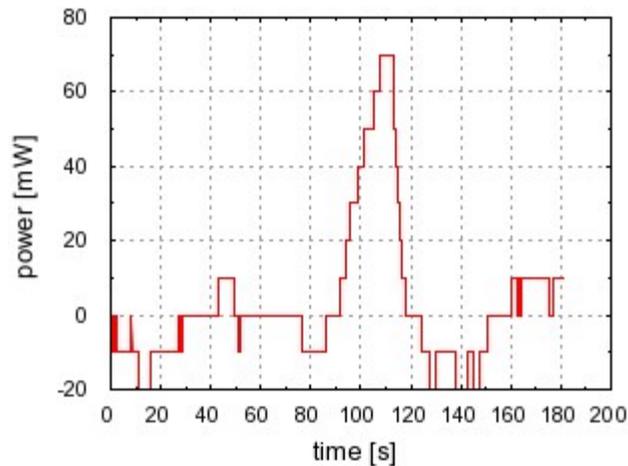
The maximum transmitted power measured was 70 mW. The video recording can be viewed [here for .mov](#) players or [here for .avi](#) players. The streak present in the video is due to saturation of the CCD element and is not the laser beam.

For both Schott glass filters, there was no transmitted power for a period of at least a few seconds. Unfortunately a synchronised time resolved measurement was not possible but observing the calorimeter during the exposure period revealed no significant departures from zero during the early stages. After removing the beam, the damage to the glass is apparent, with a small crater being present with small cracks where the beam was incident on the glass. As each lens cooled down, the whole lens cracked. It is important to note that the lens did not shatter when exposed to the beam.

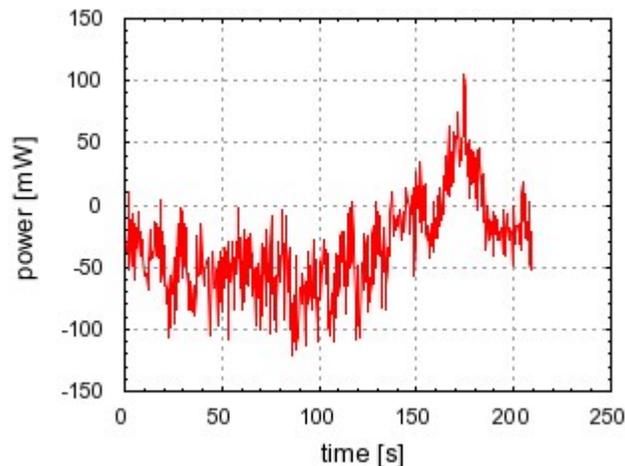
The maximum transmitted power measured was approximately 90 mW. The video recording can be viewed [here for .mov](#) players or [here for .avi](#) players.

In the case of KG5, a hole was made through the glass. There is evidence that the beam melted the glass material and some kind of sticky, oily substance oozed out.

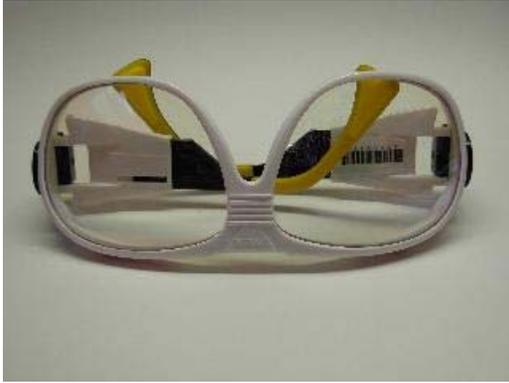
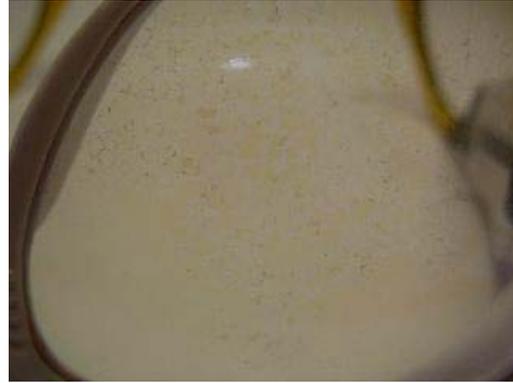
These polycarbonate laser safety eyewear were in use at the 40m Lab. The frames list an optical density of 5+ at 1064 nm. These rely on reflective coatings to reflect any incident laser light. The problem experienced at the 40m Lab is that over time, the reflective coatings became damaged either through a problem with the coating or mis-handling. This style of laser safety eyewear is shown in Figure 3. The beam diameter used in this experiment was approximately 5 mm.

**Figure 3.** The Uvex LC542 C739 laser safety eyewear that was used at the 40m Lab. On the right is a close-up view of the damaged coating region.

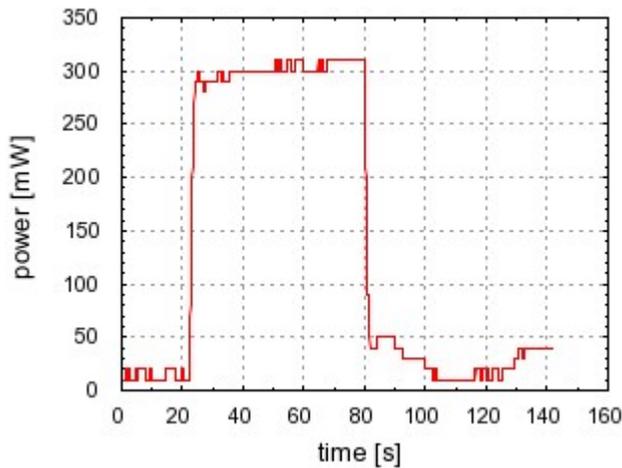
The transmission measured with the laser beam aimed at the centre of the lens, away from the damaged coating area. The maximum transmitted power measured was approximately 300 mW. The video recording can be viewed [here](#) for .mov players or [here](#) for .avi players.

In both measurements, transmitted power through the eyewear was observed as soon as the beam block was removed.

Surprisingly for the Uvex LC542 C739 laser safety eyewear no evidence of damage by the laser was visible. Even in an area where the thin-film coating appeared to be visually okay, the power transmitted by the eyewear was well above any applicable maximum permissible exposure level. This would suggest a defect in the coating and some difficulty in verifying if the coating was okay or not.

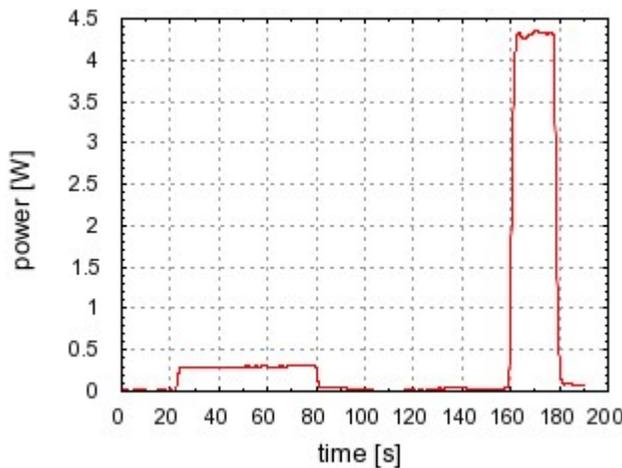
The transmission of the damaged coating region. Note the change in scale compared with previous measurements. The maximum transmitted power measured was approximately 4.3 W.

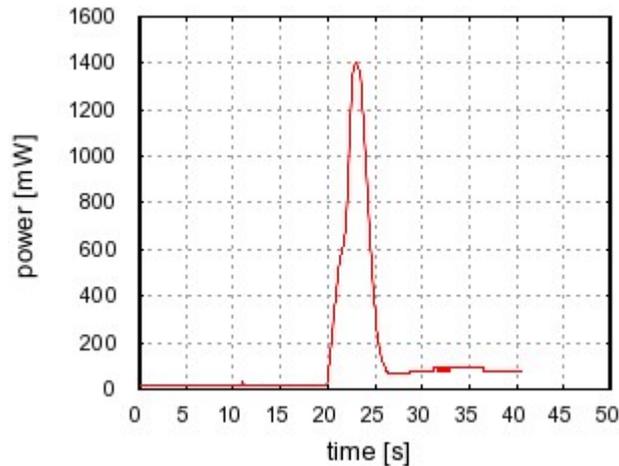
The transmission through the Flex Seal Z94.3. The maximum power transmitted was 1.4 W. The time scale is mis-leading as the power transmitted coincided with the laser light being incident on the laser safety eyewear. The measurement was rapidly shutdown to preserve the cleanliness of the laboratory.

Although tested beyond its intended use, the Flex Seal Z94.3 performed the worst with damage being done the instant the laser was incident on the eyewear. This type of laser safety eyewear should not be used for any work around the laser table. Given the reasonable number of this style of eyewear already present on the Project, they could be used for the tour groups that visit.
