VIRGOVACPISA 039 P
D.G. motorWritten: February, 1996 p 1
Revised: February 1996

Object: Outgassing measurements of D.G. stepper motor

From: M.Bernardini, C.Bradaschia, H.B.Pan, A.Pasqualetti, R. Poggiani, G.Torelli, Z.Zhang

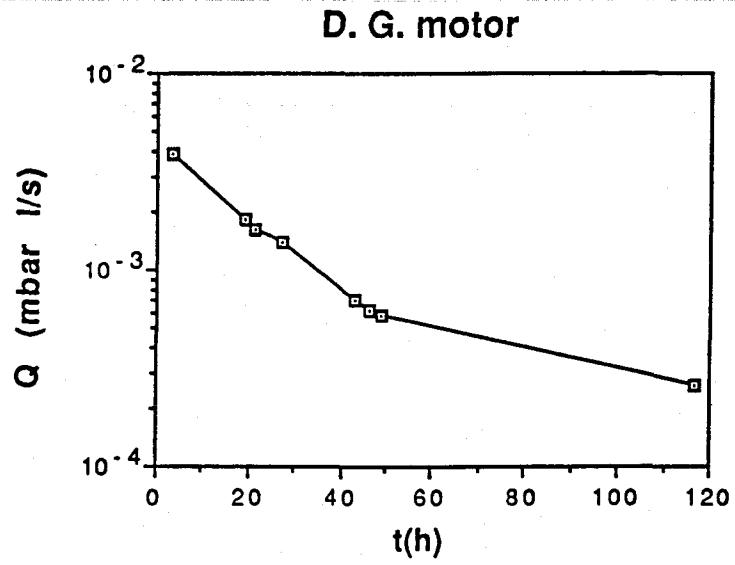
Fig. 1

The outgassing flow is reported in Fig. 1. The outgassing spectra taken after 21h (Fig. 2) showed that there is a strong hydrocarbon contamination.

The motor cannot be recommended for VIRGO due to the large outgassing flow and to the strong contamination from hydrocarbons. A visual inspection of an open motor showed that there was a large amount of not vacuum compatible materials. Moreover later the factory discovered that cleaning was not able to remove oil inside.
