G960022-

Ligo
progress
photographs
civil work
Stranco contract
Feb. 16, 1996

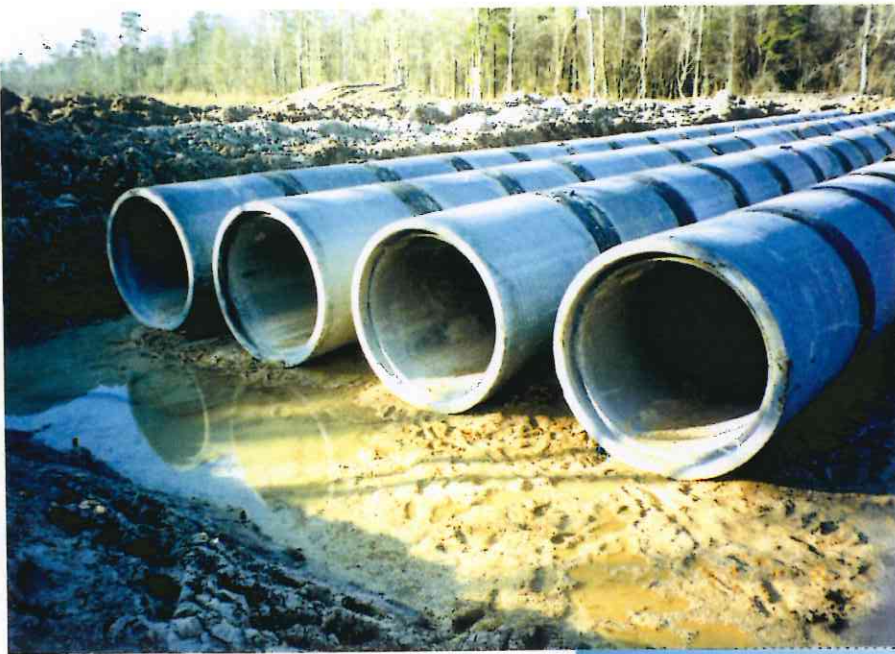
G960022-01-O-P

1. Southwest arm at station 92+60 culvert crossing.

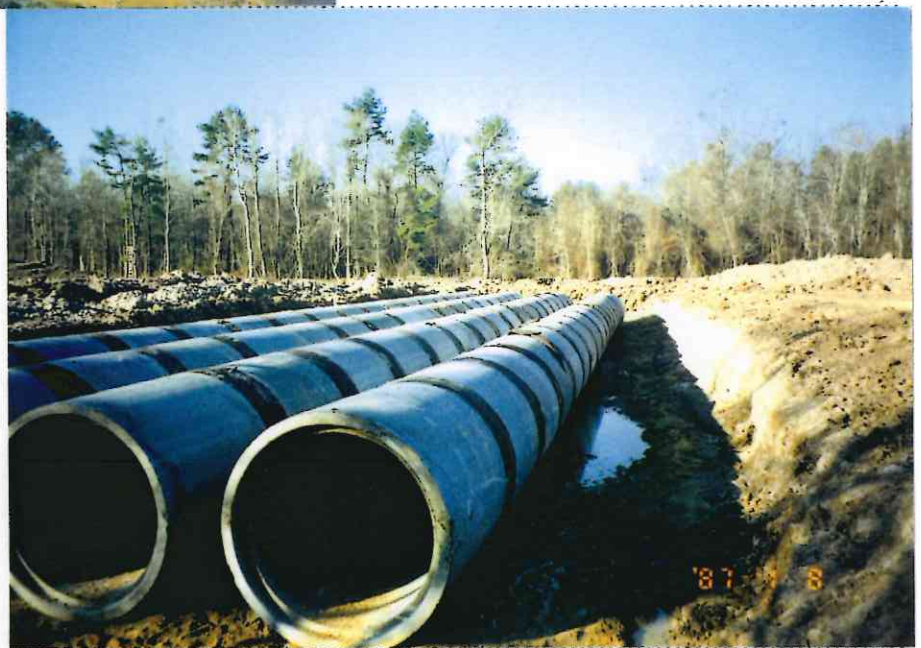
G960022-02-O-P

2. Southwest arm at station 92+60 culvert crossing

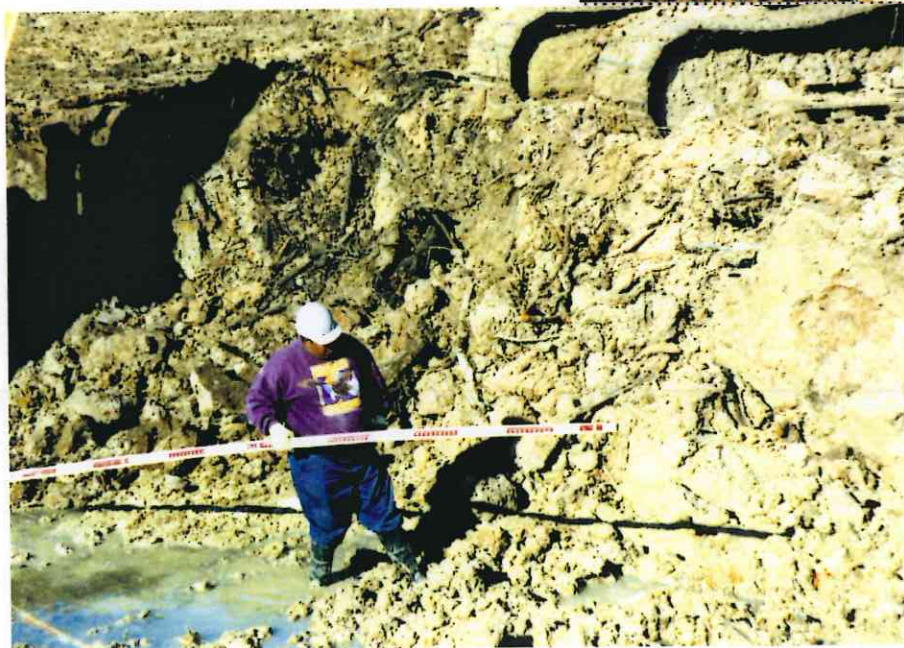
G960022-03-O-P

3. Southwest arm at station 16+40 excavating for culvert crossing.

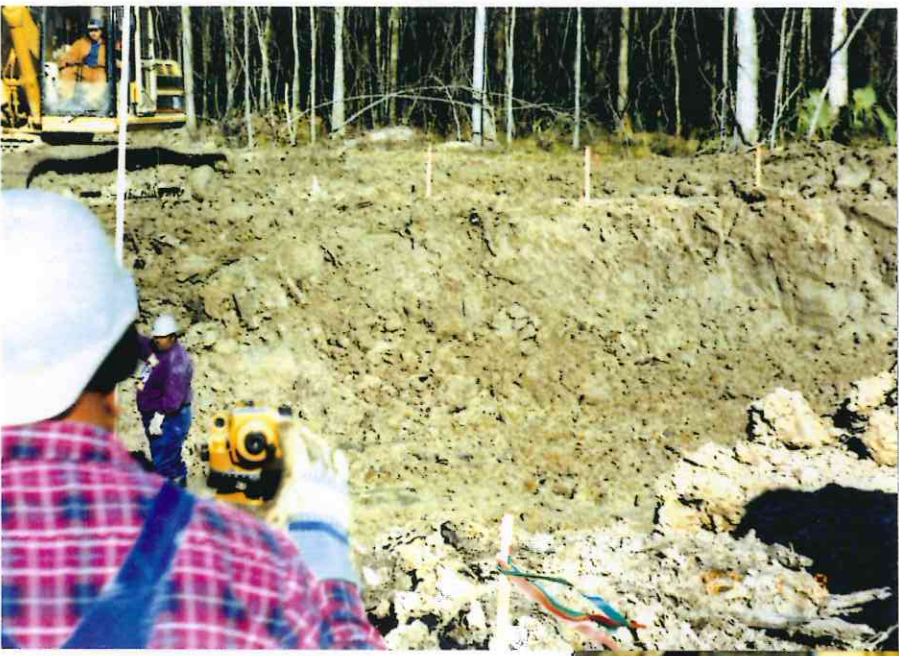
G960022-04-O-P

4. southwest arm at station 16+40 excavating for culvert crossing, checking grade.

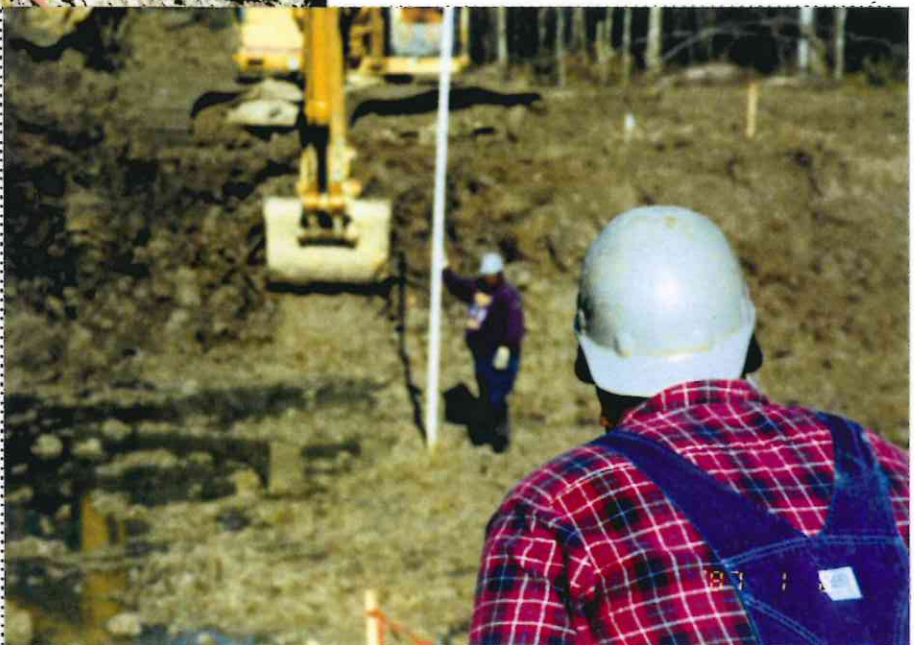
G960022-05-O-P

5 Checking grade at southwest arm, station 16+40 culvert crossing

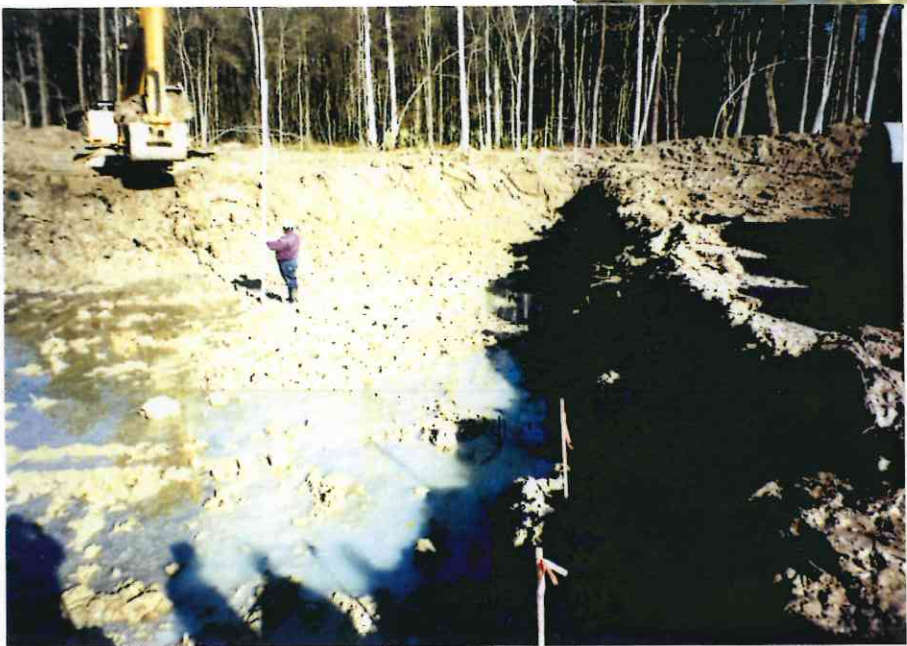
G960022-06-O-P

6 Southwest arm at station 16+40, checking grade at culvert crossing

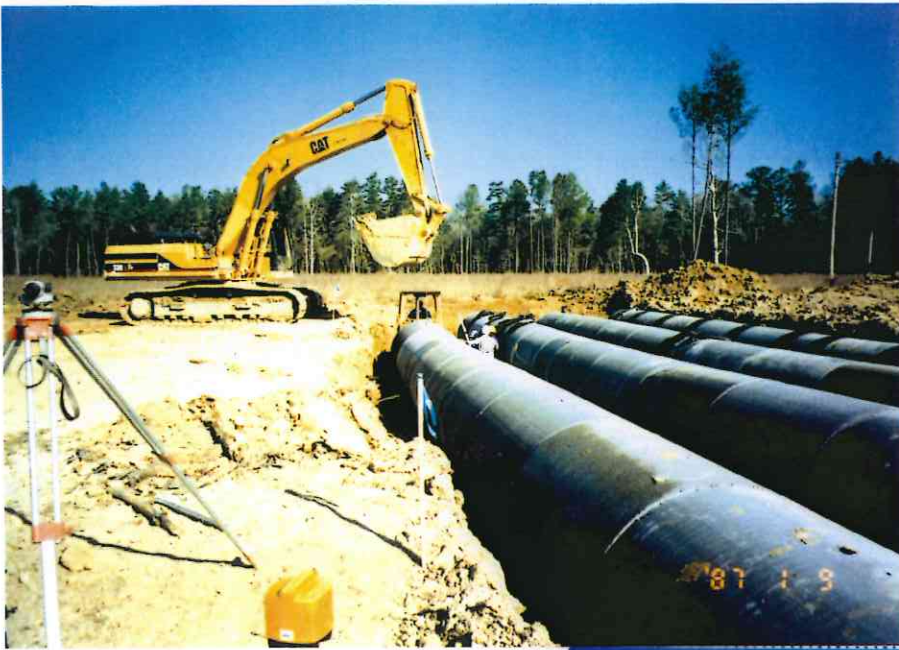
G960022-07-O-P

7. Southwest arm at station 123 culvert crossing, setting pipe in place.

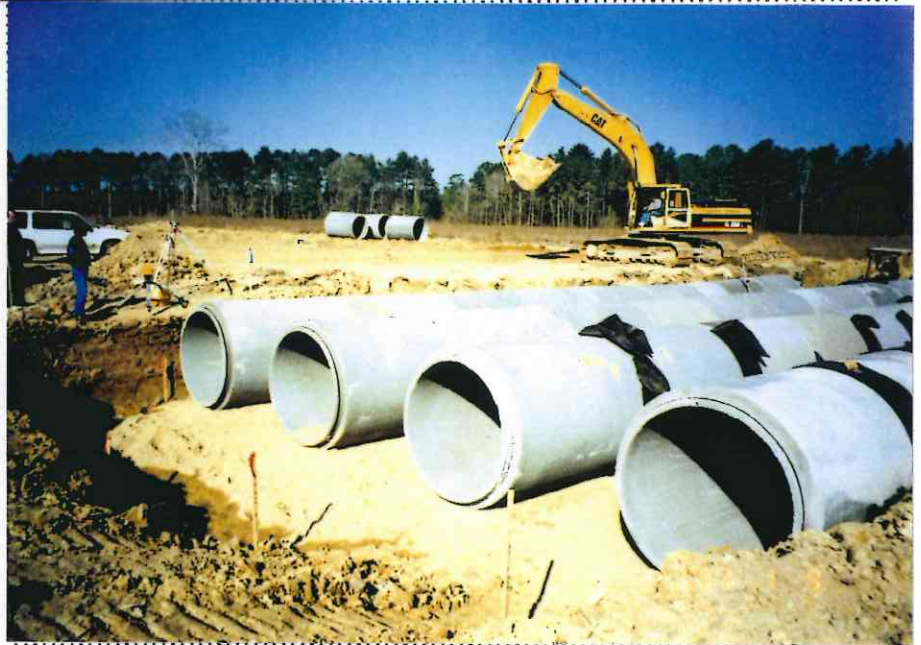
G960022-08-O-PV

8. Southwest arm at station 123 culvert crossing, checking pipe installation.

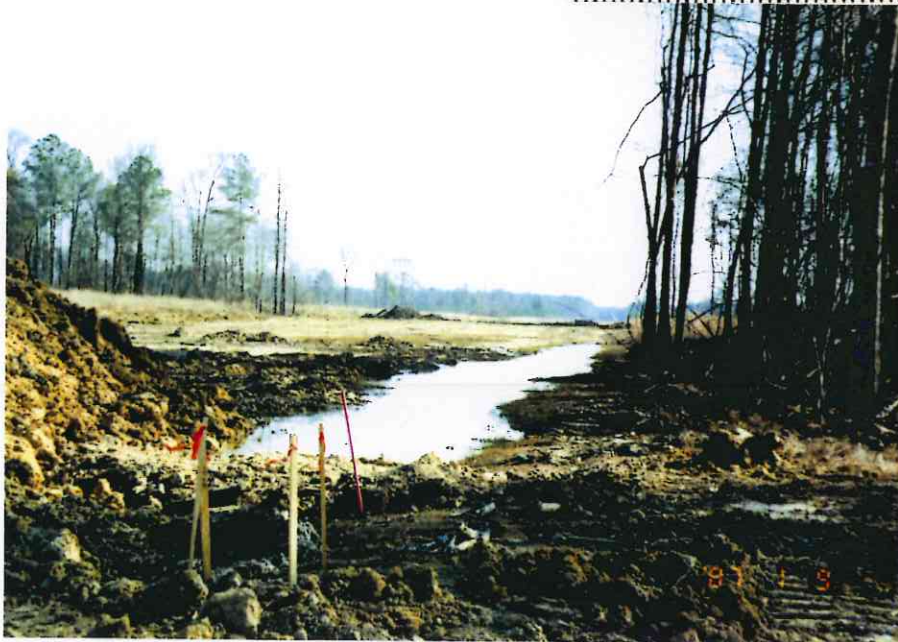
G960022-09-O-P

9. Southwest arm at station 123 looking northeast reviewing surface drainage.

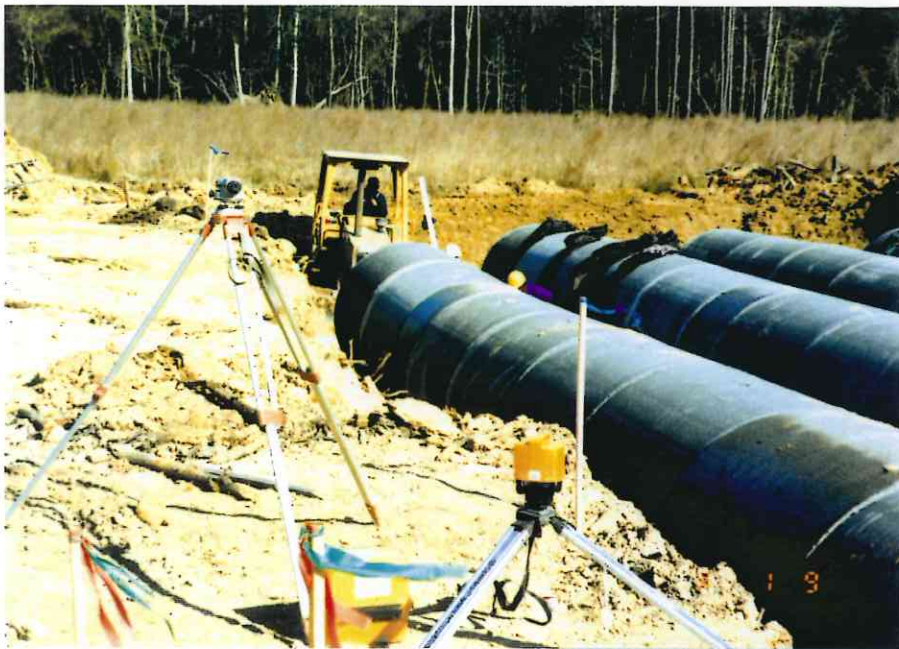
G960022-10 -O-P

10 Southwest arm at station 92.60 installing pipe for the first time ,correction followed.

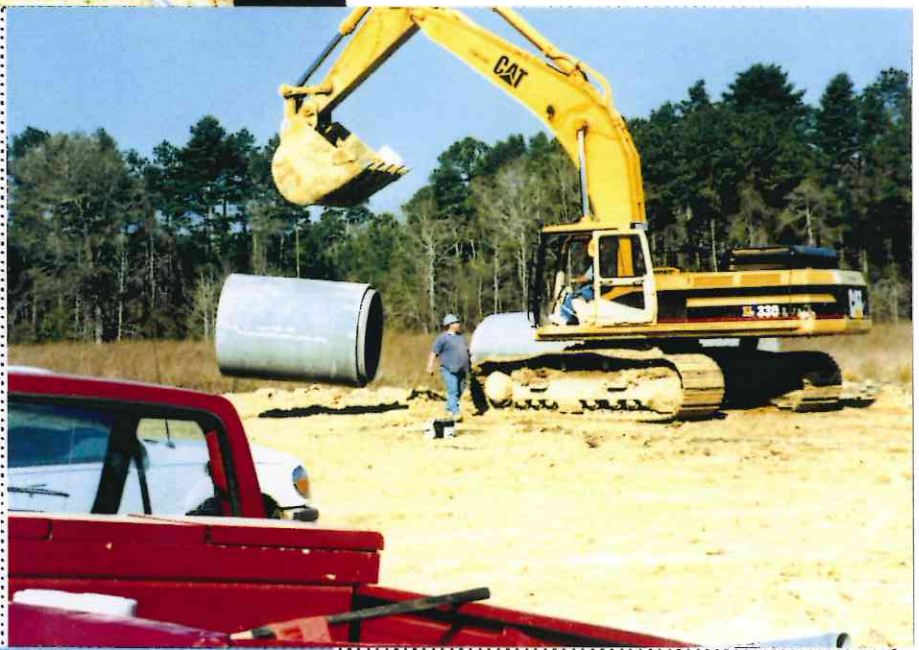
G960022-11 -O-P

11.Southwest arm at station 92+60 rigging pipe into place.

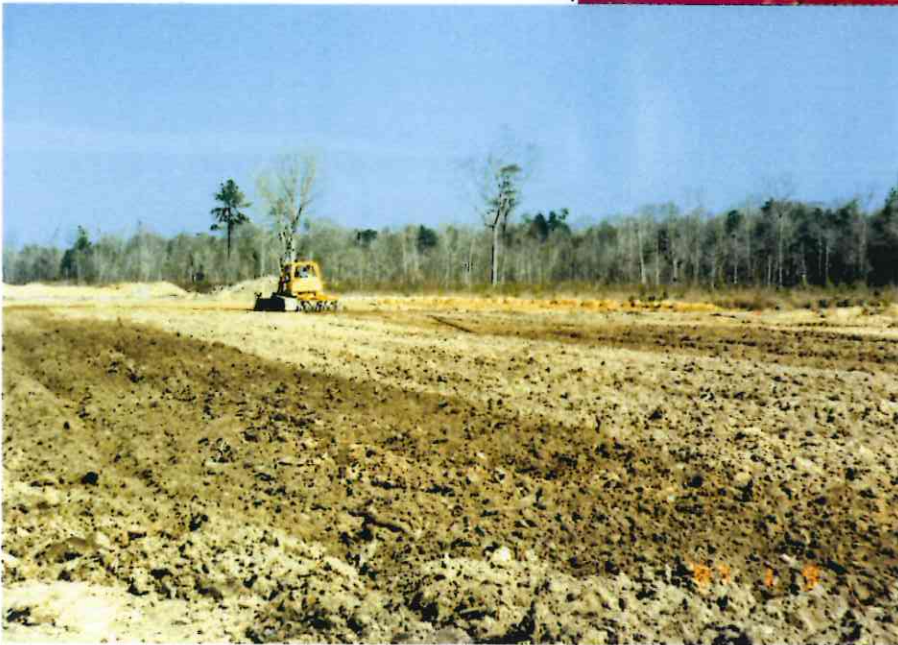
G960022-12 -O-P

12.Southeast arm
disking berm at station
113+00

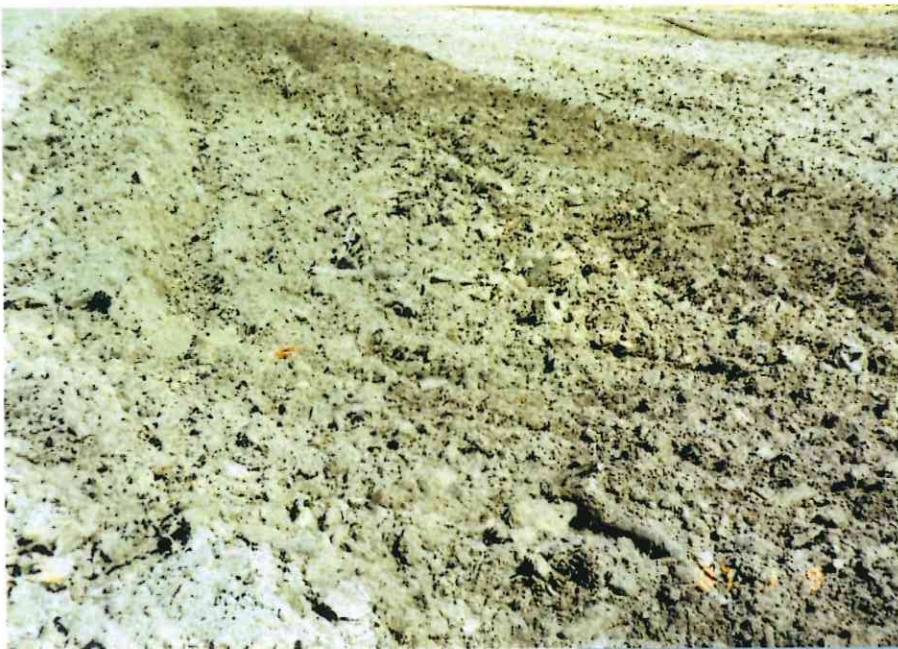
G960022-13-O-P

13. Southeast arm around station 115 , Organic material exposed during disking operation.

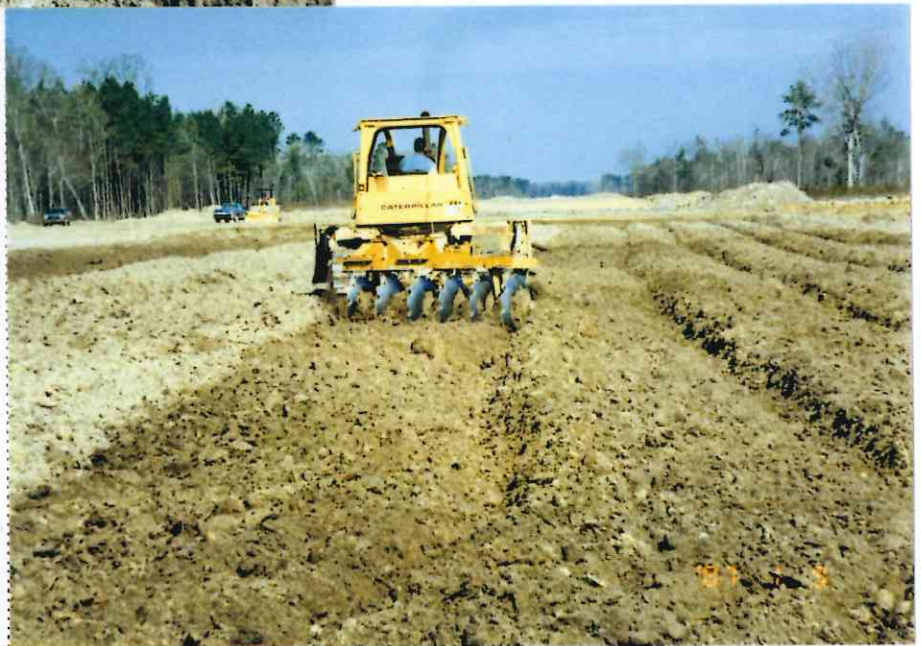
G960022-14-O-PV

14. Southeast arm at station 113+00 disking berm material to remove moisture.

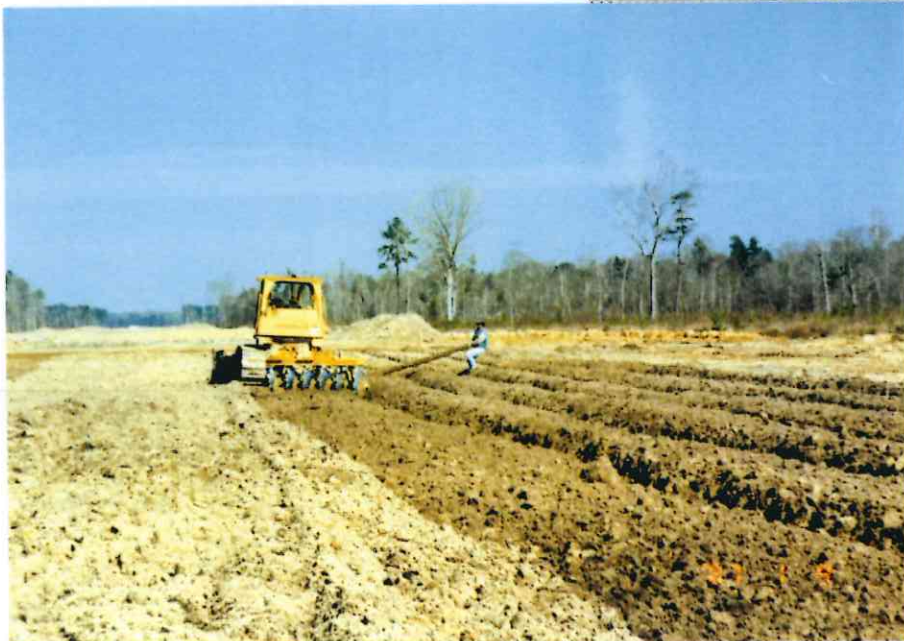
G960022-15-O-P

15. Southeast arm at station 113+00 removing small tree found by disking.

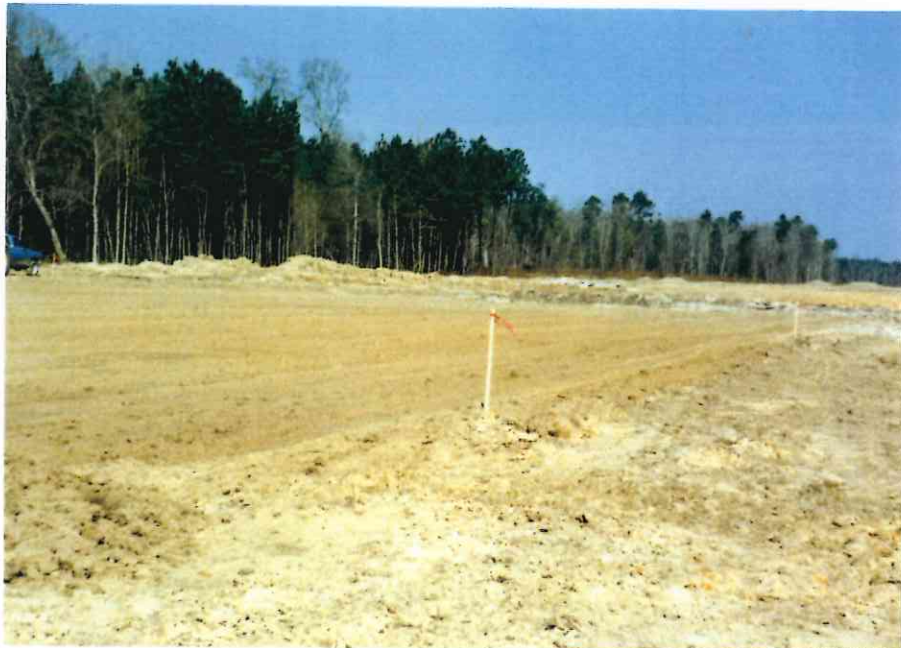
G960022-16-O-P

16. Southeast arm at station 113+00 showing compacted fill.

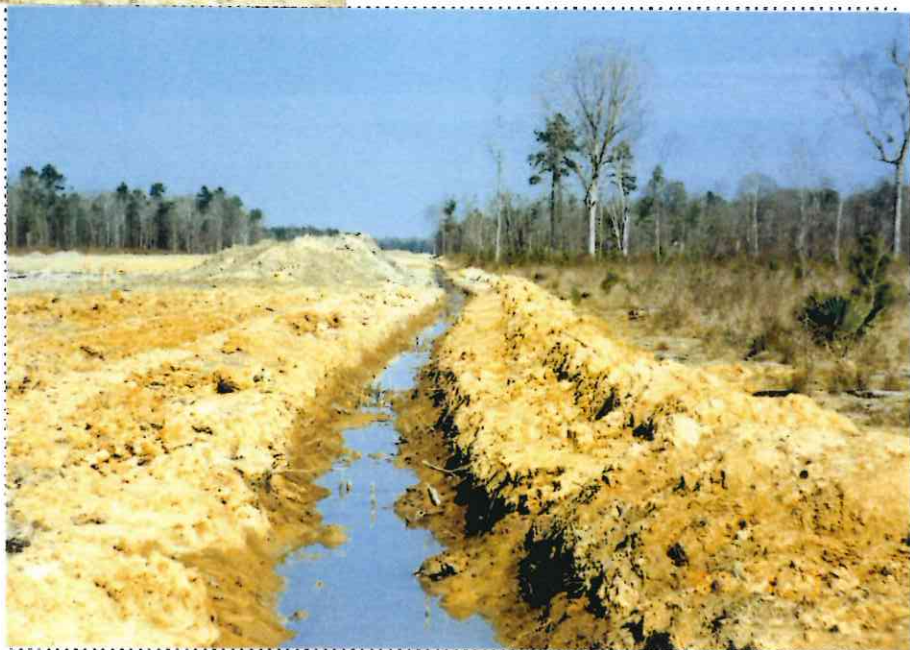
G960022-17-O-PV

17. southeast arm this is a view looking north at a drainage ditch used for construction.

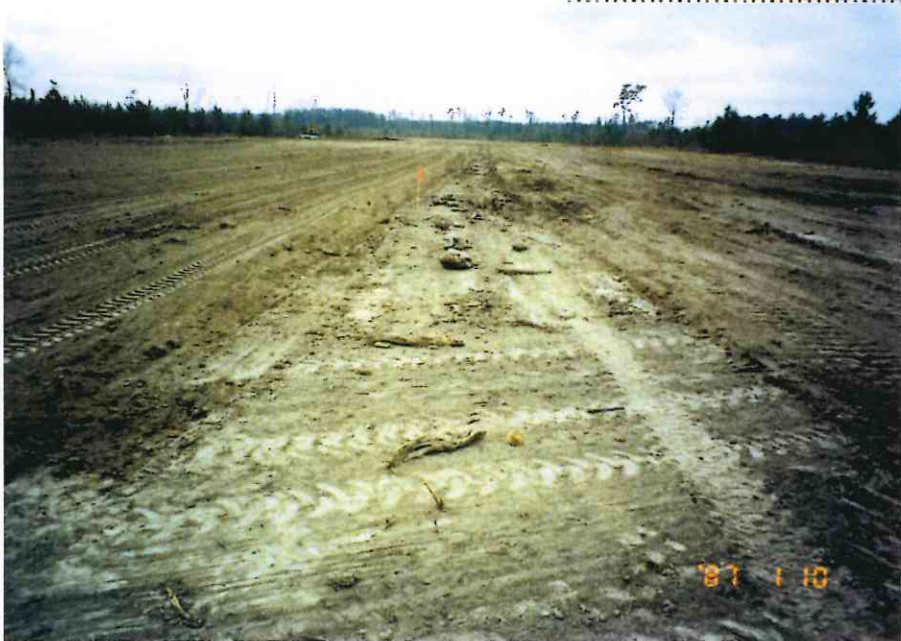
G960022-18-O-P

18 Southeast arm at station 118 looking SE to the end of boundary.

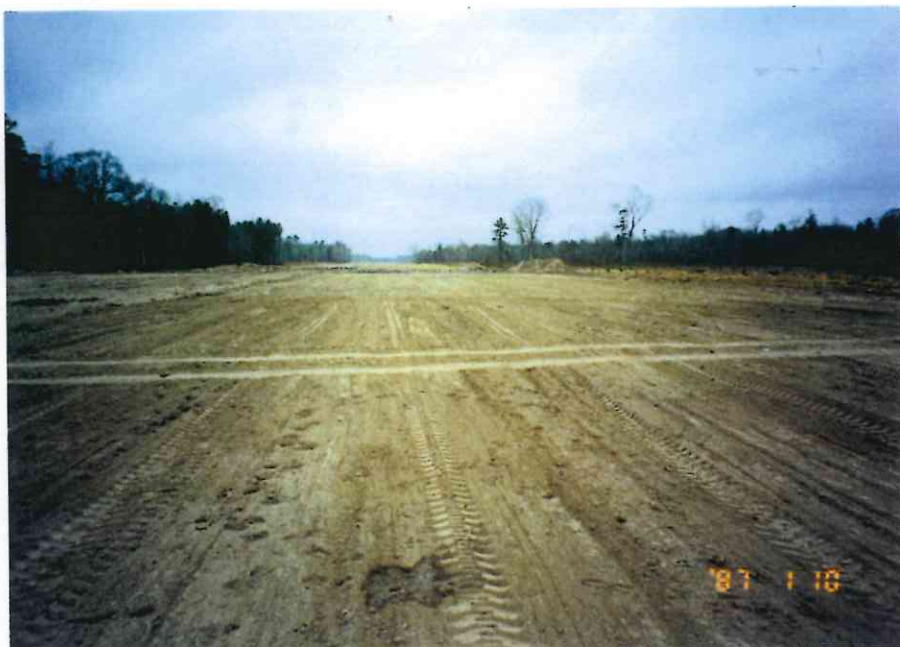
G960022-19 -O-PV

19. Southeast arm at station 112 looking northeast, compacted berm.

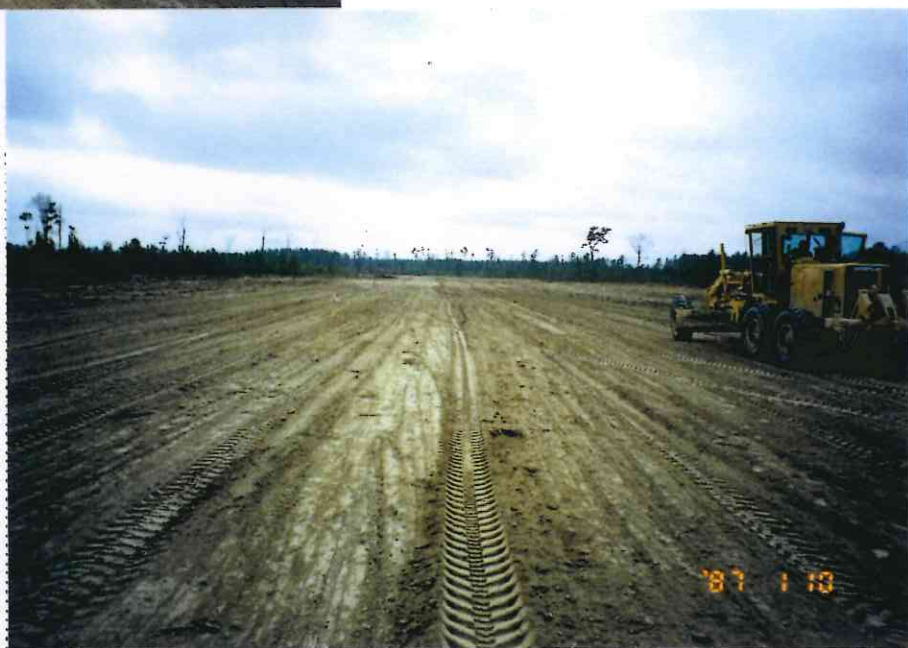
G960022-20-O-P

20 Southeast arm looking SE at end of boundary limit. compacted fill

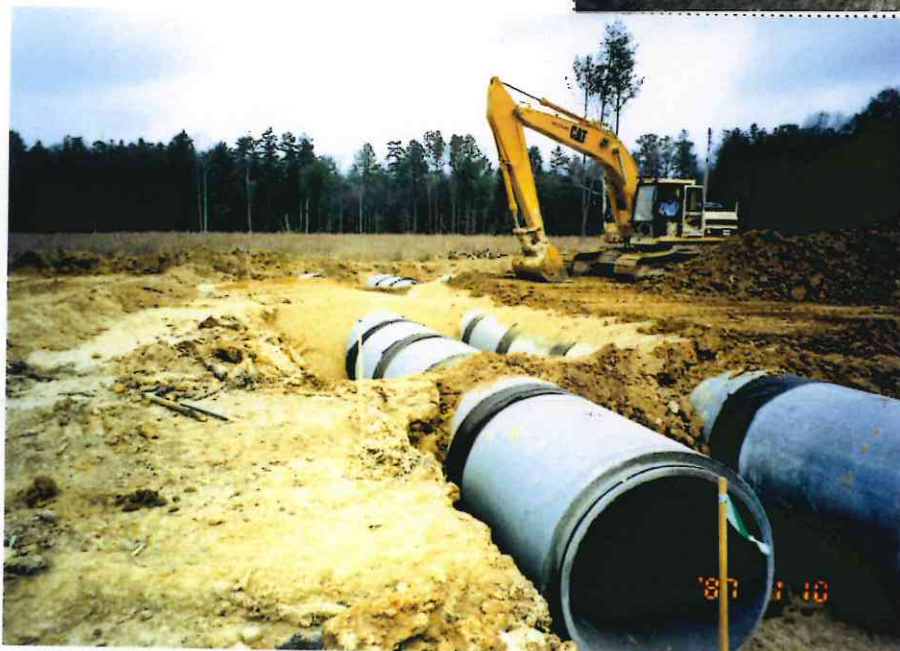
G960022-21-O-P

21 Southwest arm at station 123+00 culvert crossing. backfill operation

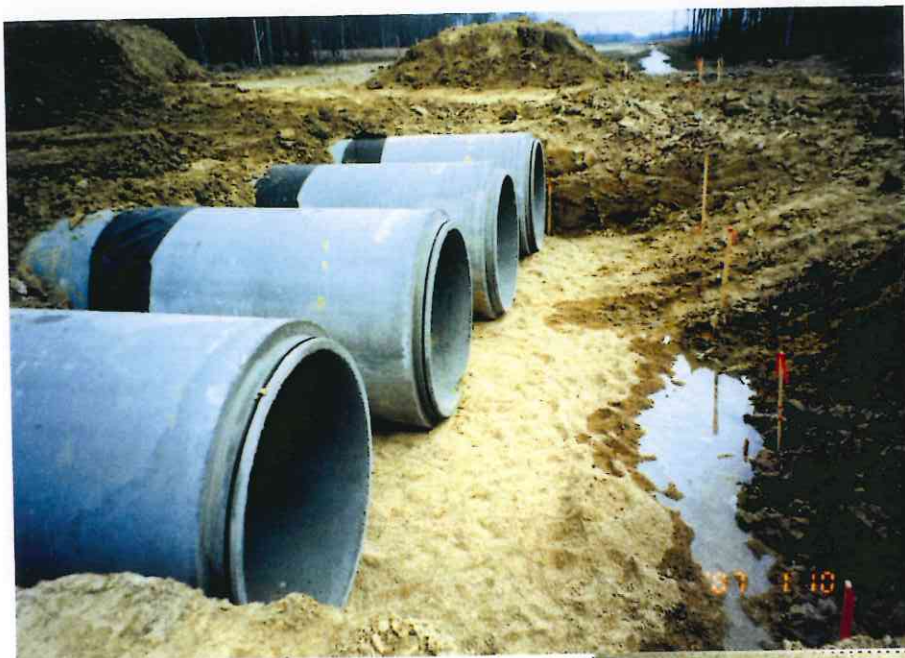
G960022-22-O-P

22.Southwest arm at station 123 culvert crossing .

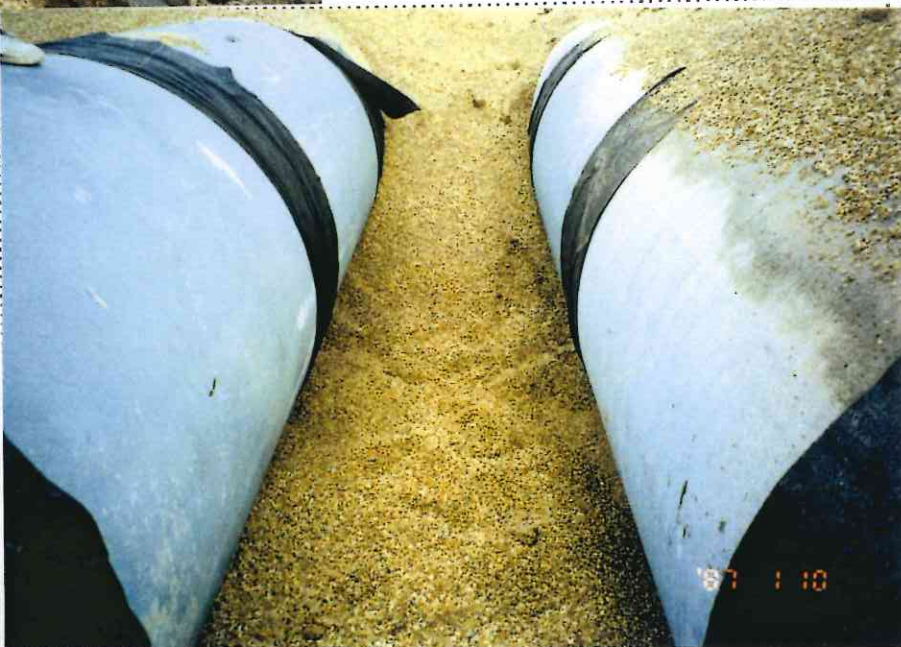
G960022-23-O-P

23 southwest arm at station 123+00 culvert crossing showing pea gravel backfil around pipe

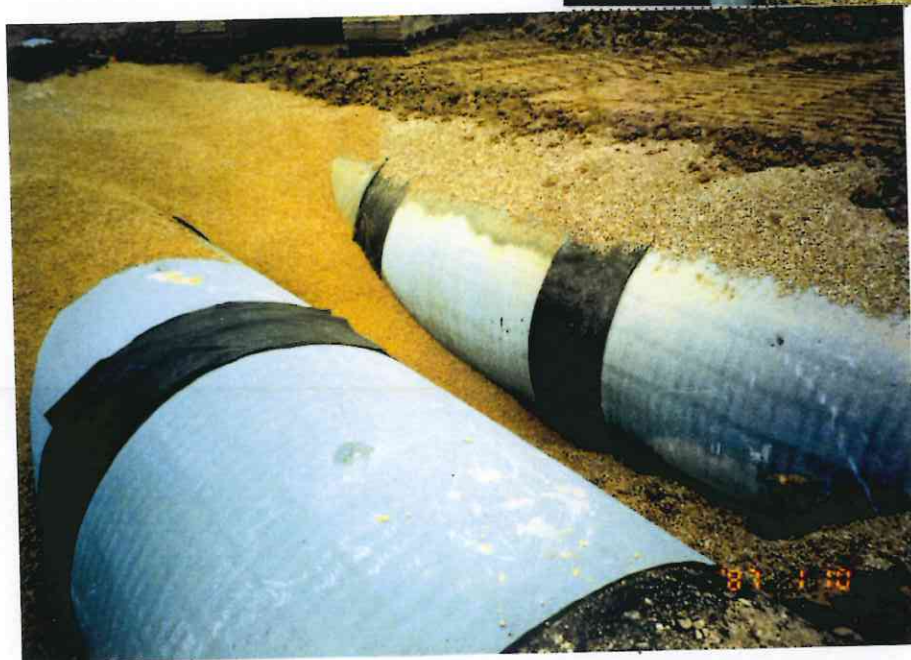
G960022-24-O-P

24.Southwest arm at station 123+00 culvert crossing backfil operation.
