Evaluation of three as-built aLigo optical levers at LHO: PR3, HAM2, ITMY

Cheryl Vorvick
Optical Lever Acceptance Review
LHO
6/6/2013
T1300651-v1

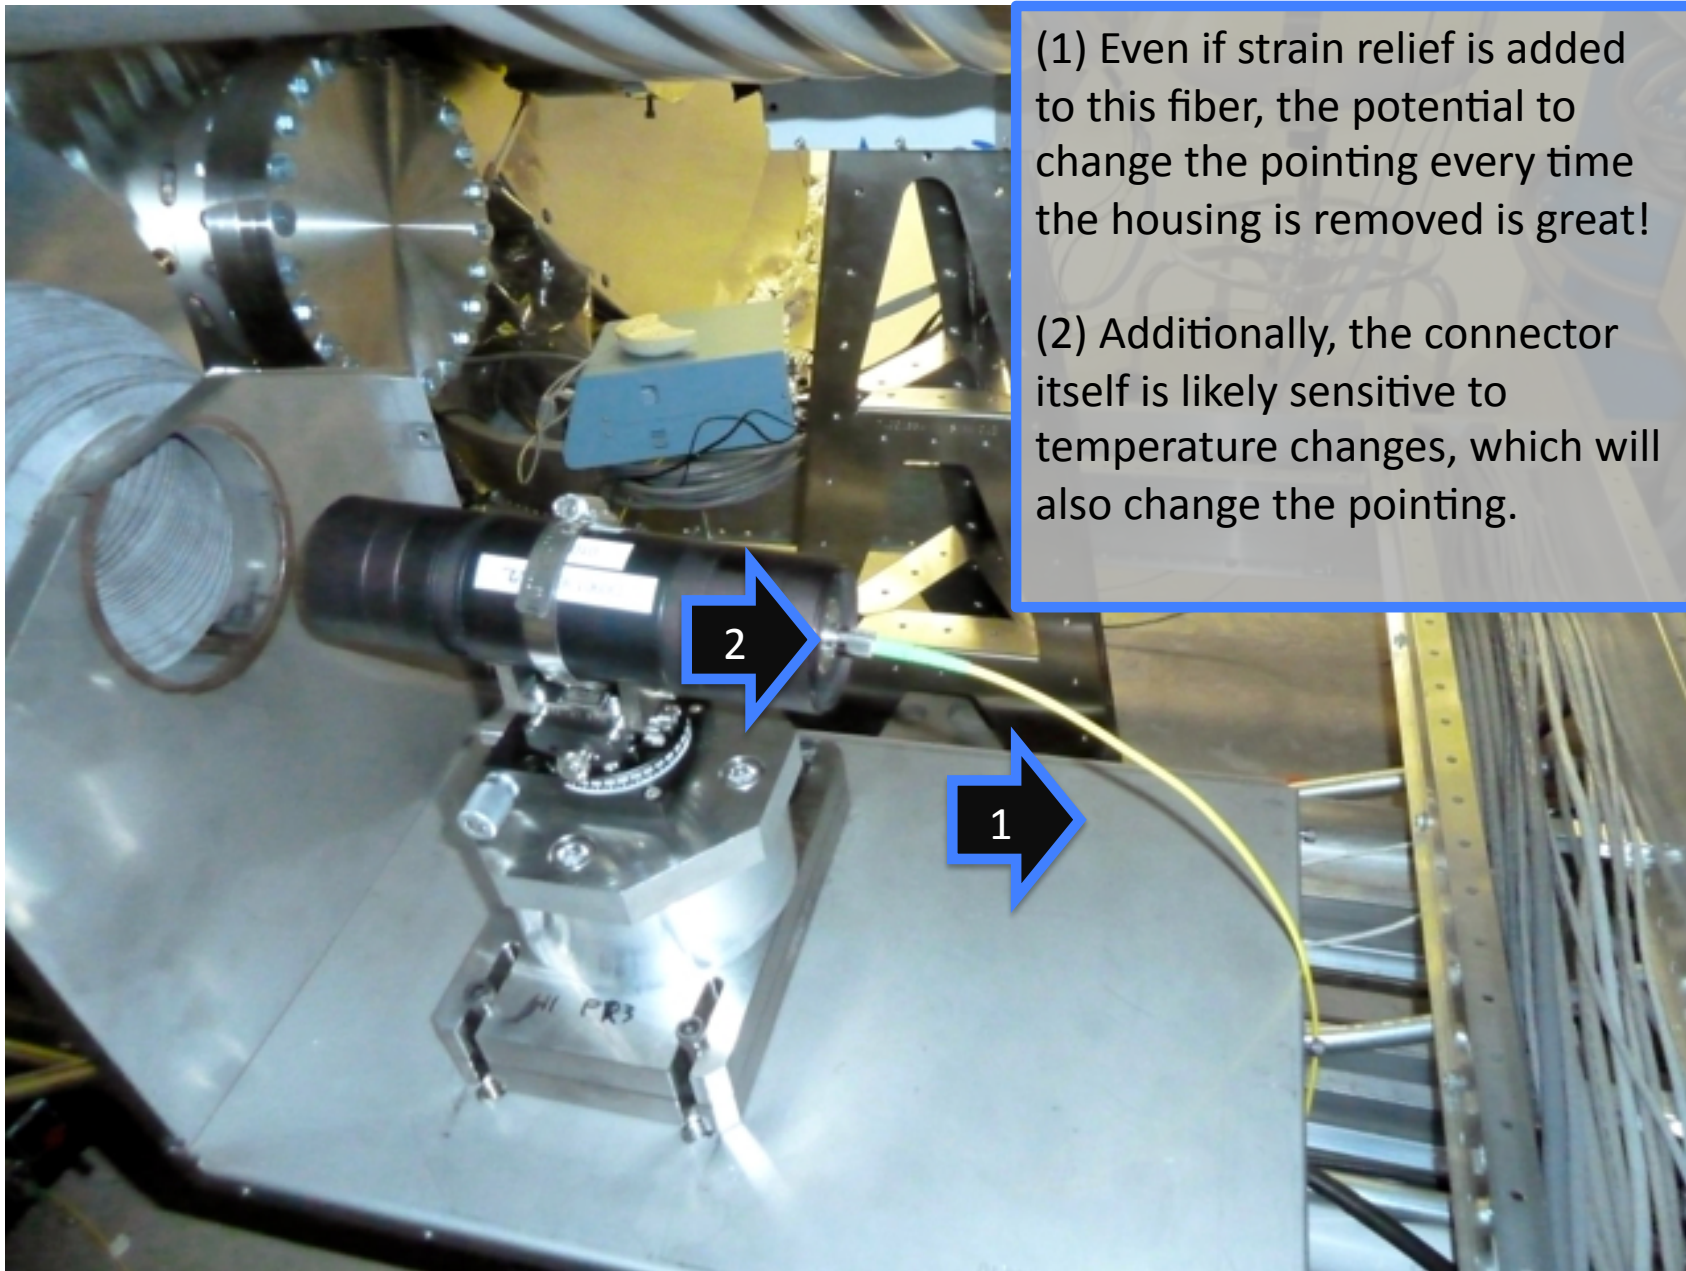
PR3 Optical Lever

(1) Even if strain relief is added to this fiber, the potential to change the pointing every time the housing is removed is great!

(2) Additionally, the connector itself is likely sensitive to temperature changes, which will also change the pointing.

(3) Known dissimilar metal issue?
What tests have been done to
evaluate this issue?

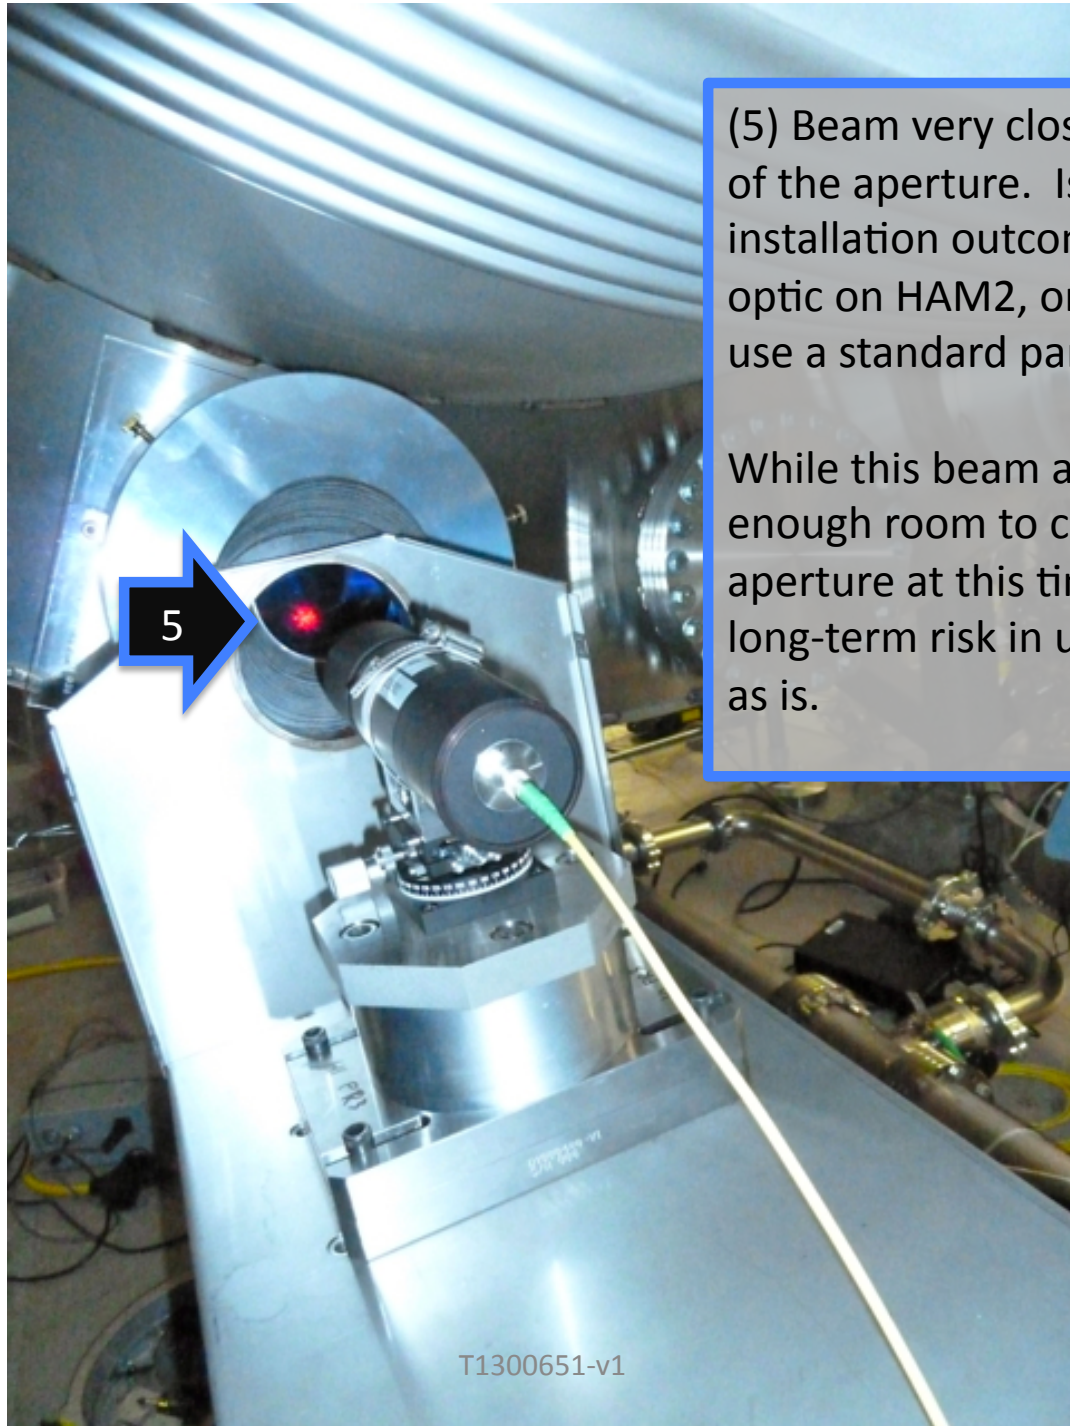
(5) Beam very close to the edge of the aperture. Is this installation outcome due to the optic on HAM2, or some need to use a standard part?

While this beam appears to have enough room to clear the aperture at this time, there is a long-term risk in using the setup as is.

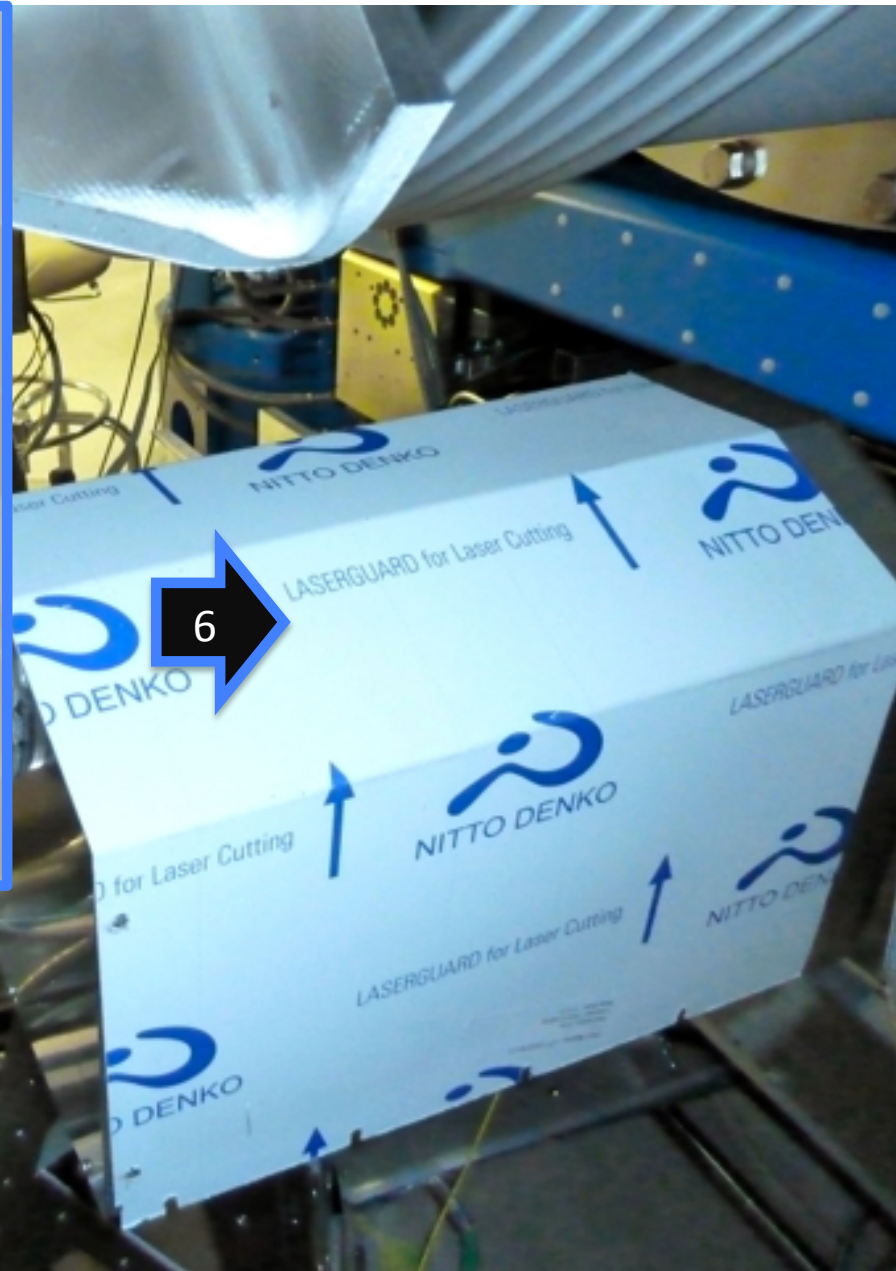
(6) One-piece housing may seem like a good idea, but increases the chance of impact as it's installed and removed, and exposes every part inside the housing to contamination and impact risks while the housing is not installed!

There is a time that happens after installation, and before a science run, where access to the hardware is necessary. **Housings need to protect hardware AND allow access while minimizing risk.**

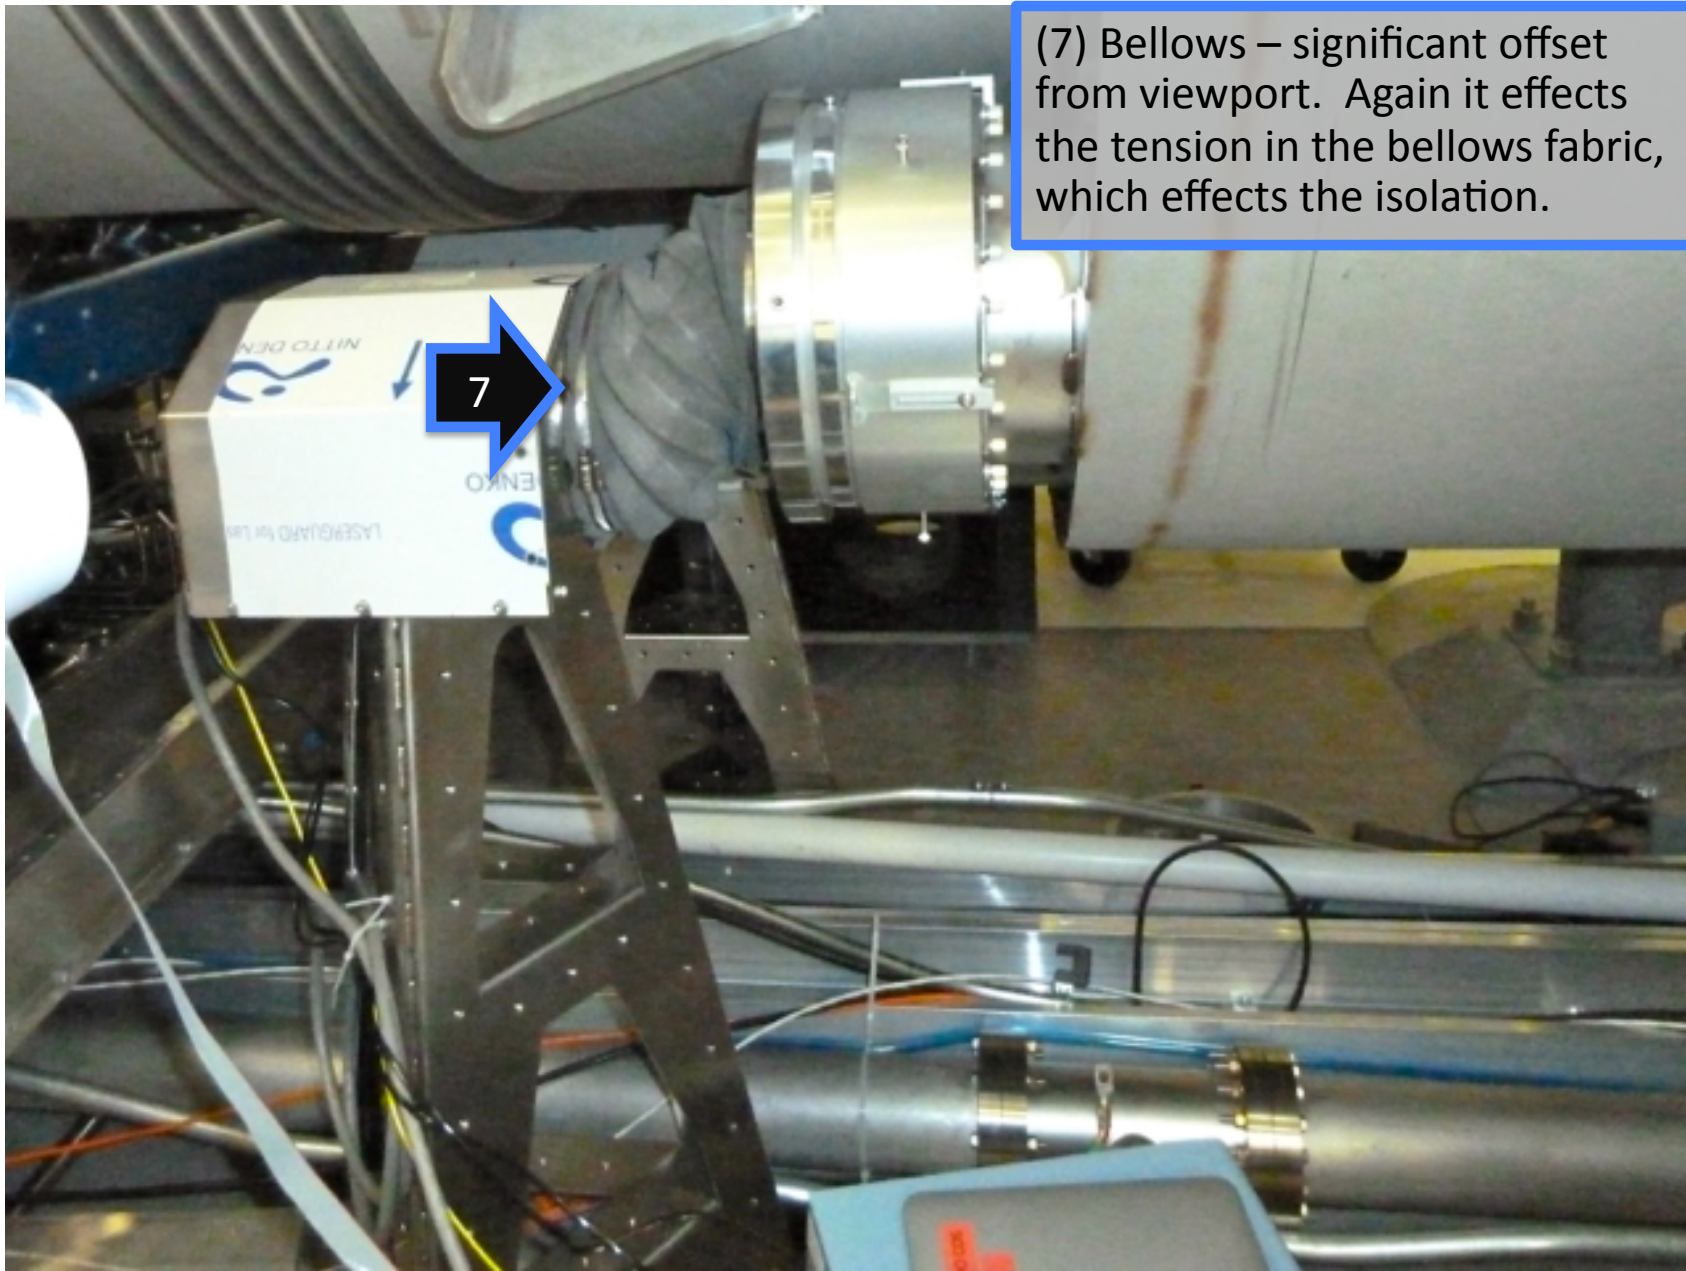
HAM2 Optical Lever

(7) Bellows – significant offset from viewport. Again it effects the tension in the bellows fabric, which effects the isolation.

(1) This fiber, even if strain relief is added, will potentially cause alignment changes due to the removal and installation of the housing.

(2) Fiber attachment point sensitivity to temperature - effect on pointing?

Removing the housing by definition will change the temperature.

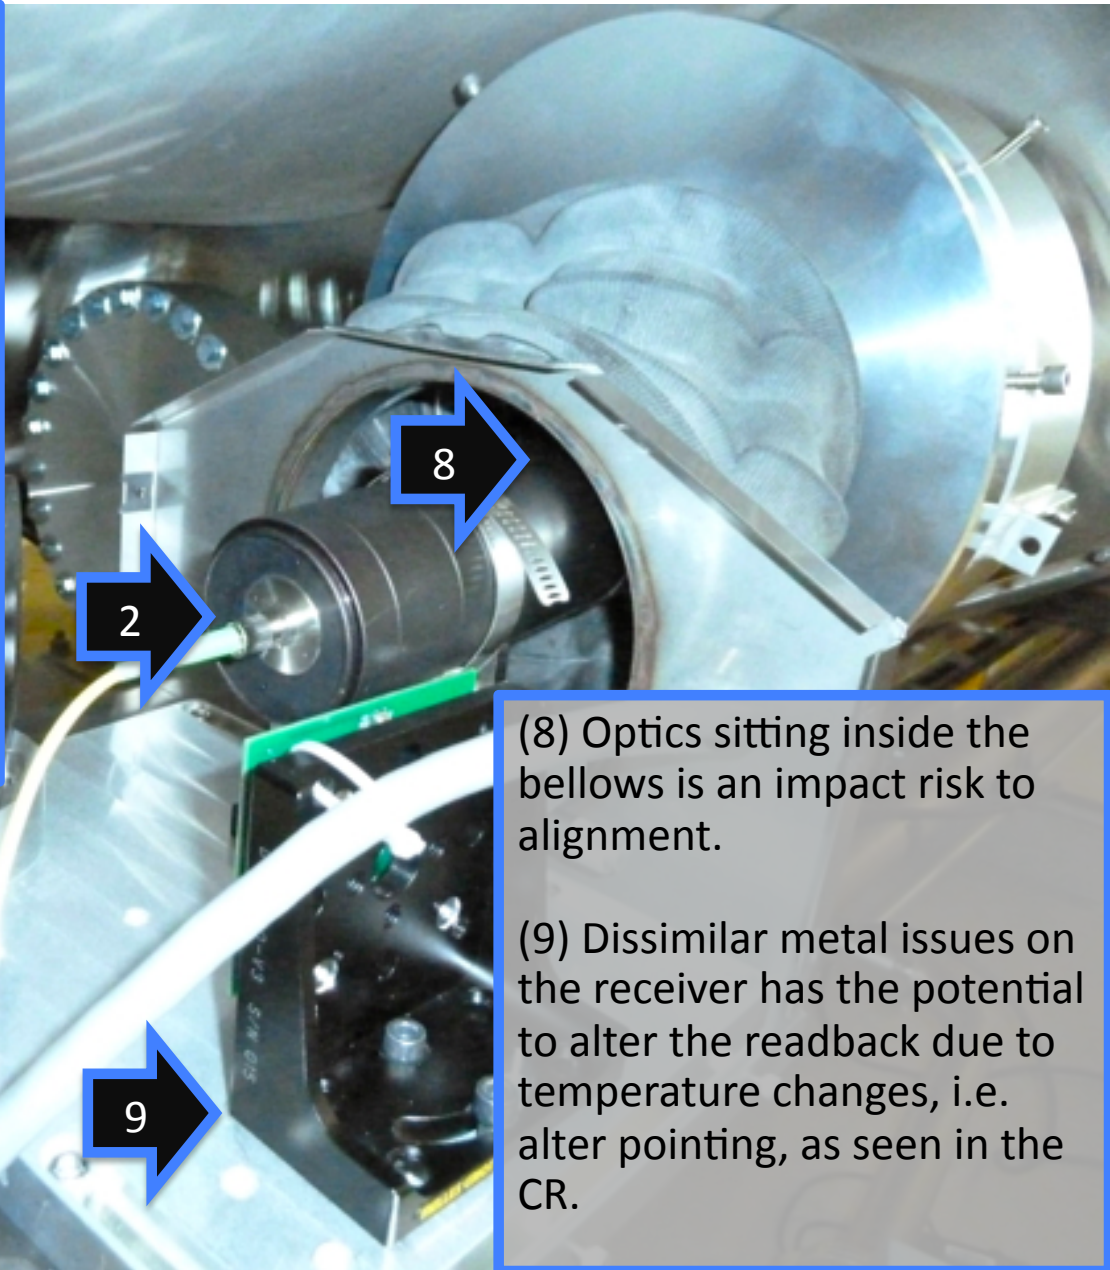
(8) Optics sitting inside the bellows is an impact risk to alignment.

(9) Dissimilar metal issues on the receiver has the potential to alter the readback due to temperature changes, i.e. alter pointing, as seen in the CR.

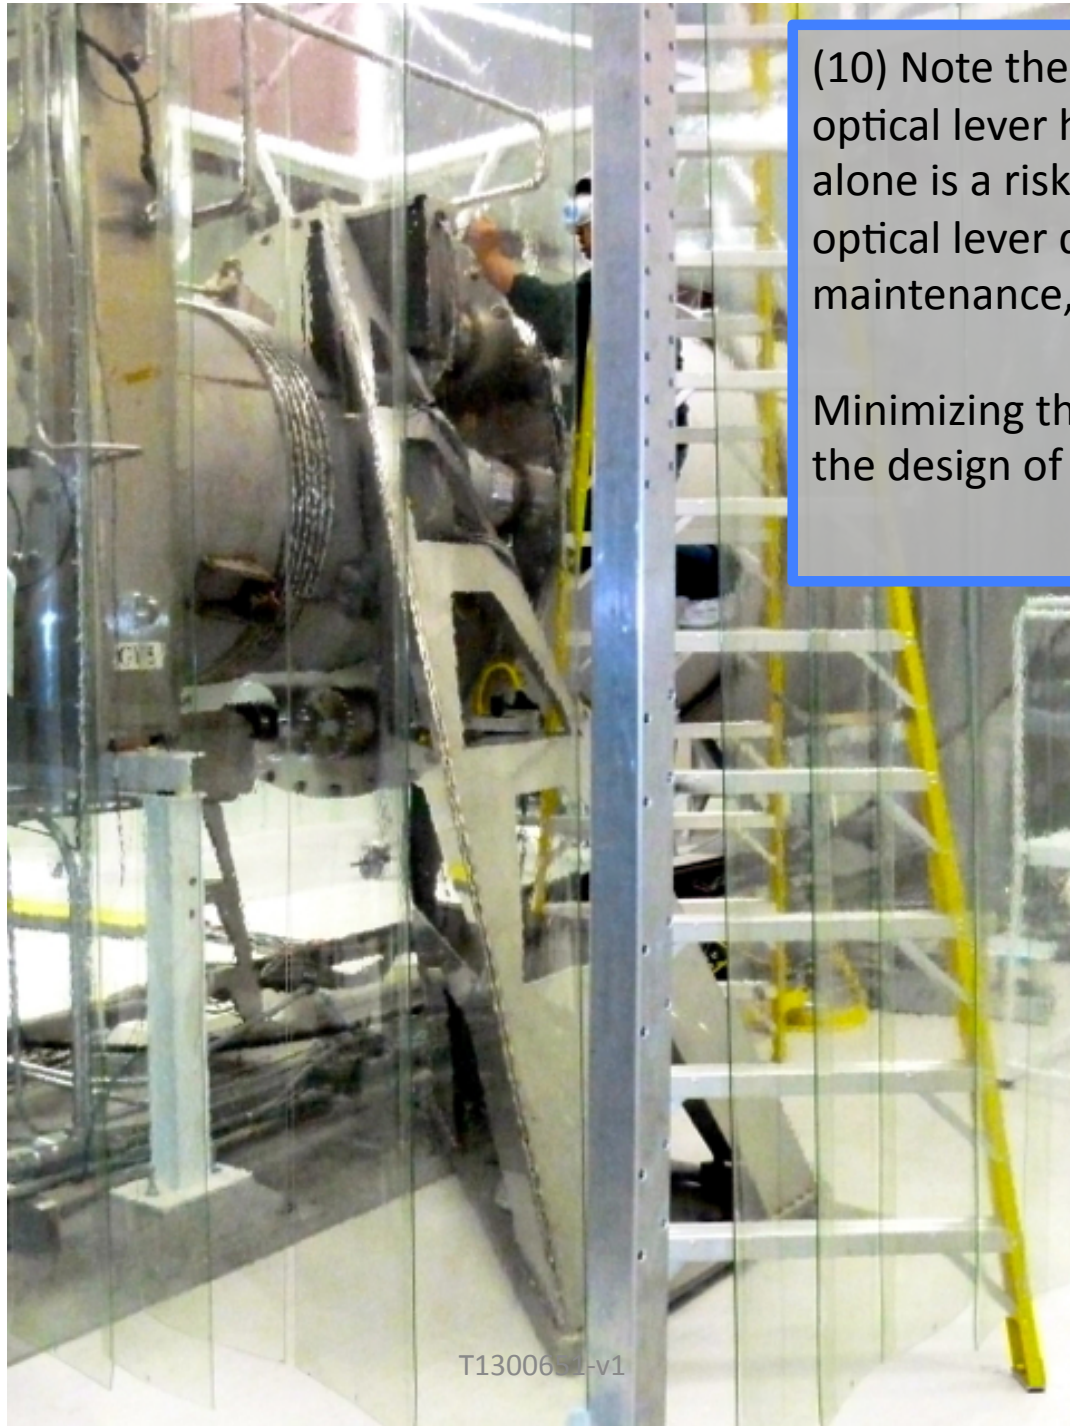
10

(10) Note the height of this optical lever hardware. Height alone is a risk factor for this optical lever during installation, maintenance, and operation.

Minimizing this risk should drive the design of the housing.

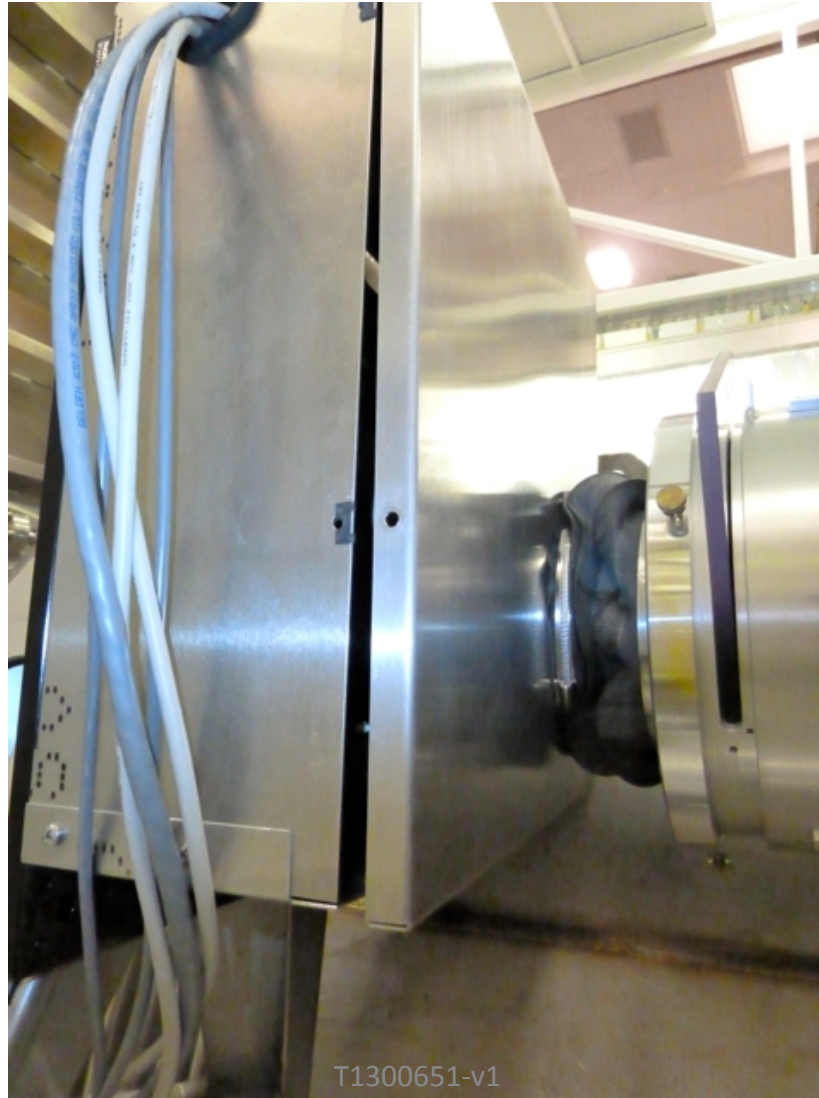
ITMY OpLev Receiver Housing

(4) Bellows - an issue for isolation.

(11) Access to the hardware is through this 1/4" slit.

(12) Alternatively, access is gained through removing the entire front of the housing and the bellows and the oplet viewport enclosure reducer (where the bellows are attached on the viewport side).

Either scenario is a risk to the hardware and the person doing the work.

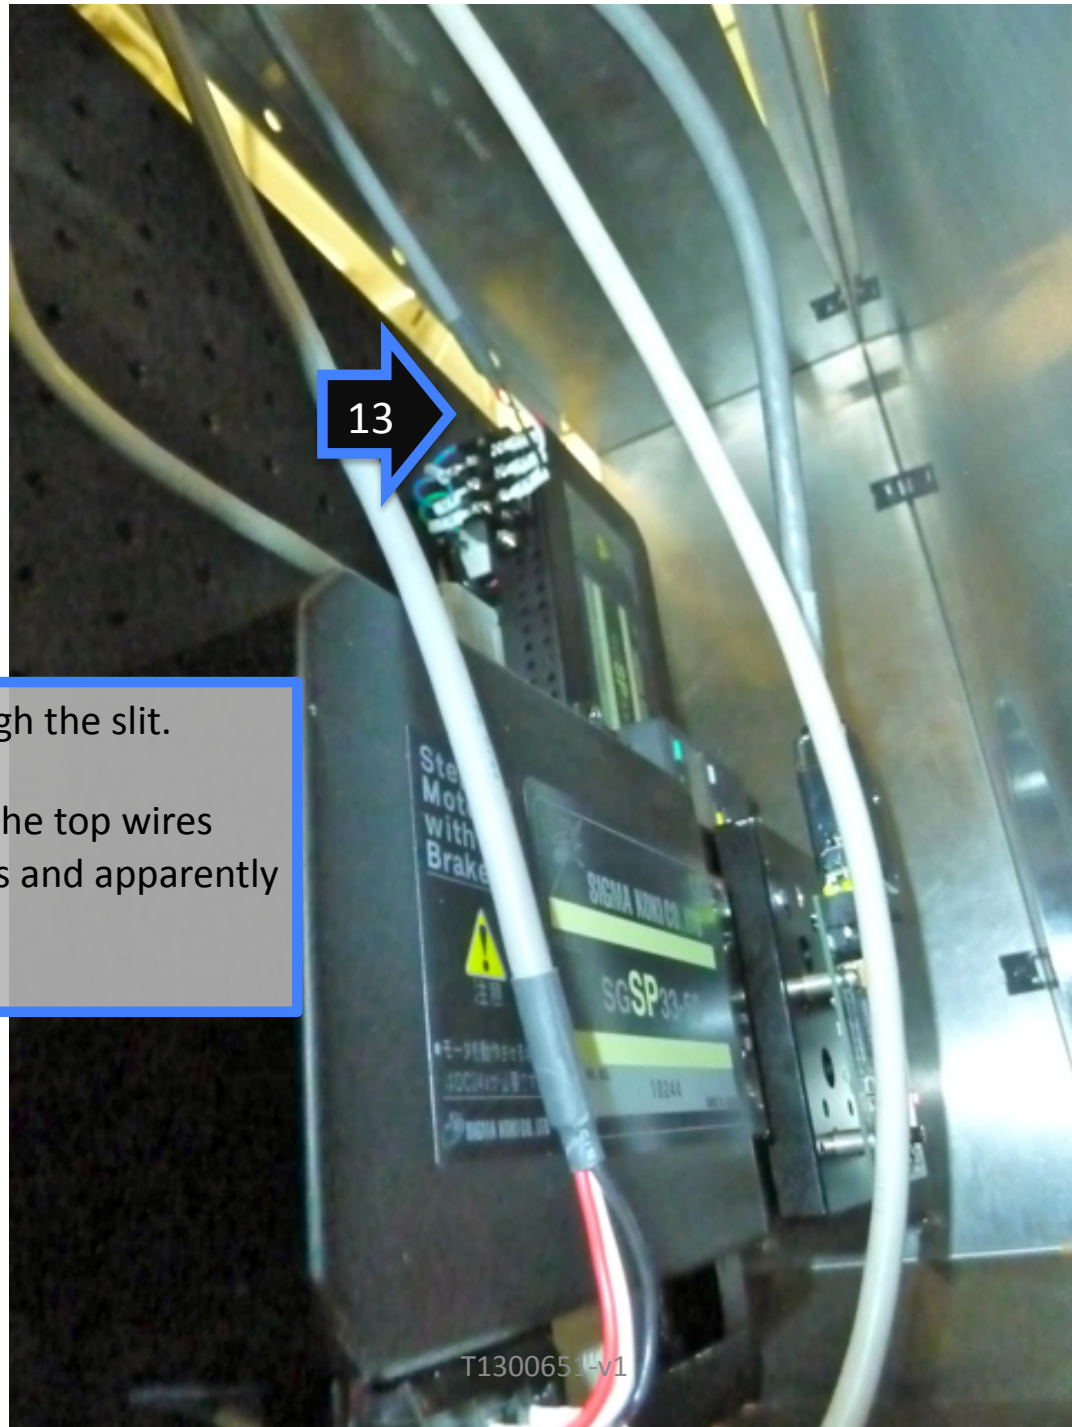
(13b) View through the slit.

A better view of the top wires folded 90 degrees and apparently under tension.

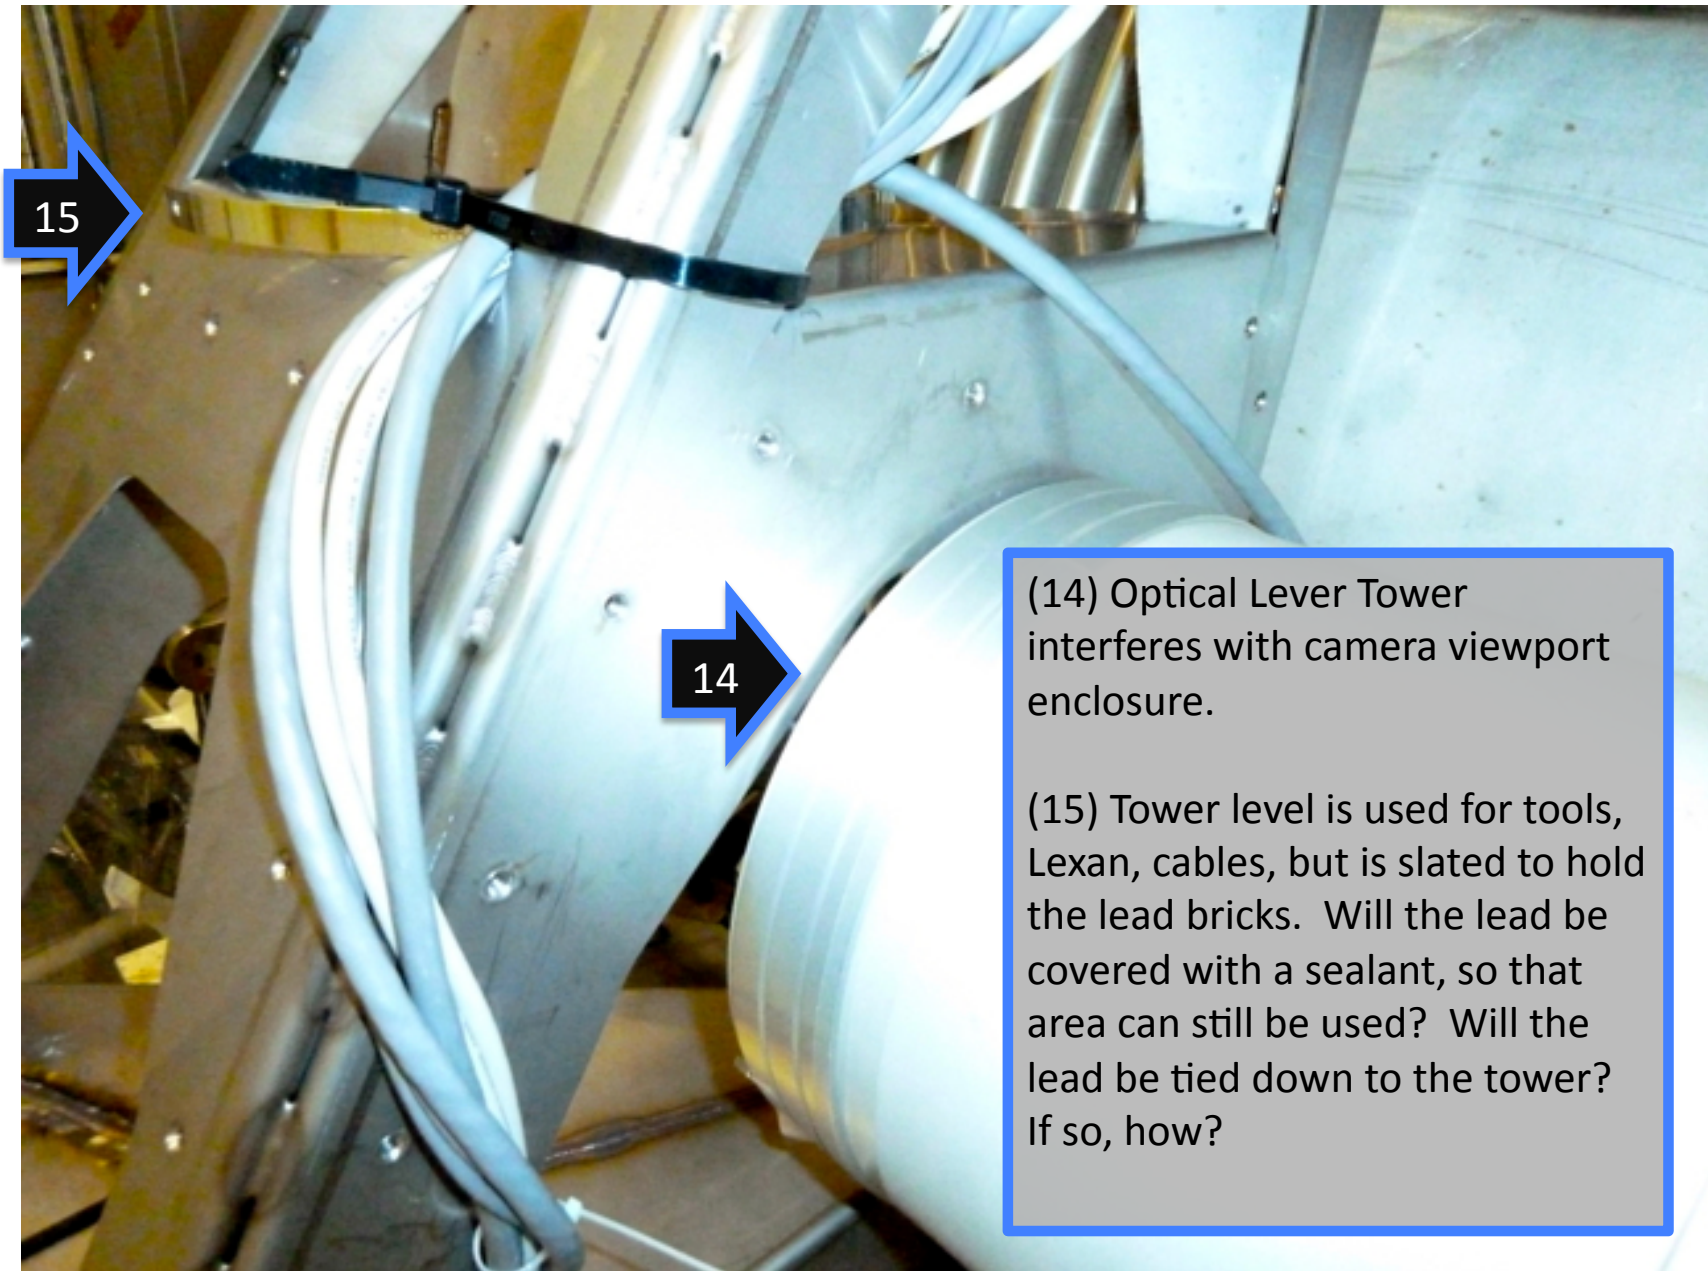
(14) Optical Lever Tower interferes with camera viewport enclosure.

(15) Tower level is used for tools, Lexan, cables, but is slated to hold the lead bricks. Will the lead be covered with a sealant, so that area can still be used? Will the lead be tied down to the tower? If so, how?

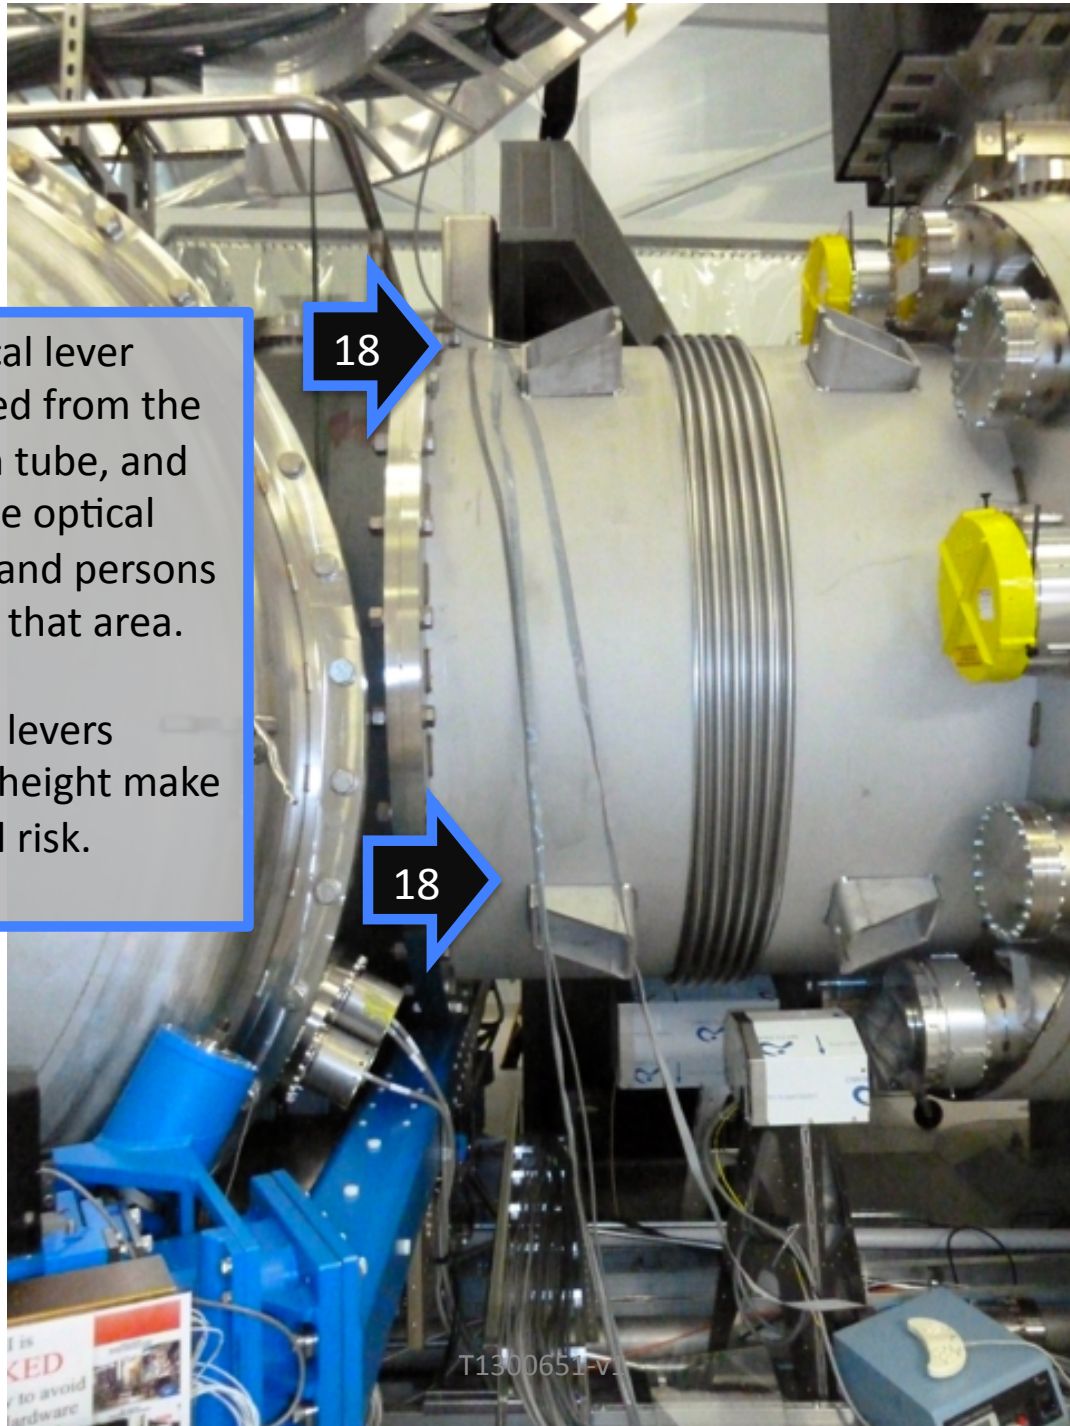
(16) The controller used to center the QPDs is bulky and must be carried to each optical lever, plugged in, and disconnected, every time an optical lever needs to be centered.

This is a risk to hardware and a risk that an off-center optical lever will remain off-center due to limited access, degrading its performance.

Additionally, connecting and disconnecting (or turning on and off) the control box moves the pointing in an unpredictable way.

(17) What tests have been done to show how often centering will be needed?

Do the tests support the belief that centering does NOT need to be handled from the Control Room?

(18) These optical lever cables are draped from the top of the beam tube, and pose a risk to the optical lever hardware and persons working around that area.

Multiple optical levers installed at this height make this a non-trivial risk.
