DYP-2S Corrosion Investigation

Colin Campbell

7/16/04

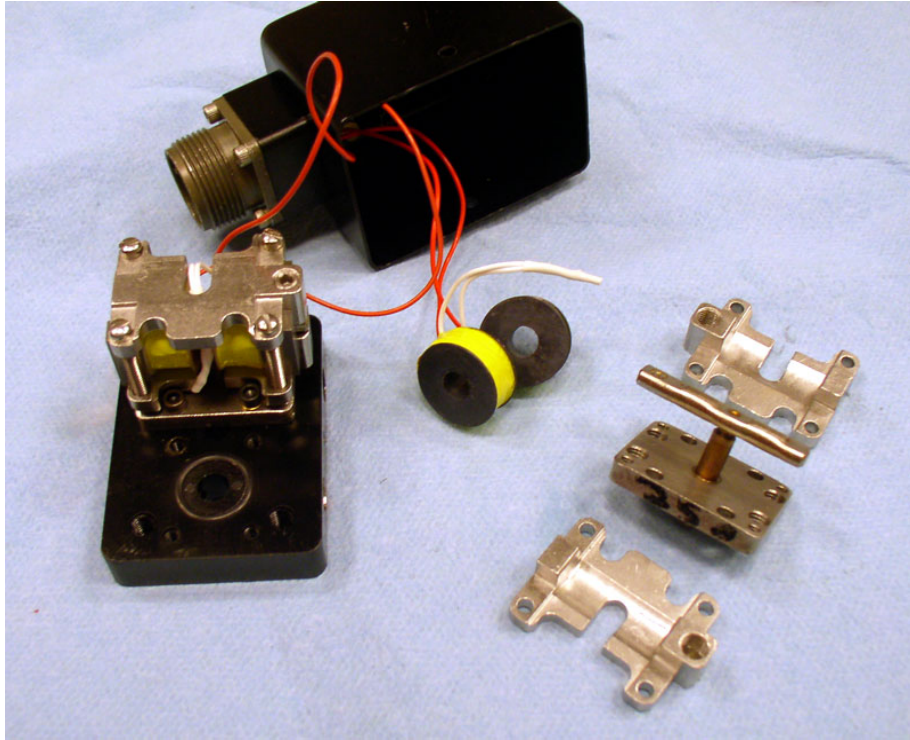
Figure 1. Disassembled valve from LASTI, showing T-shaped flapper assembly at right.

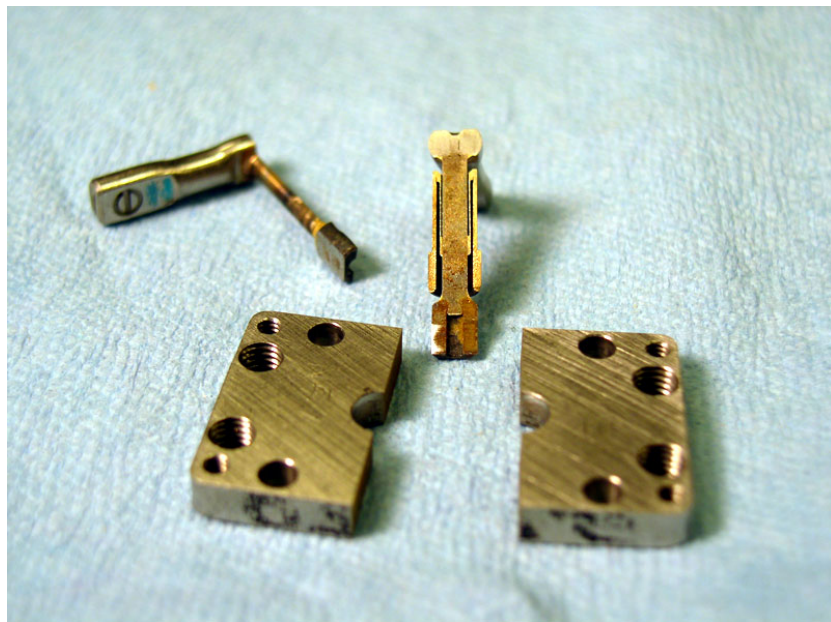
Figure 2. Flapper assembly sectioned by wire EDM.

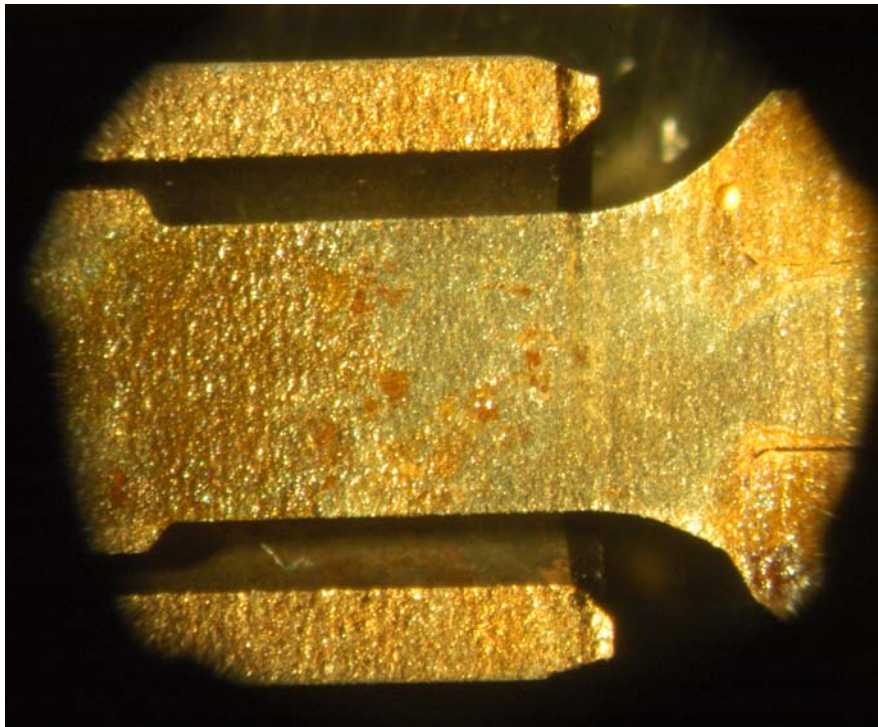
Overview – end of flapper arm, showing flapper tip brazed to the flapper arm.

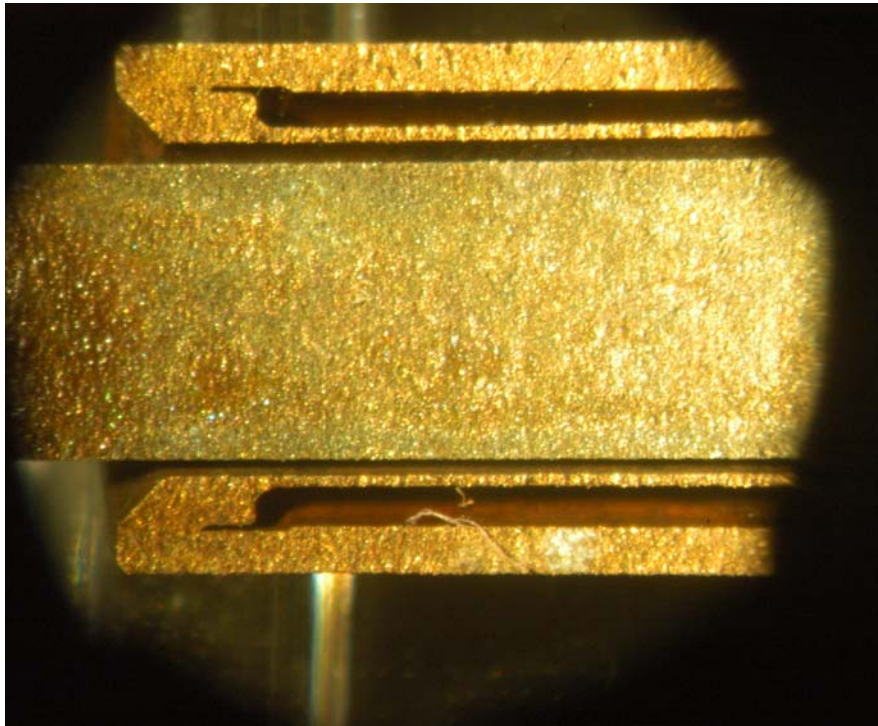
Overview – flapper arm in center, surrounded by flex tube and support tube. Braze between flex tube and support tube visible in upper and lower left.

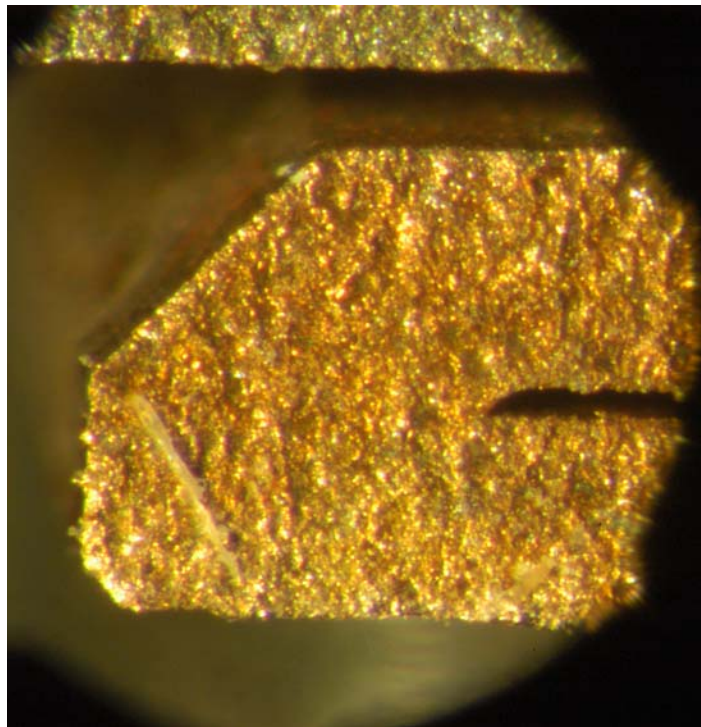
Detail of the braze between the flex and support tubes; from the lower left of previous frame

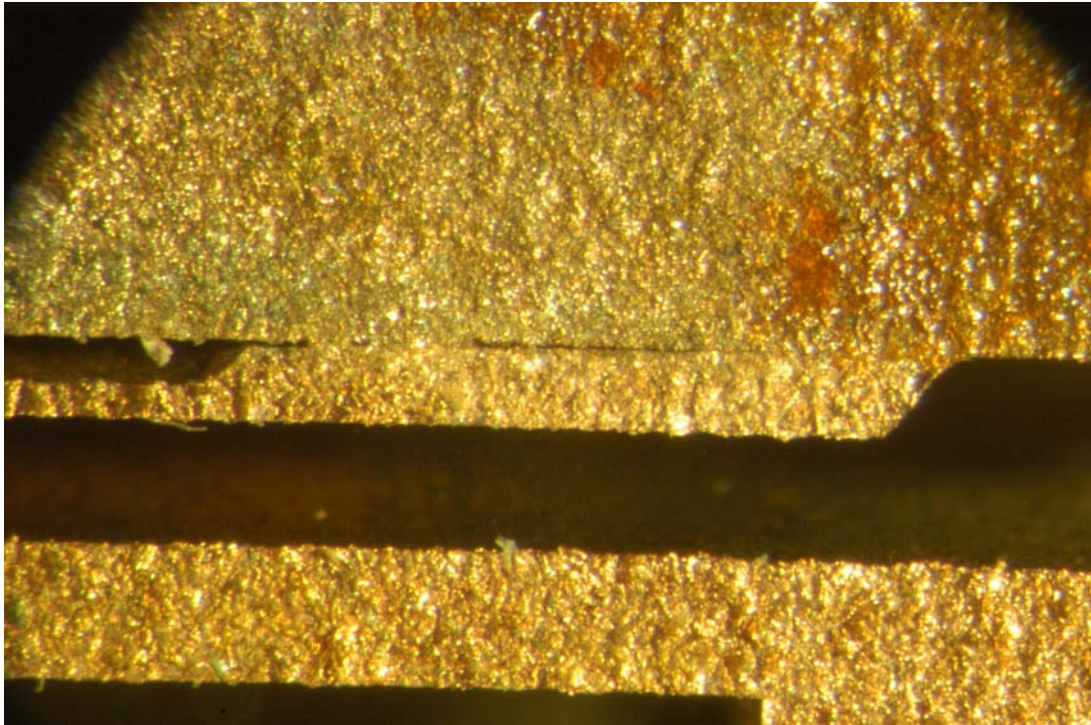
Detail of the press fit between the flex tube and the flapper arm

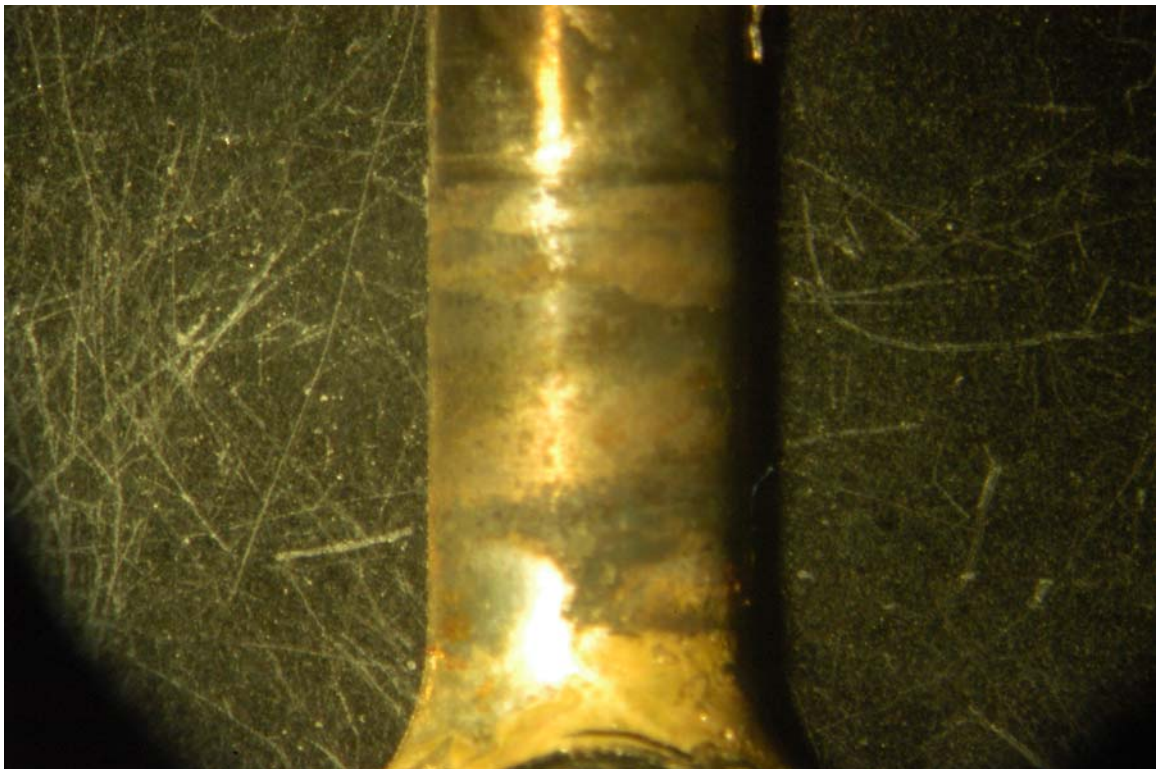
Detail of the press fit area on the flapper arm, after removing the flapper arm from the flex tube

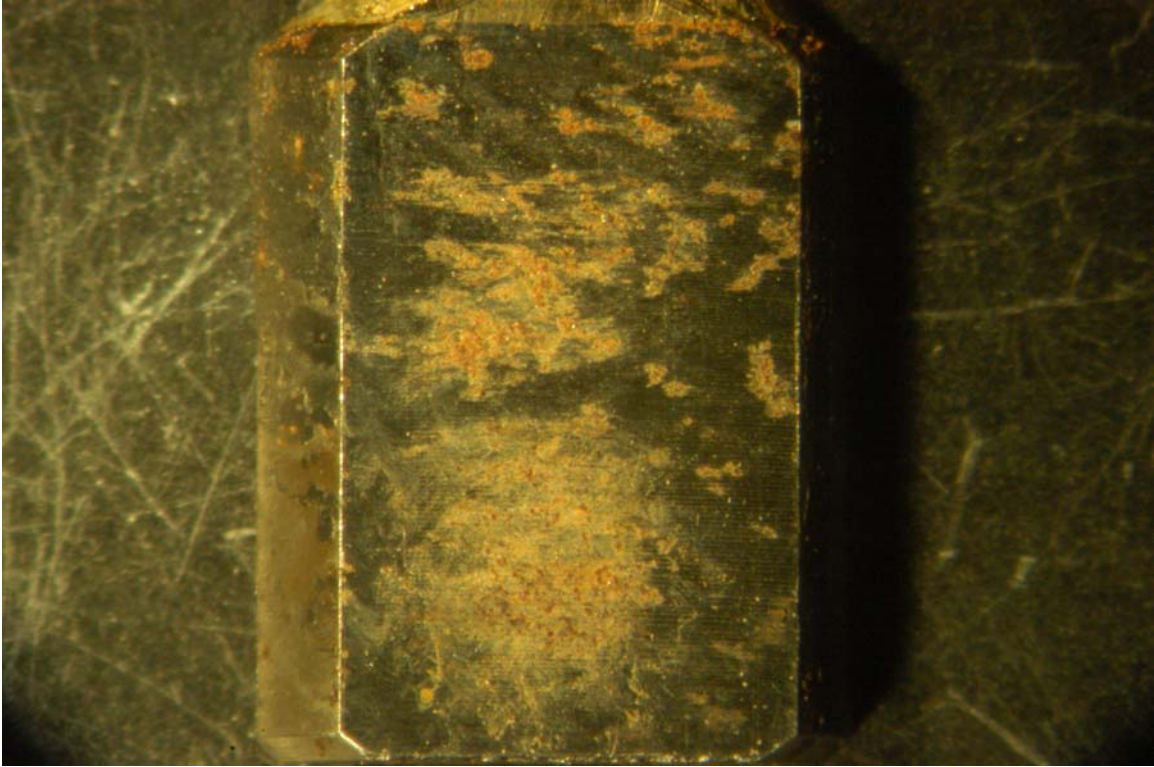
Flapper face. Corrosion seen here is from the wire EDM liquid.

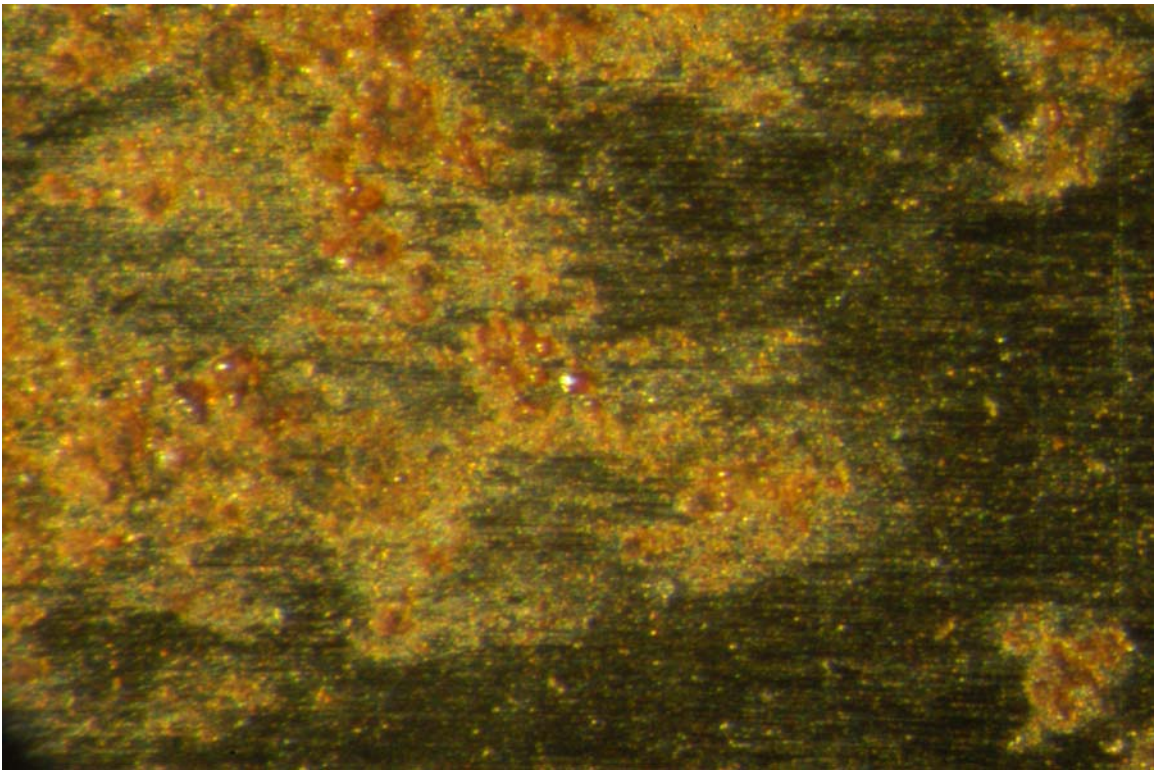
Detail of rust from the EDM bath on the flapper face

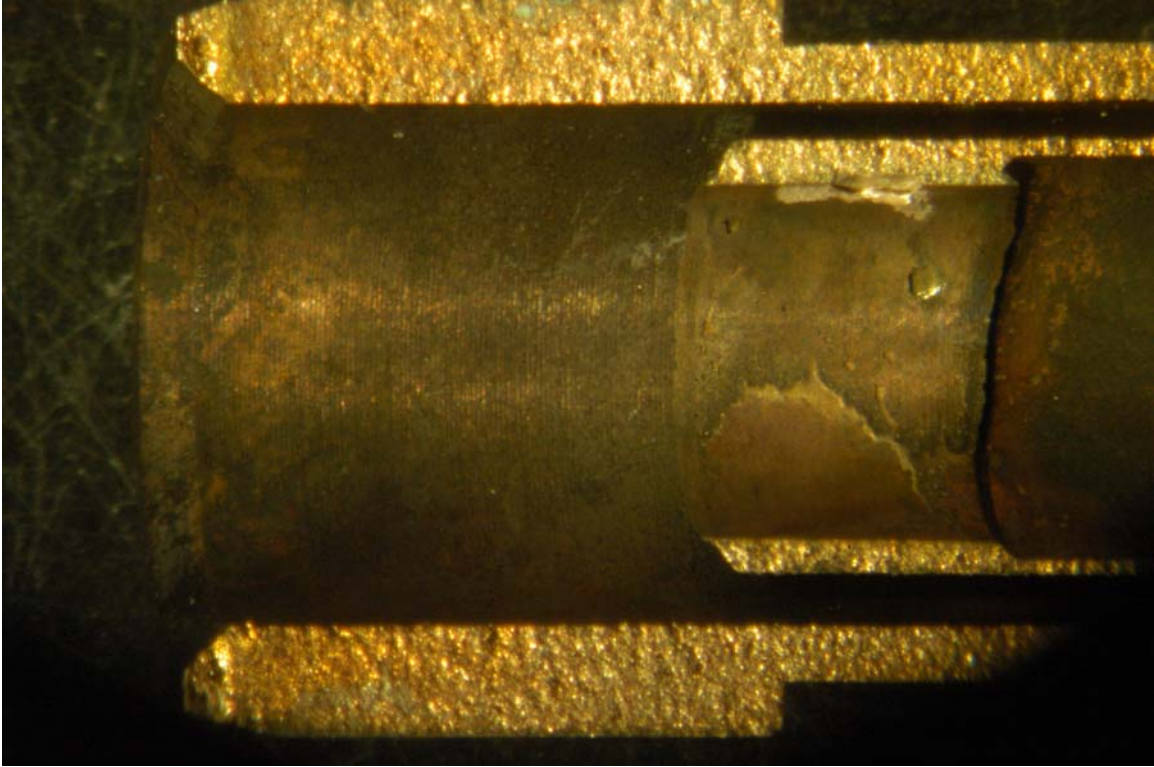
Flex tube on the right, support tube enclosing it. The press fit area on the flex tube is visible.

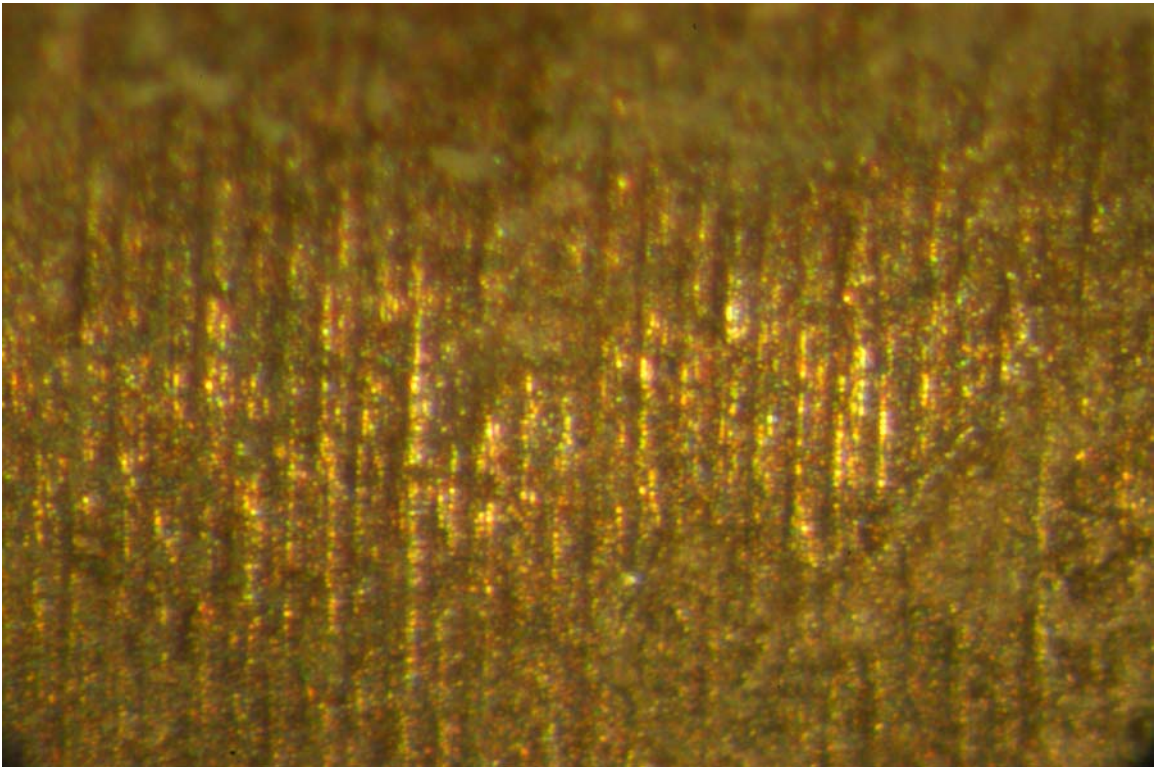
Detail of the press fit area on the flex tube, showing machining marks

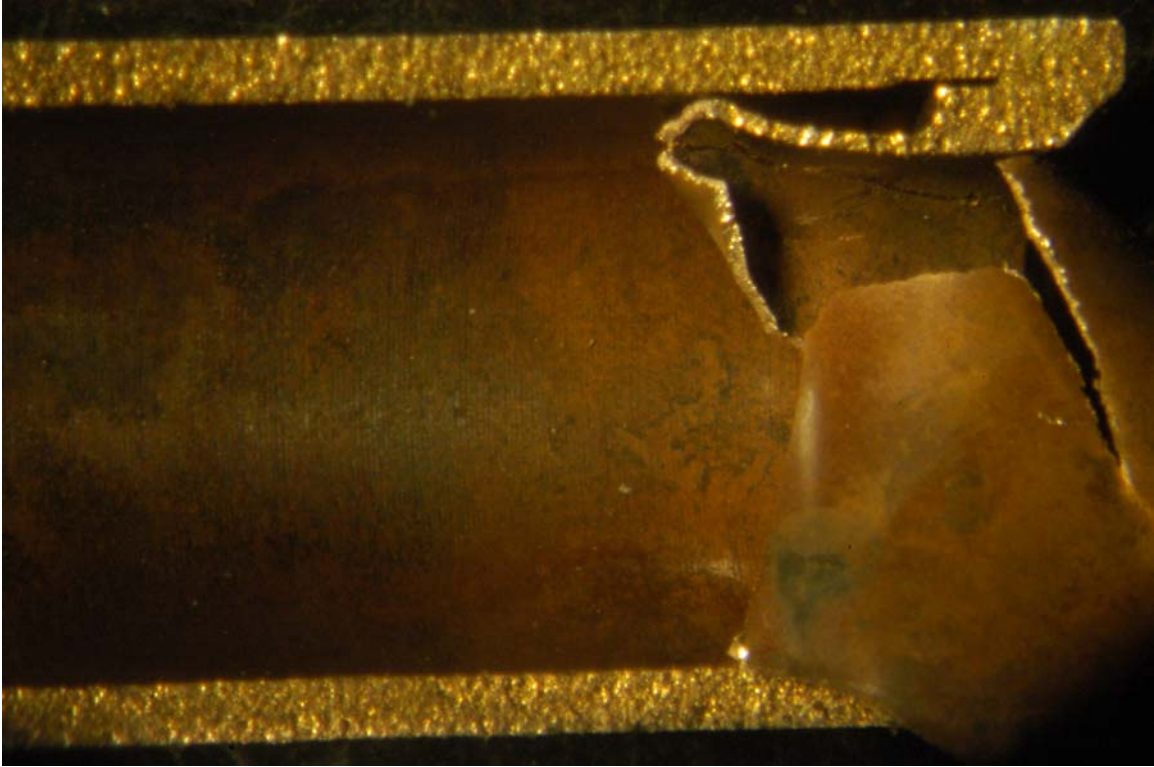
Inner surface of the support tube, after the flex tube has been peeled away on the right.

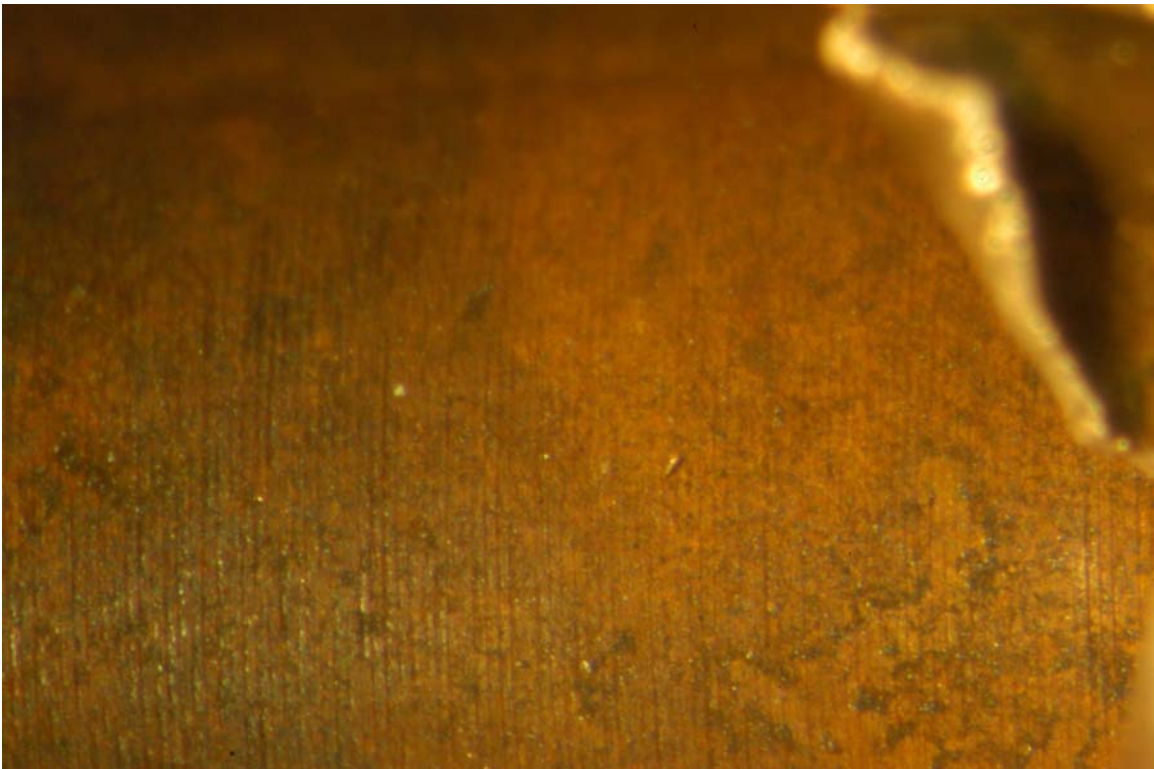
Detail of the inner surface of the support tube.

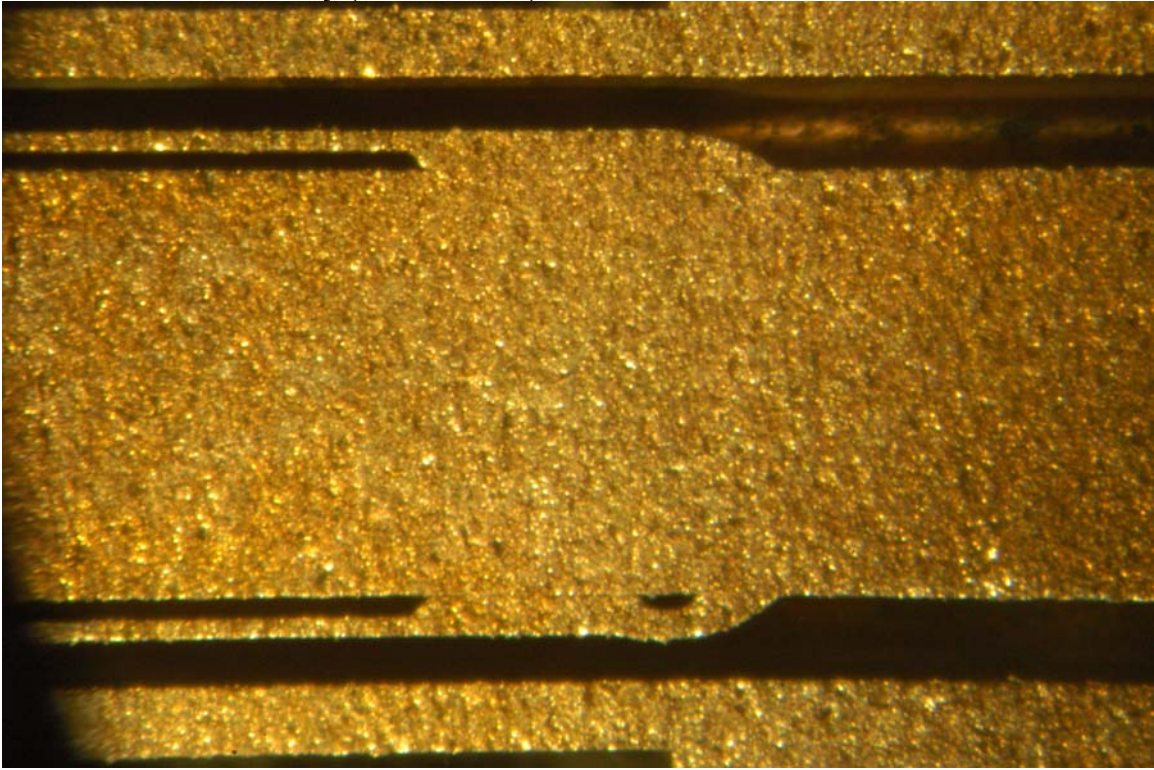
Overview – press fit from flex tube to flapper arm

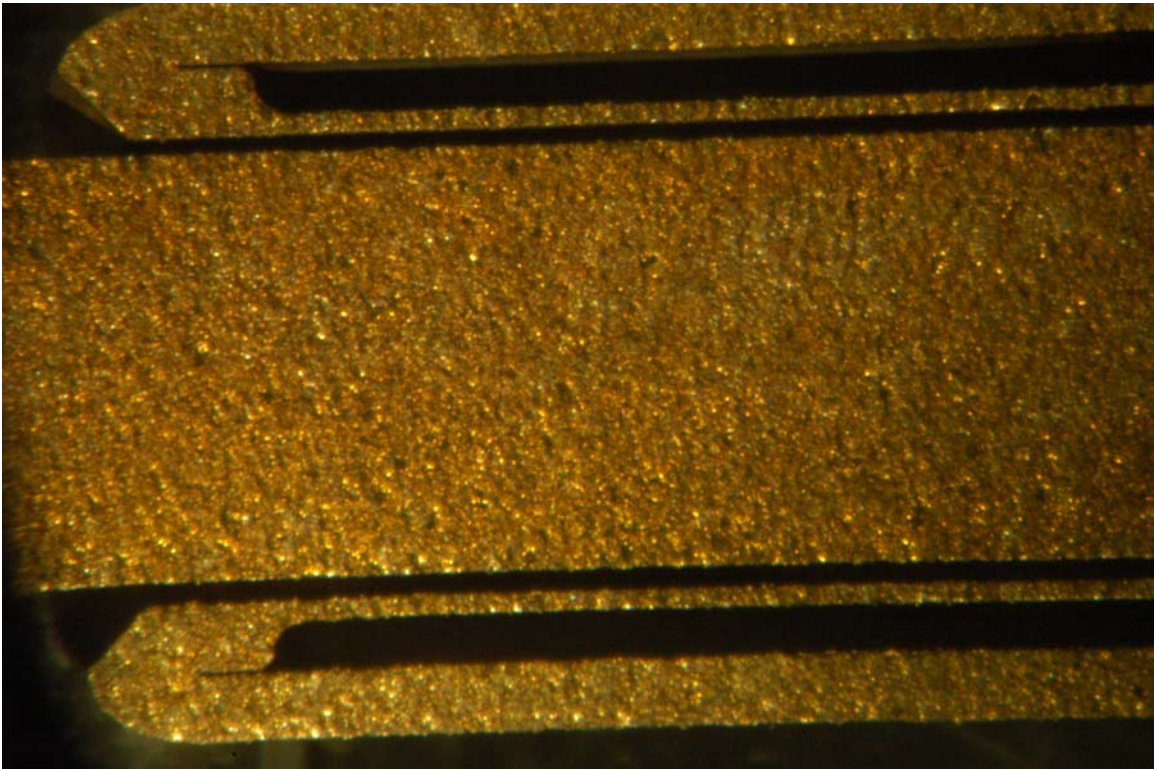
Overview – braze from flex tube to support tube

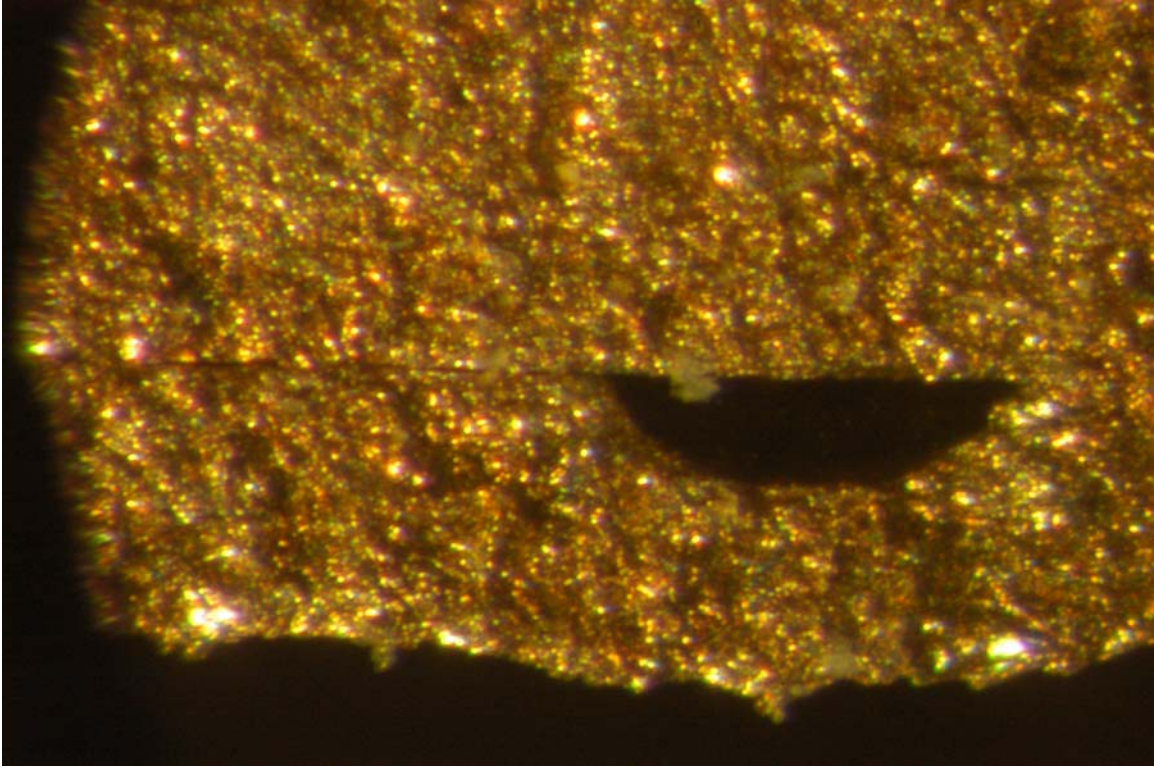
Detail – void in press fit from flex tube to flapper rmp

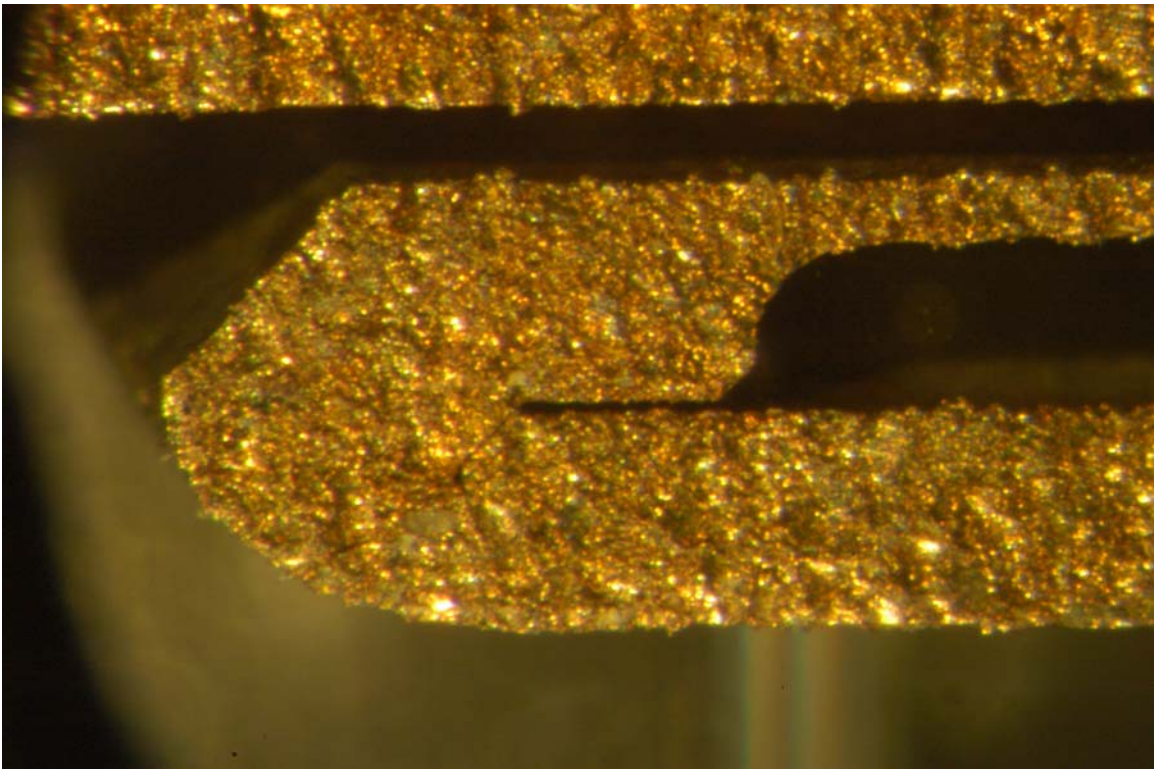
Detail – braze of flex tube to support tube. Note hairline crack extending to the lower left.

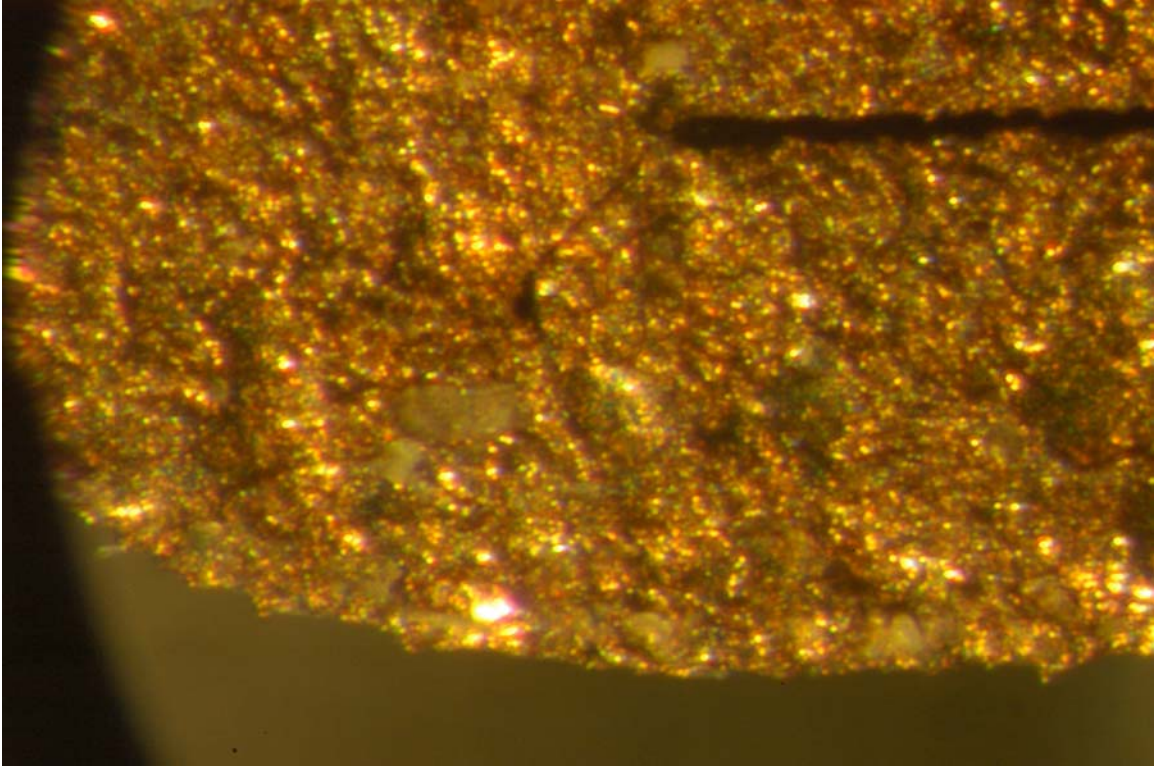
Detail of the hairline crack in the braze.

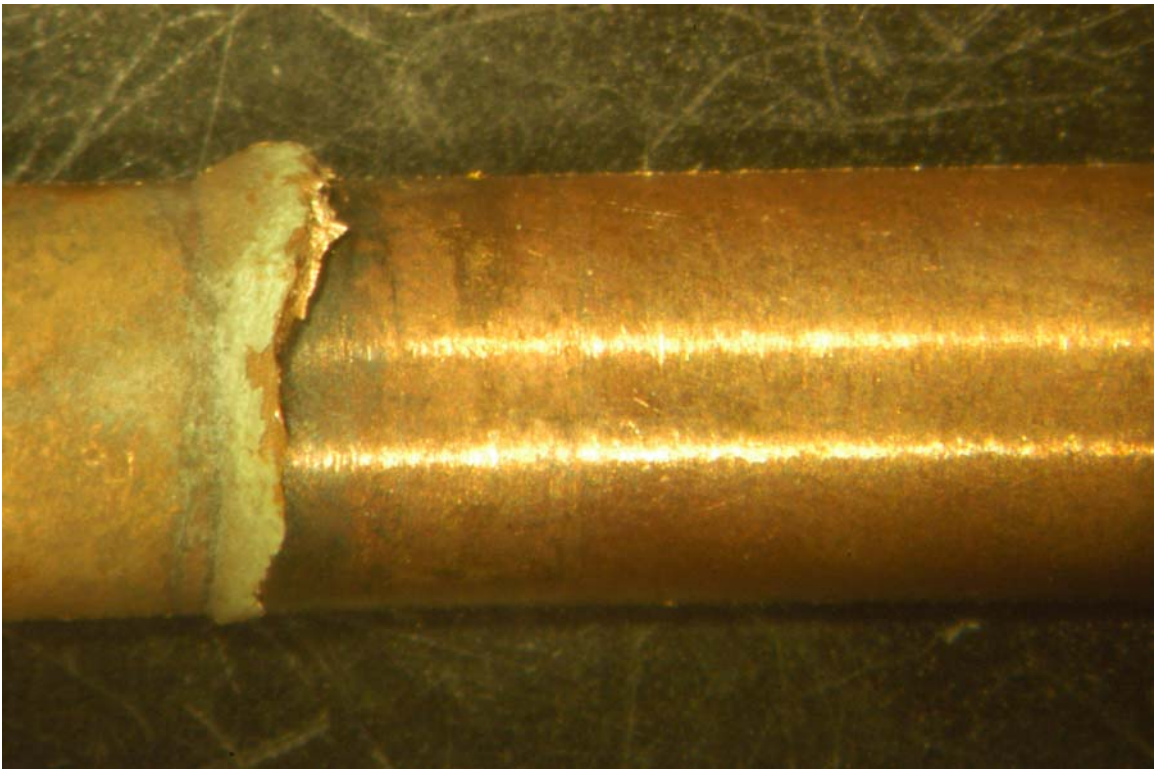
Press fit area on flapper arm, where flex tube was attached. It seems that some flux and/or braze material from the flapper arm/flapper tip joint crept up and partially brazed this joint as well.

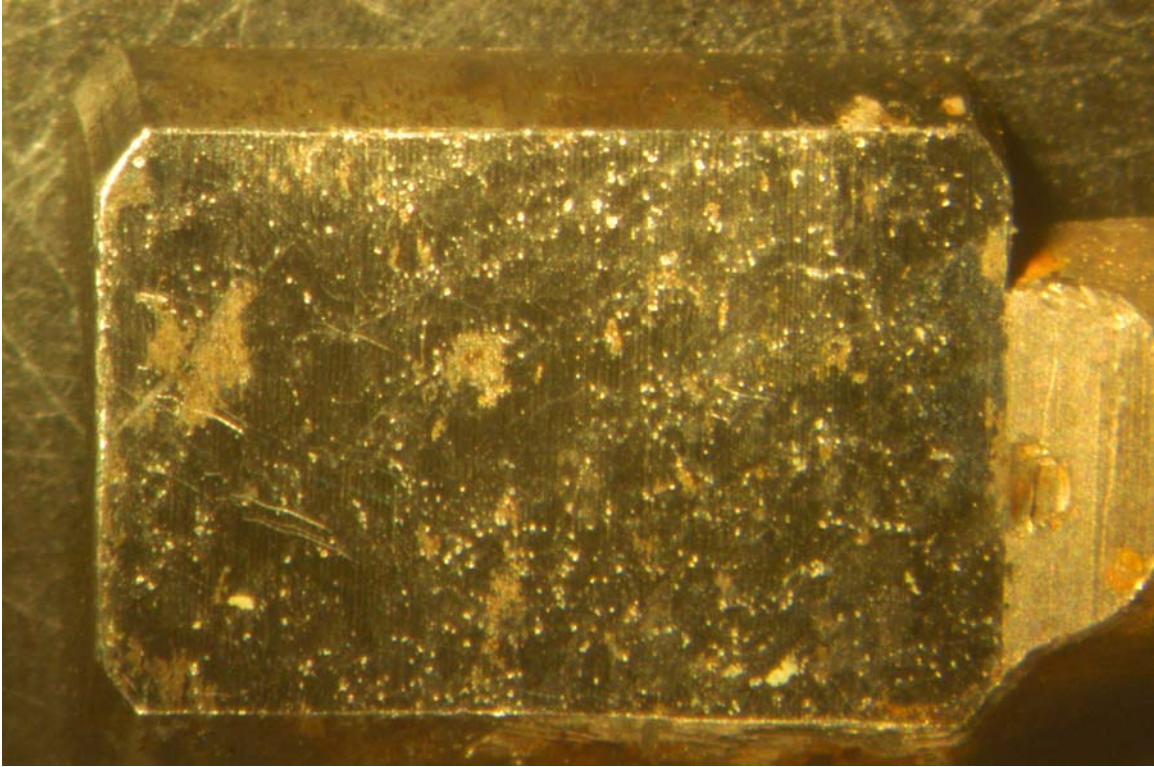
Flapper face. Note the small pits, possibly due to impact from particulates in the working fluid.

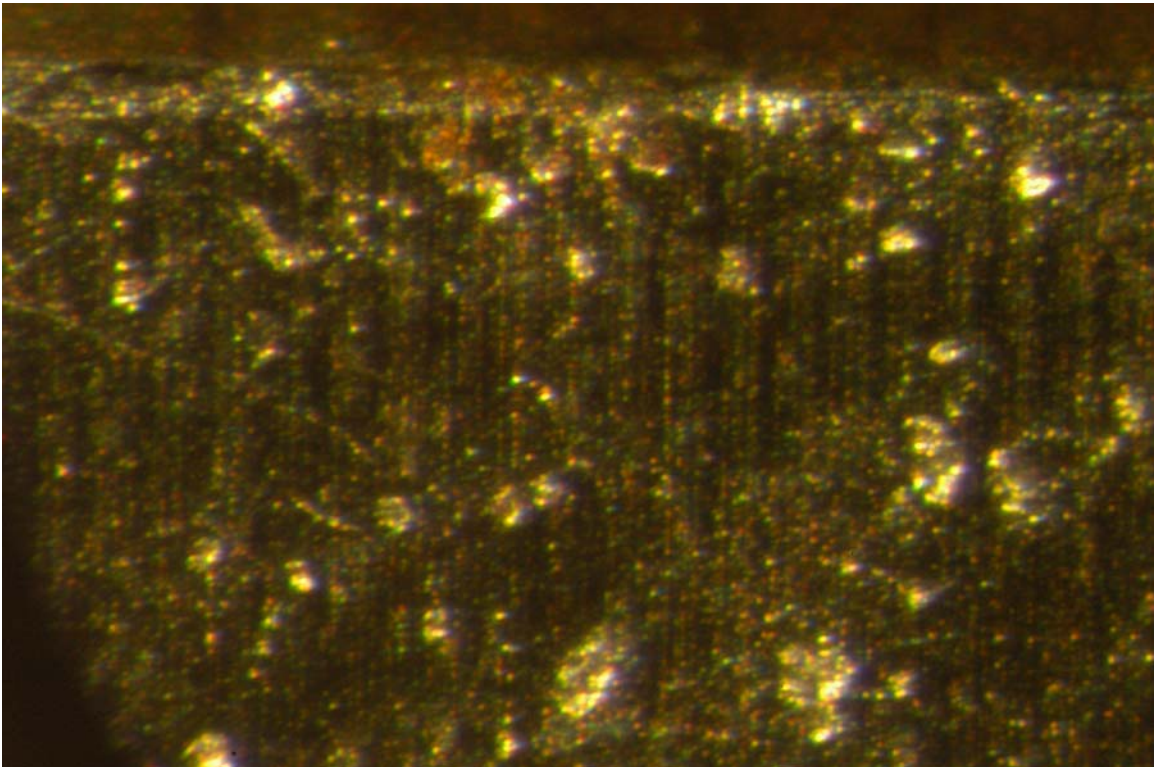
Detail of the small pits on the flapper face.

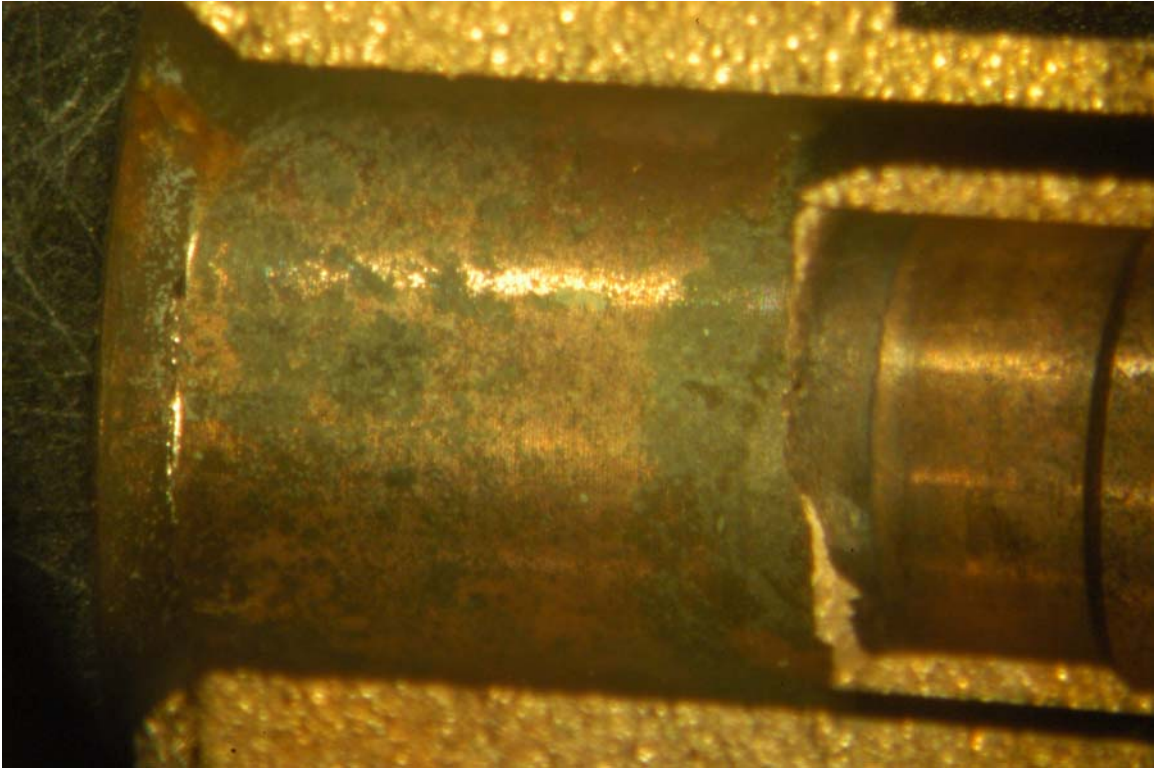
After inspection under an optical microscope, we determined that the valve removed from service had slight surface corrosion but nothing close to compromising its function or fluid integrity. Neither the valve removed from service nor the new valve pulled from the assembly line had any visible defects in the joints sufficient to cause leaks. No biological growth of any kind was observed.

Inner surface of the support tube, with flex tube at right. Some corrosion is evident.

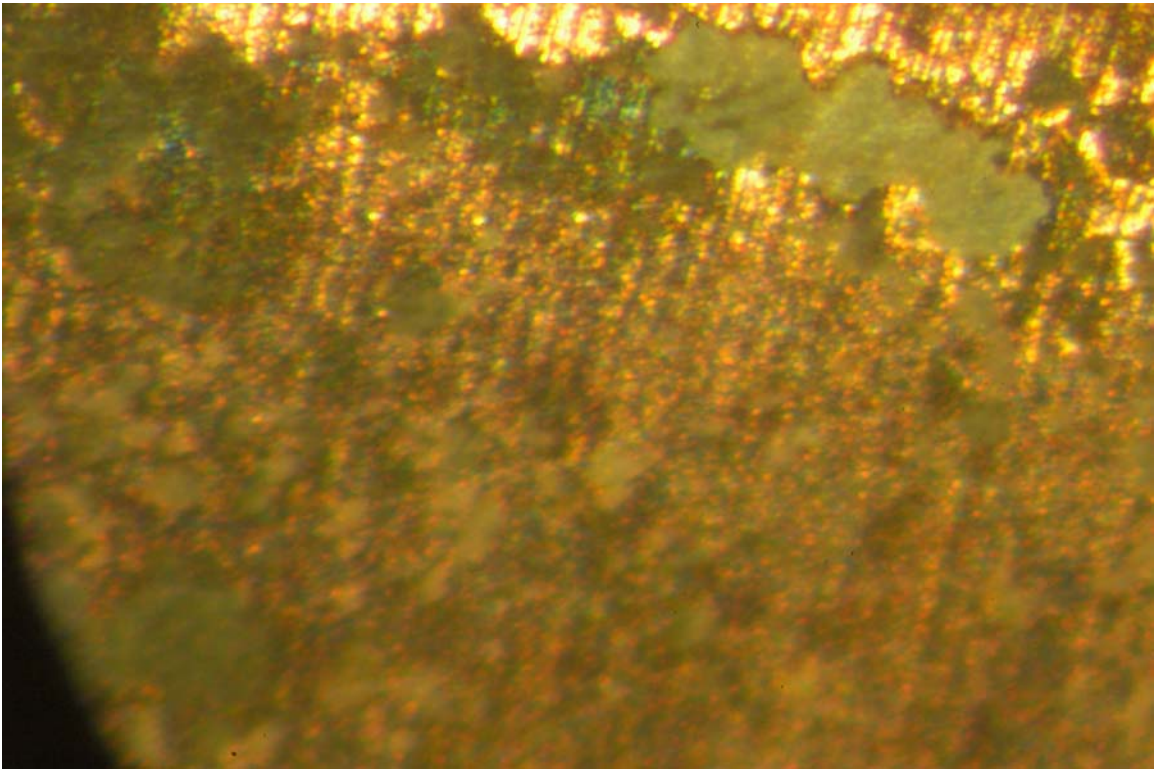
Detail of mild corrosion on inner surface of support tube.

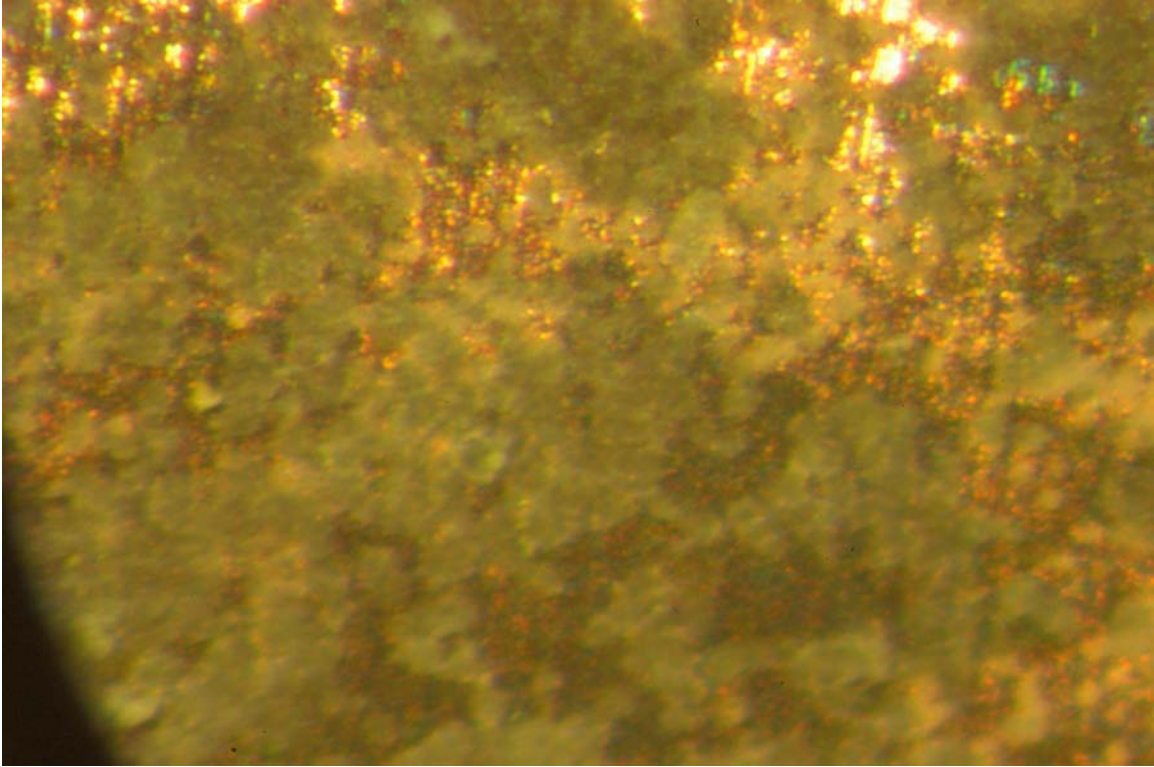
Further detail of mild corrosion on inner surface of support tube.

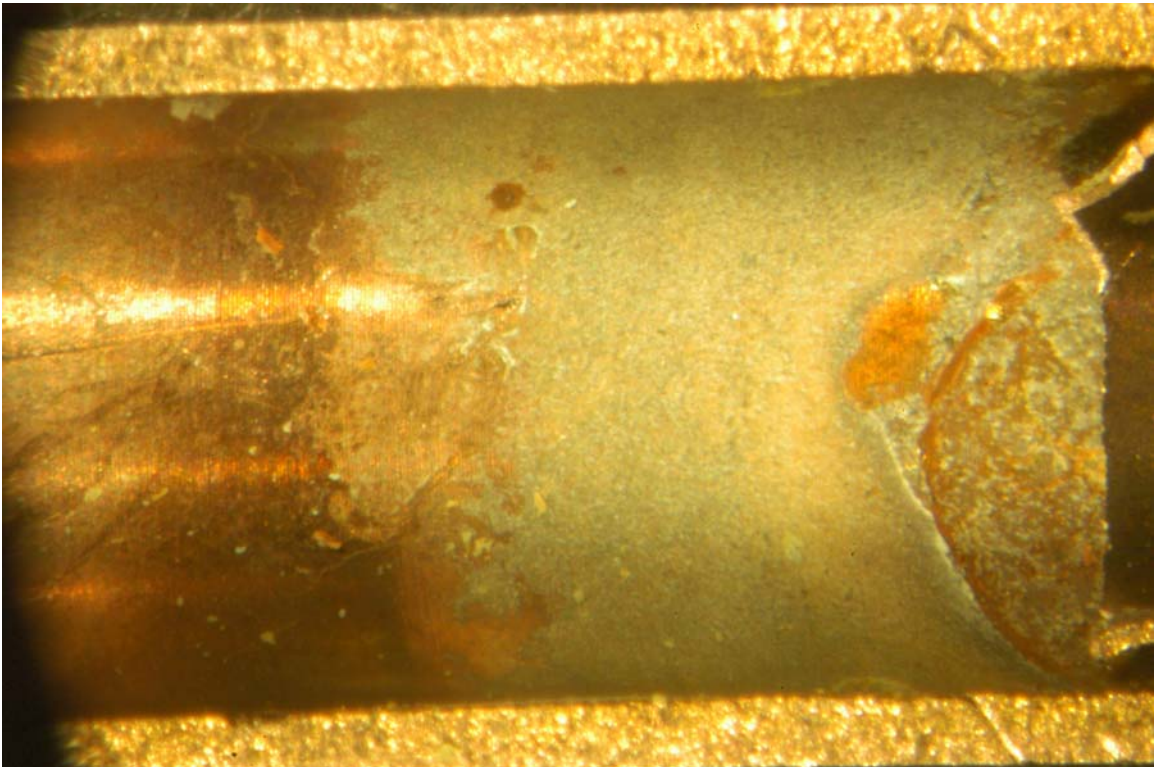
Inner surface of support tube, with flex tube completely removed at right. Again, there is some mild surface corrosion.

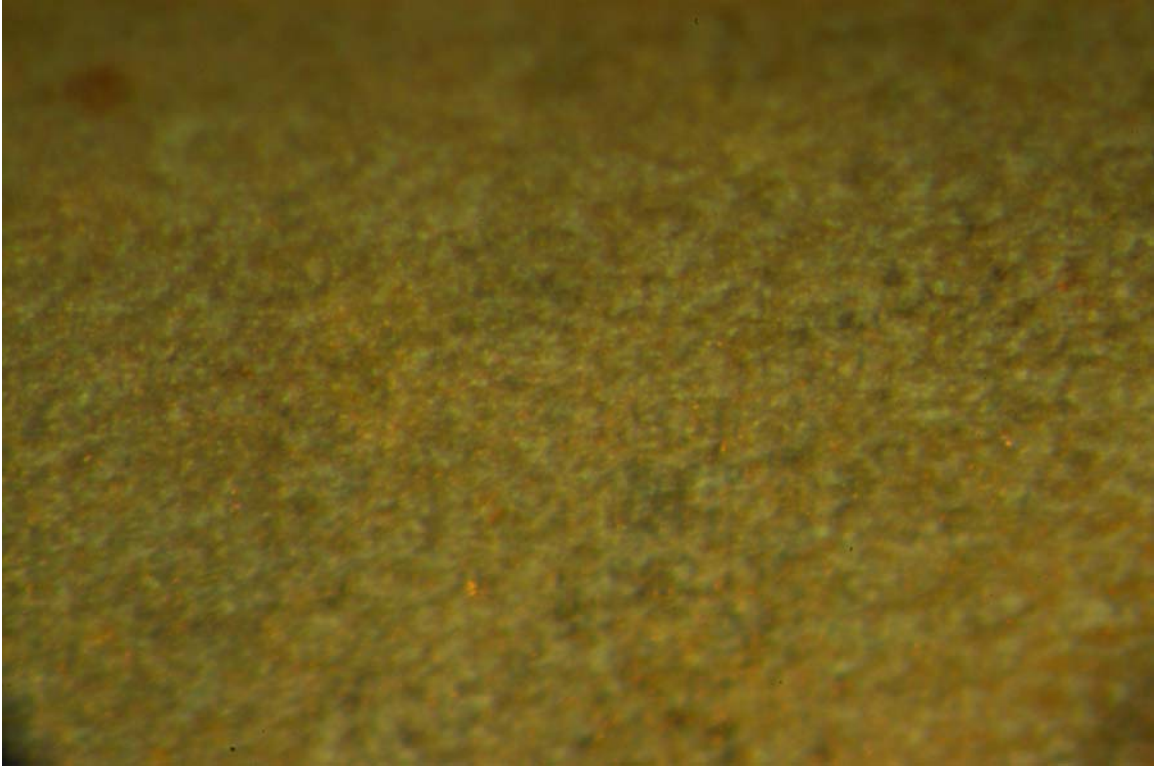
Detail of mild corrosion on inner surface of support tube.
