MEMORANDUM

SUBJECT: Modifications to the TTFSS V4

Refer to: LIGO-E1700364-v2

This document lists the modifications to the 4th generation TTFSS, based on PCB D1700346-v1 and on schematics <u>D1700077</u>, <u>D1700076</u> and <u>D1700078</u>.

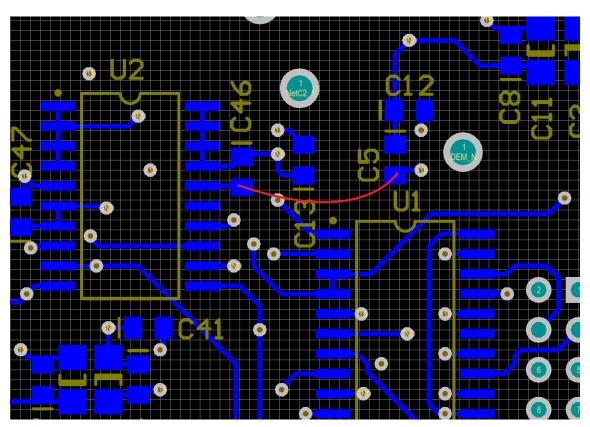
Change 1:

U2 is missing the +15V rail. Add a jumper wire between the C5 pad towards U1 and the C46 pad towards U1 (Servo board, D1700077, bottom).

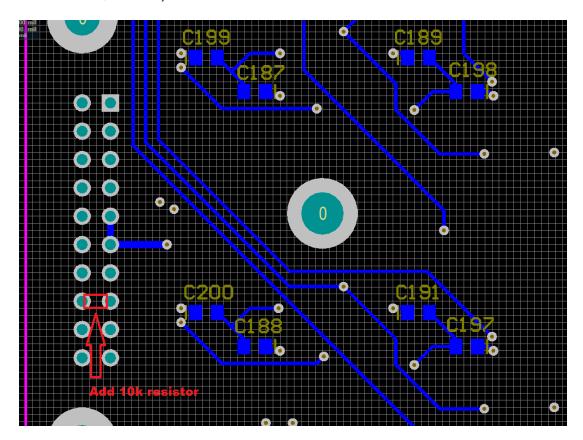
Change 2:

Input to U26 is floating when OPT4 is selected without an option board. Add a 10 k Ω resistor (R174) between pins 8 and 18 of header JP1 (Servo board, D1700077, bottom).
