MEMORANDUM

TO: SQZ team
FROM: Daniel Sigg, Marc Pirello
SUBJECT: Modifications to the TTFSS V4
Refer to: LIGO-E1700364-v3

This document lists the modifications to the 4th generation TTFSS, based on PCB D1700346-v1 and on schematics [D1700077](#), [D1700076](#) and [D1700078](#).

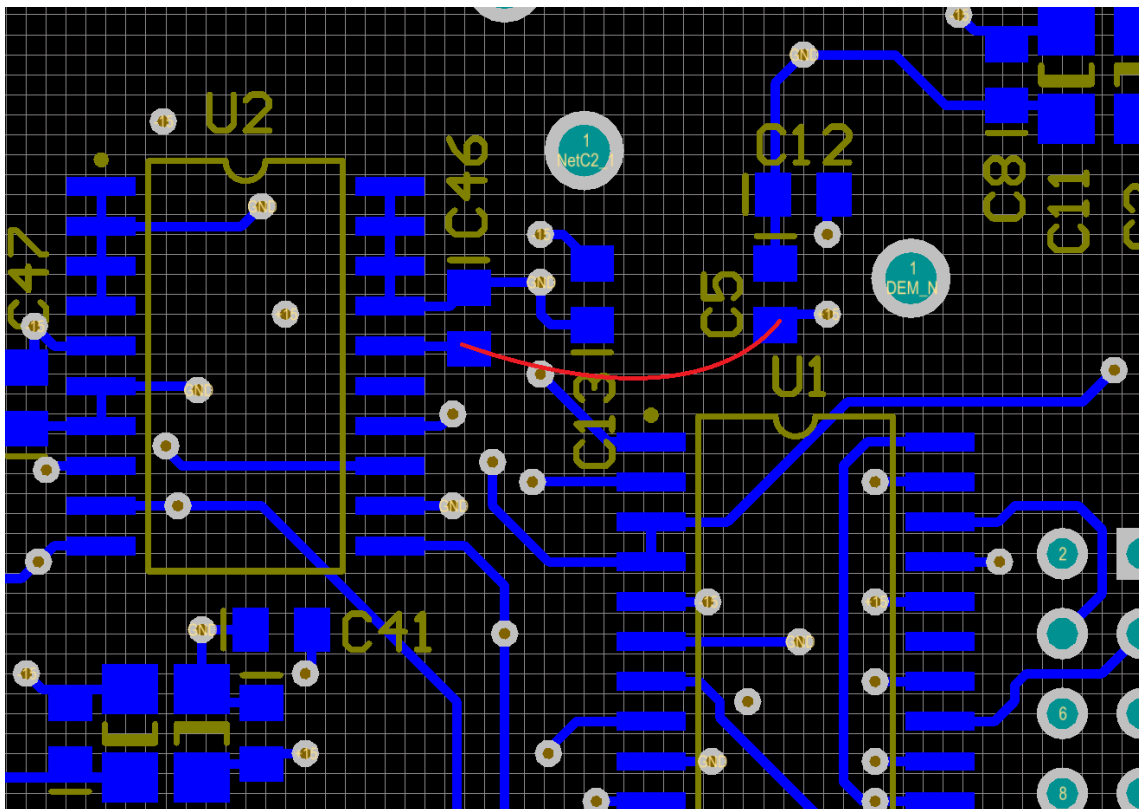
Change 1:

U2 is missing the +15V rail. Add a jumper wire between the C5 pad towards U1 and the C46 pad towards U1 (Servo board, D1700077, bottom).

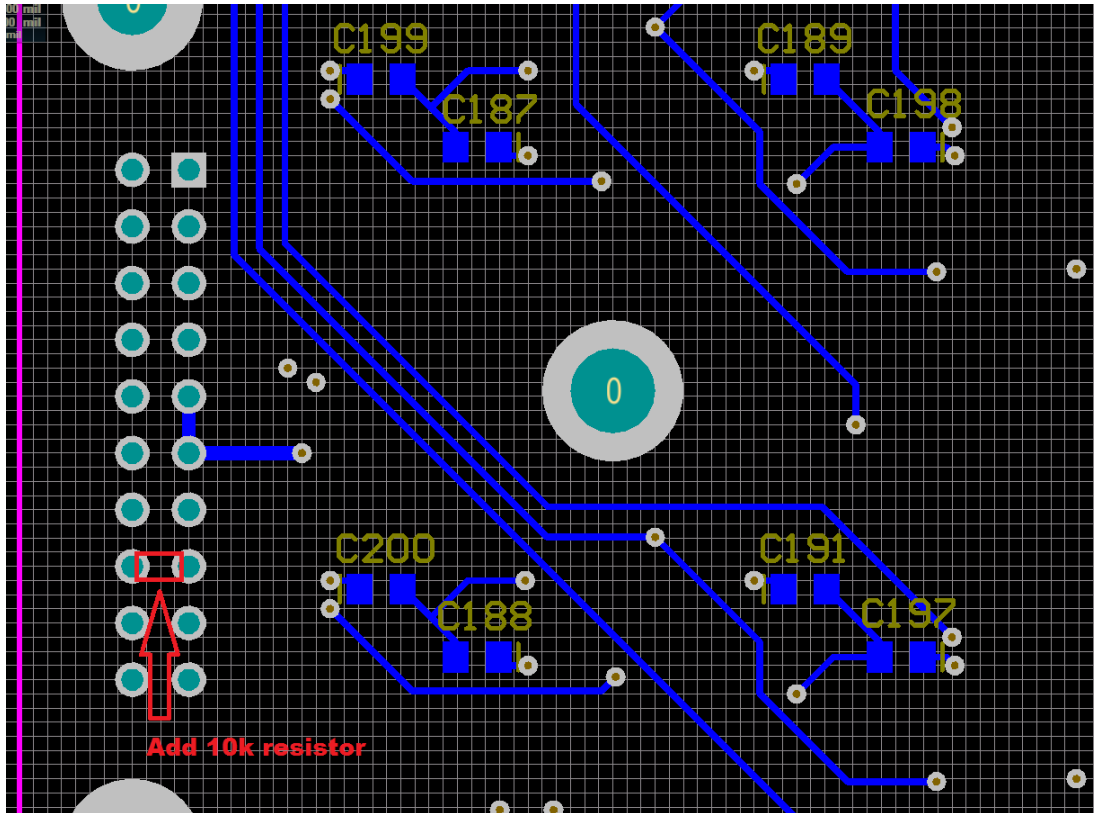
Change 2:

Input to U26 is floating when OPT4 is selected without an option board. Add a 10 k Ω resistor (R174) between pins 8 and 18 of header JP1 (Servo board, D1700077, bottom).

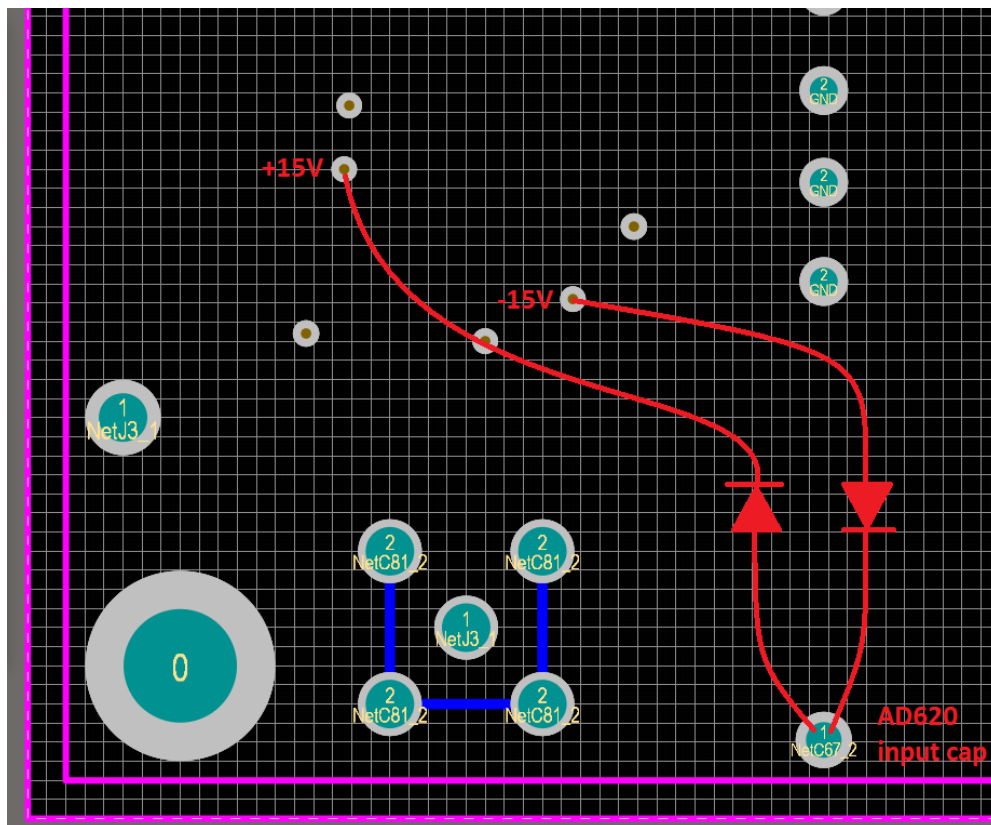
Change 11:

Add protection diodes between the AD620 inputs and the supplies to discharge the input capacitor upon power failure (HV board, D1700076, bottom).

Bottom of HV board, D1700076, beneath U17, AD620.
