Point absorbers in aLIGO coating

Slawek Gras, Kevin Kuns, and Peter Fritschel

MIT
December 2019

DCC: T1900838

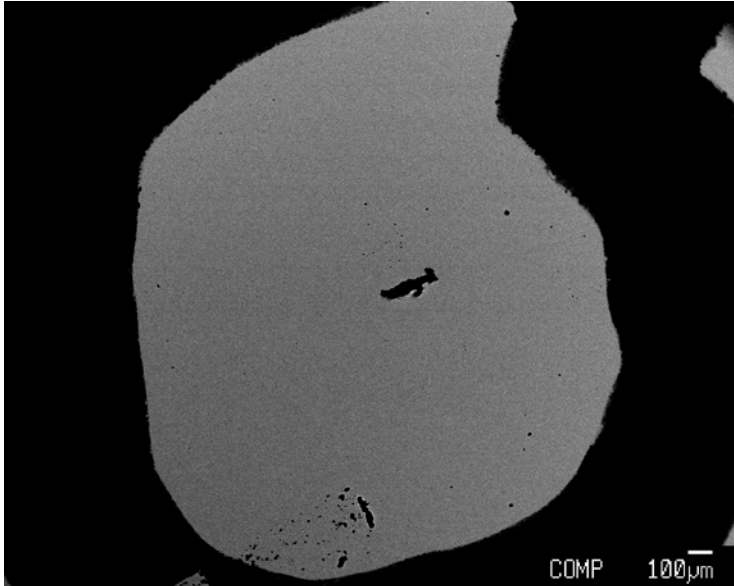
A area

The thick black contours correspond to the ink circles mark areas with high absorption. We left them on the coating.

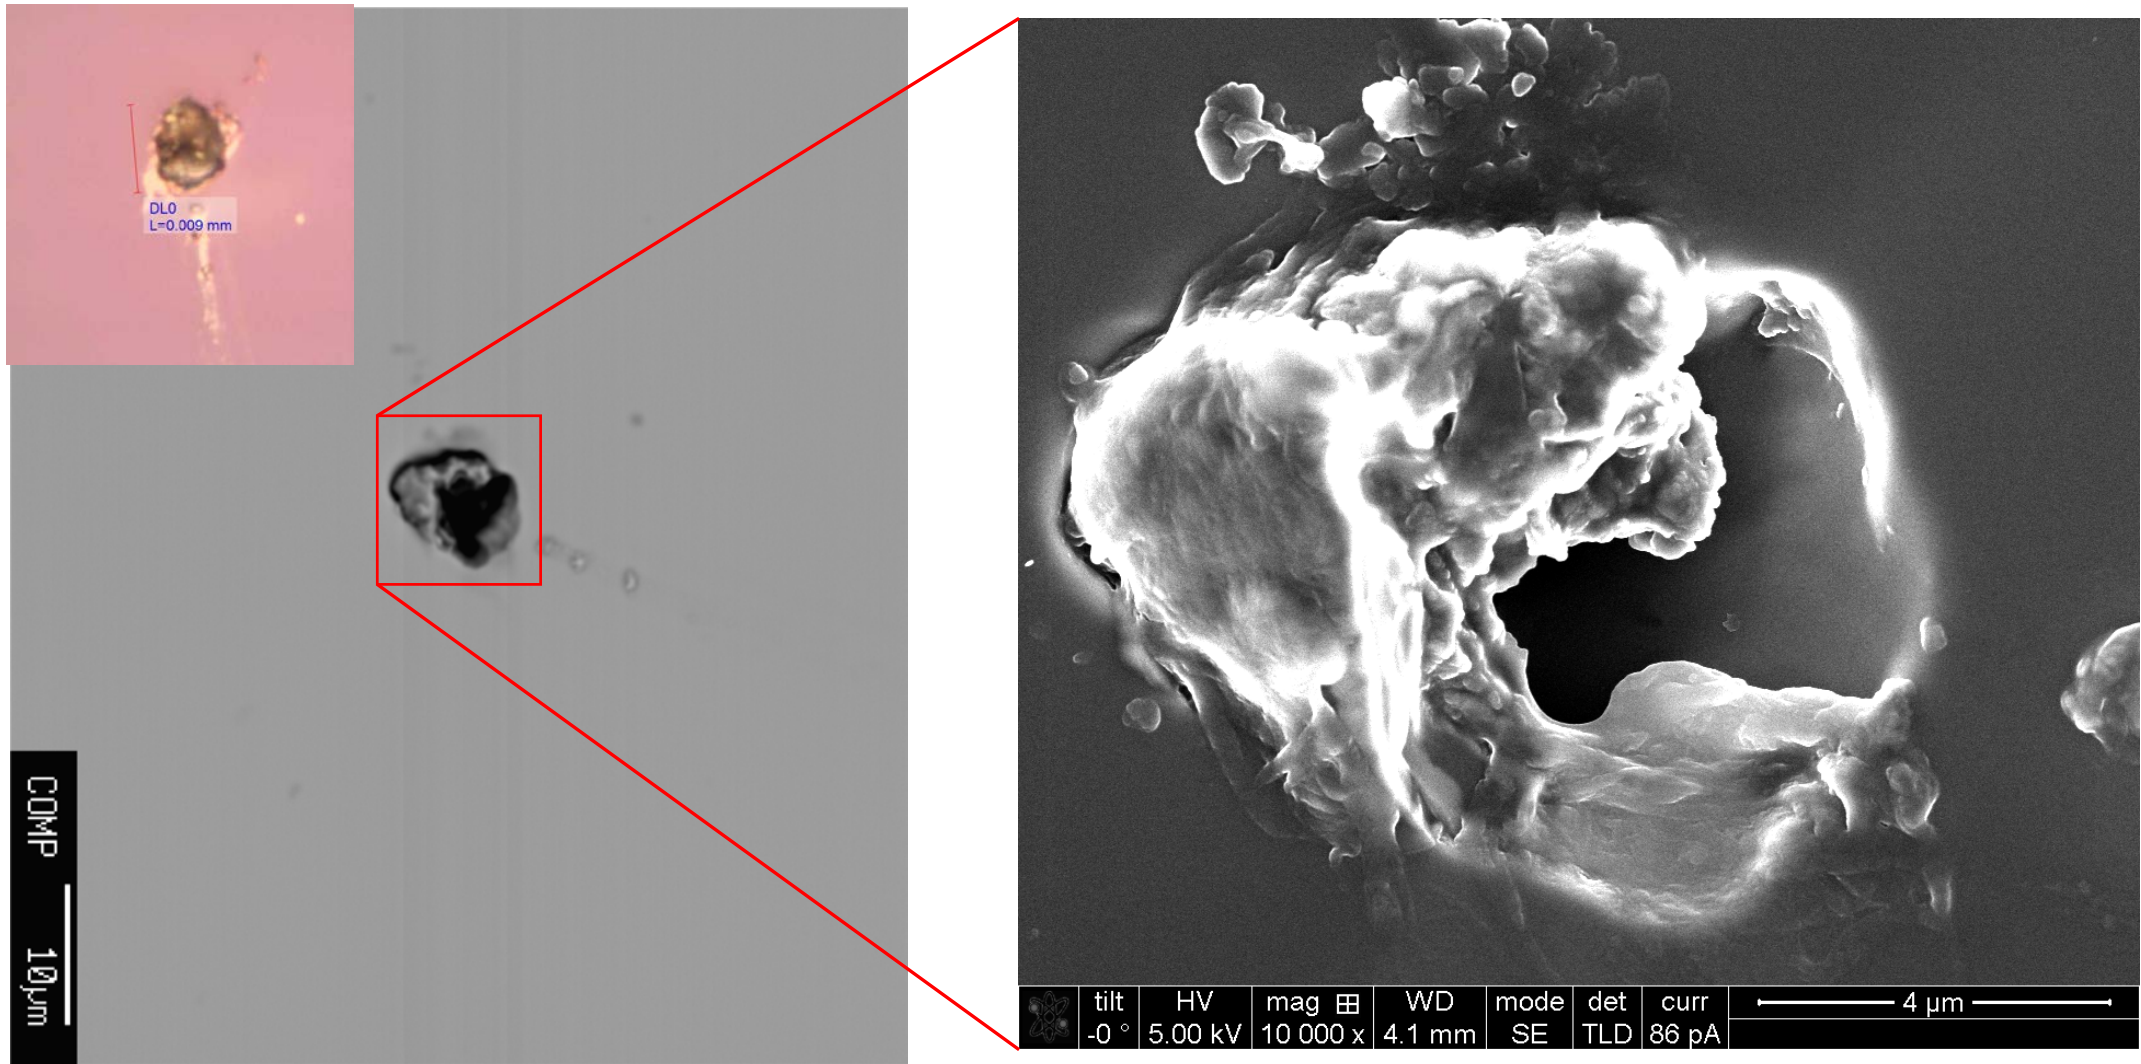
Area B, point absorber B1

Located in Area B. This defect is of ~ 6 μm in diameter, irregular shape, possibly located in the top layers of the coating

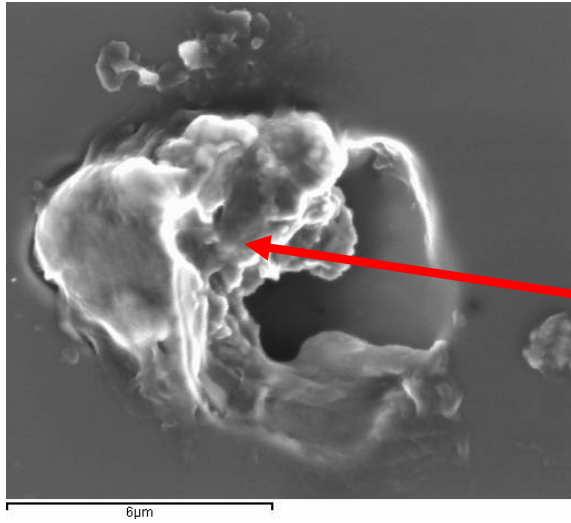
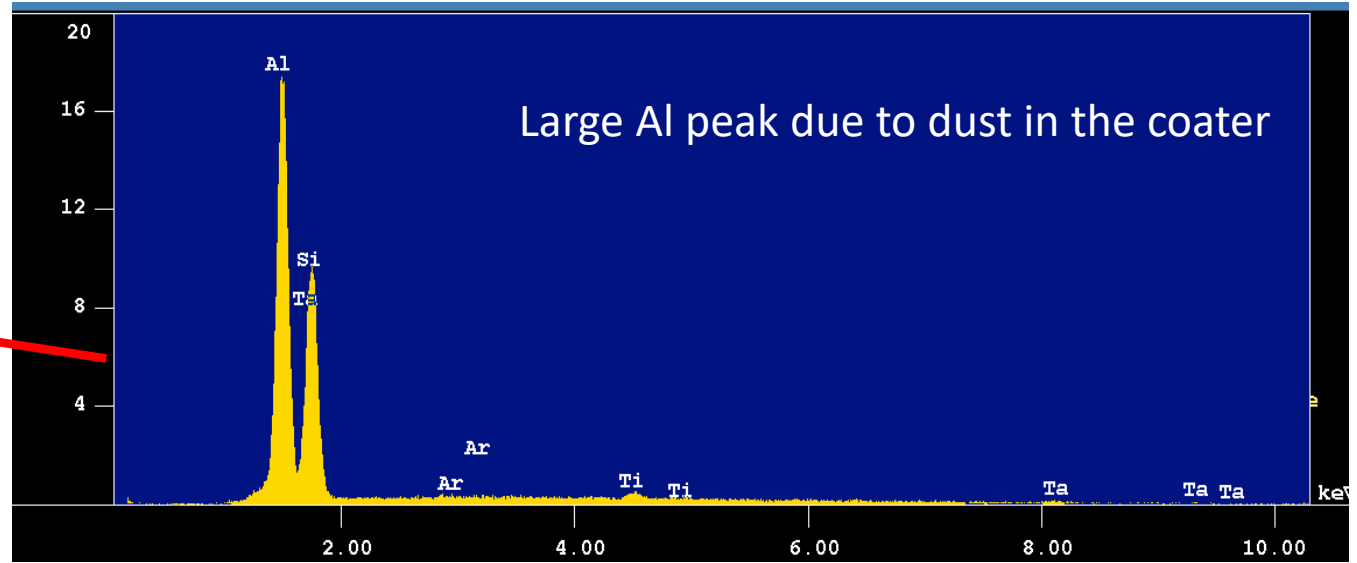
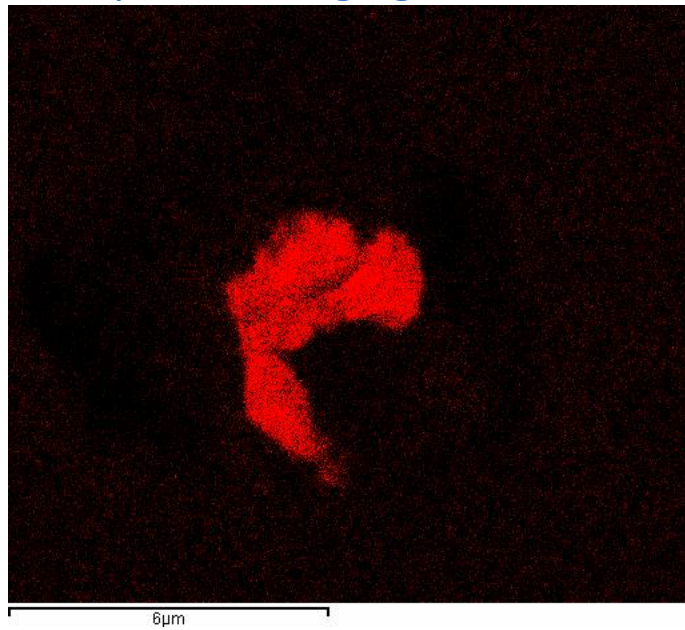
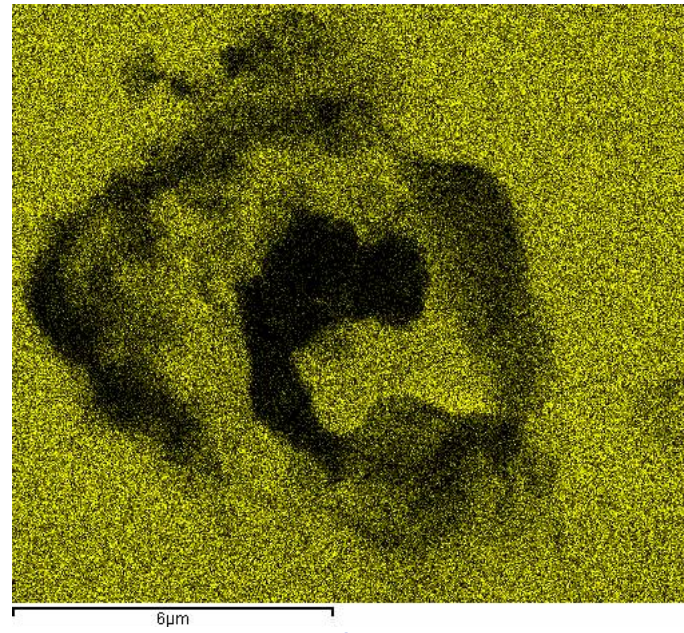
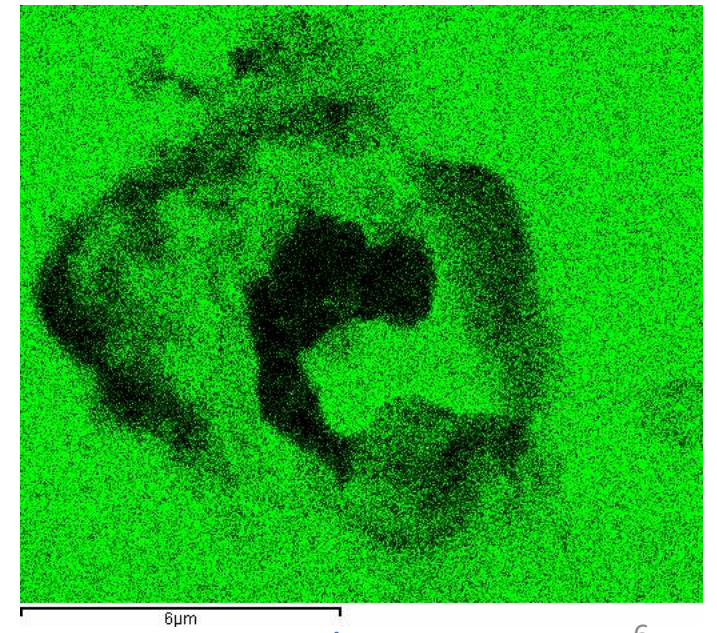
Area B, point absorber B1

EDS spectral imaging:

Aluminum

Tantalum

Silicon

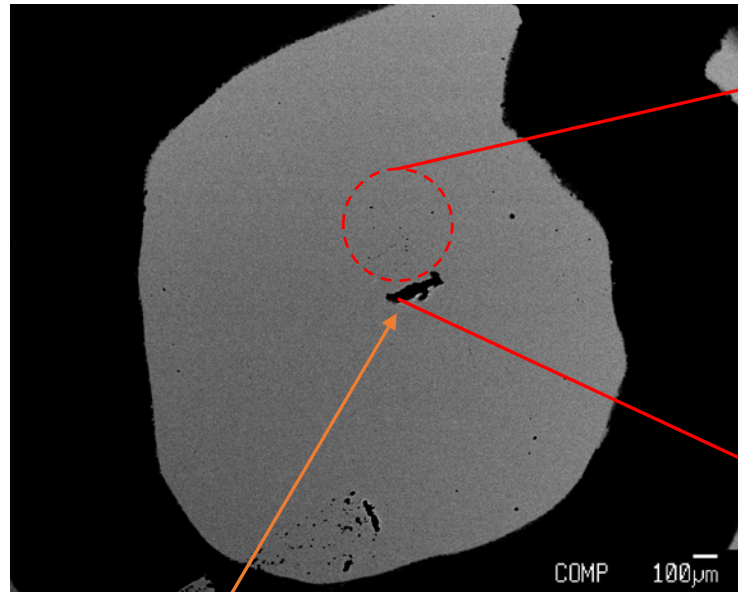
Overview of area A

Missing coating previously thought to be a point absorber > 100 µm

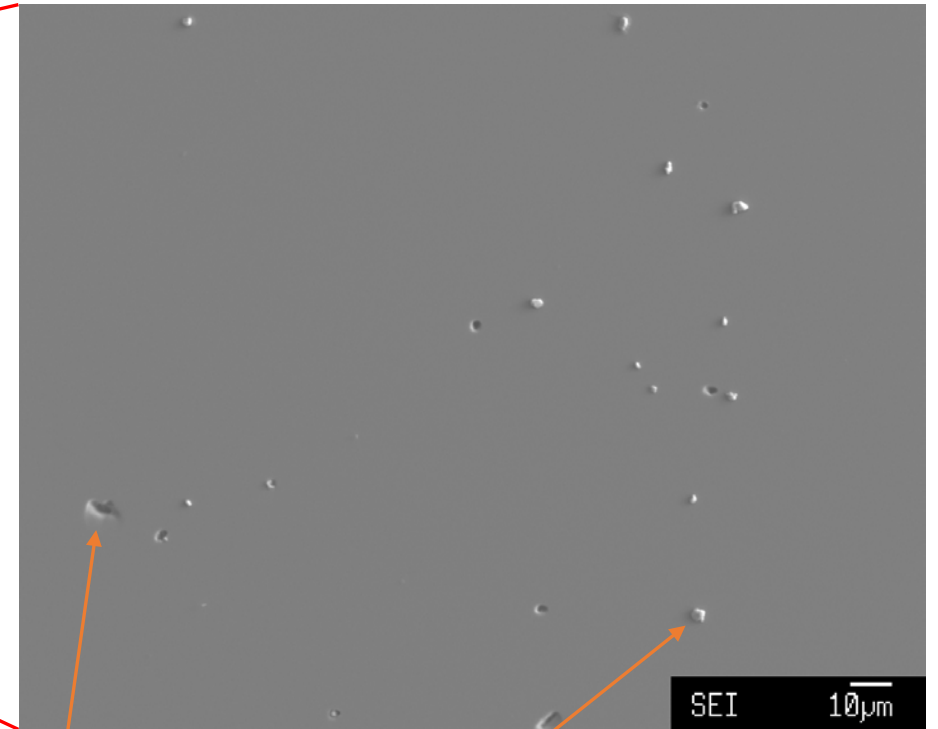
Debris field

missing coating < 10 µm

point absorber A1

We observe many defects in this field; possible point absorbers, only one inspected so far

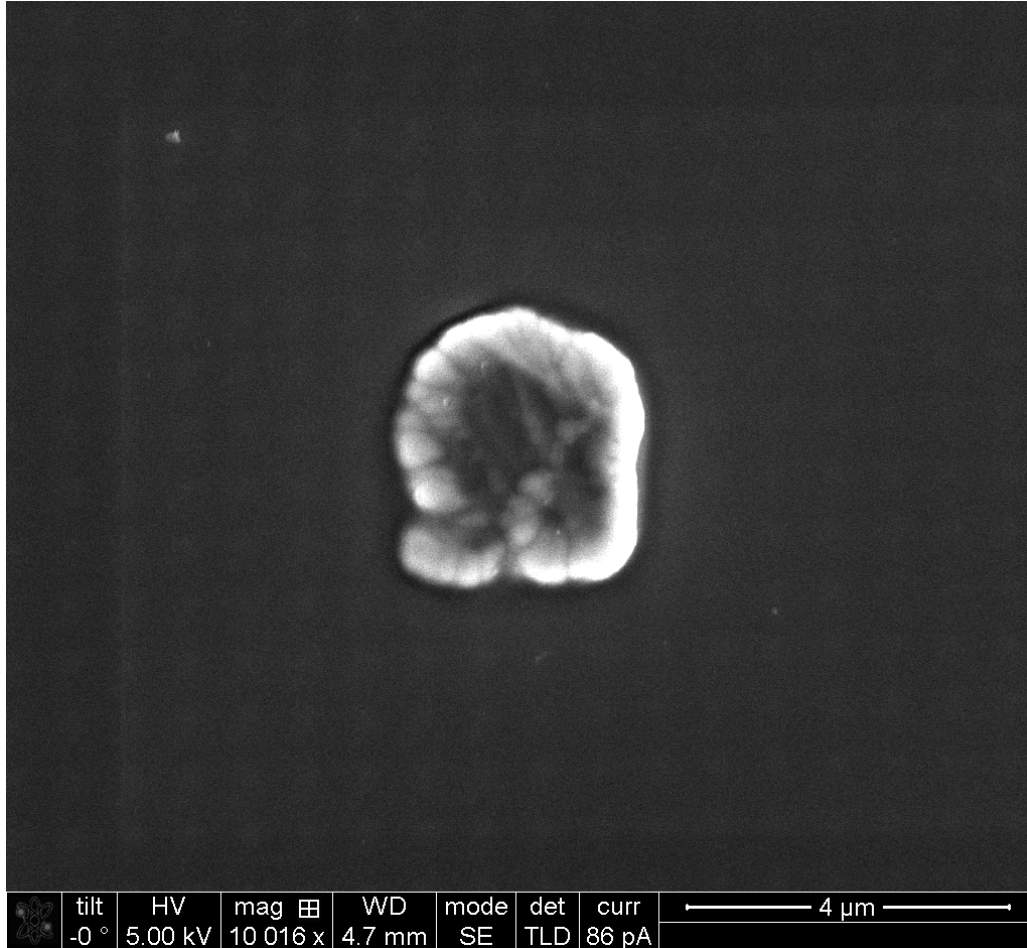
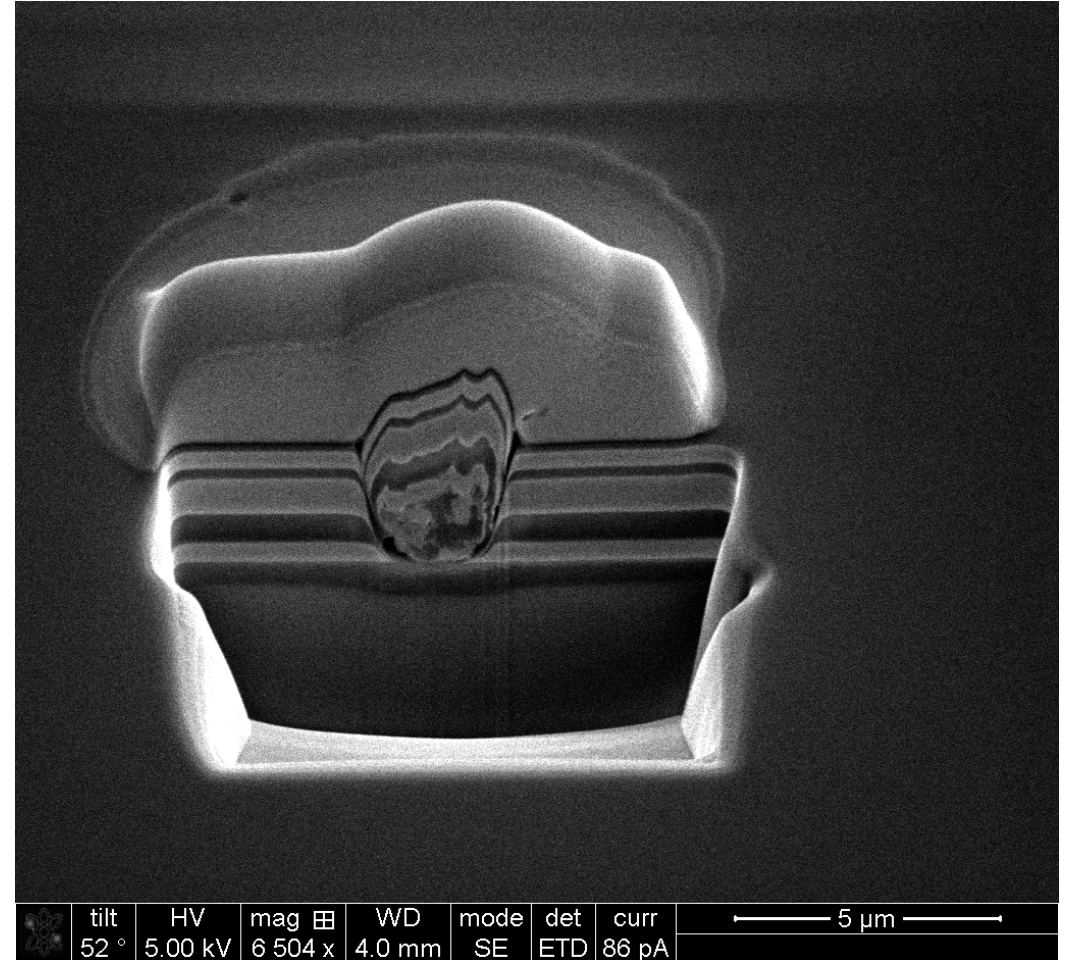
Area A, point absorber A1

- This defect appears to be part of the coating; it does not look like a particle on the surface
- Spectrum on the surface is the same as that of the clean coating

- Used FIB to cut a cross section through the defect:

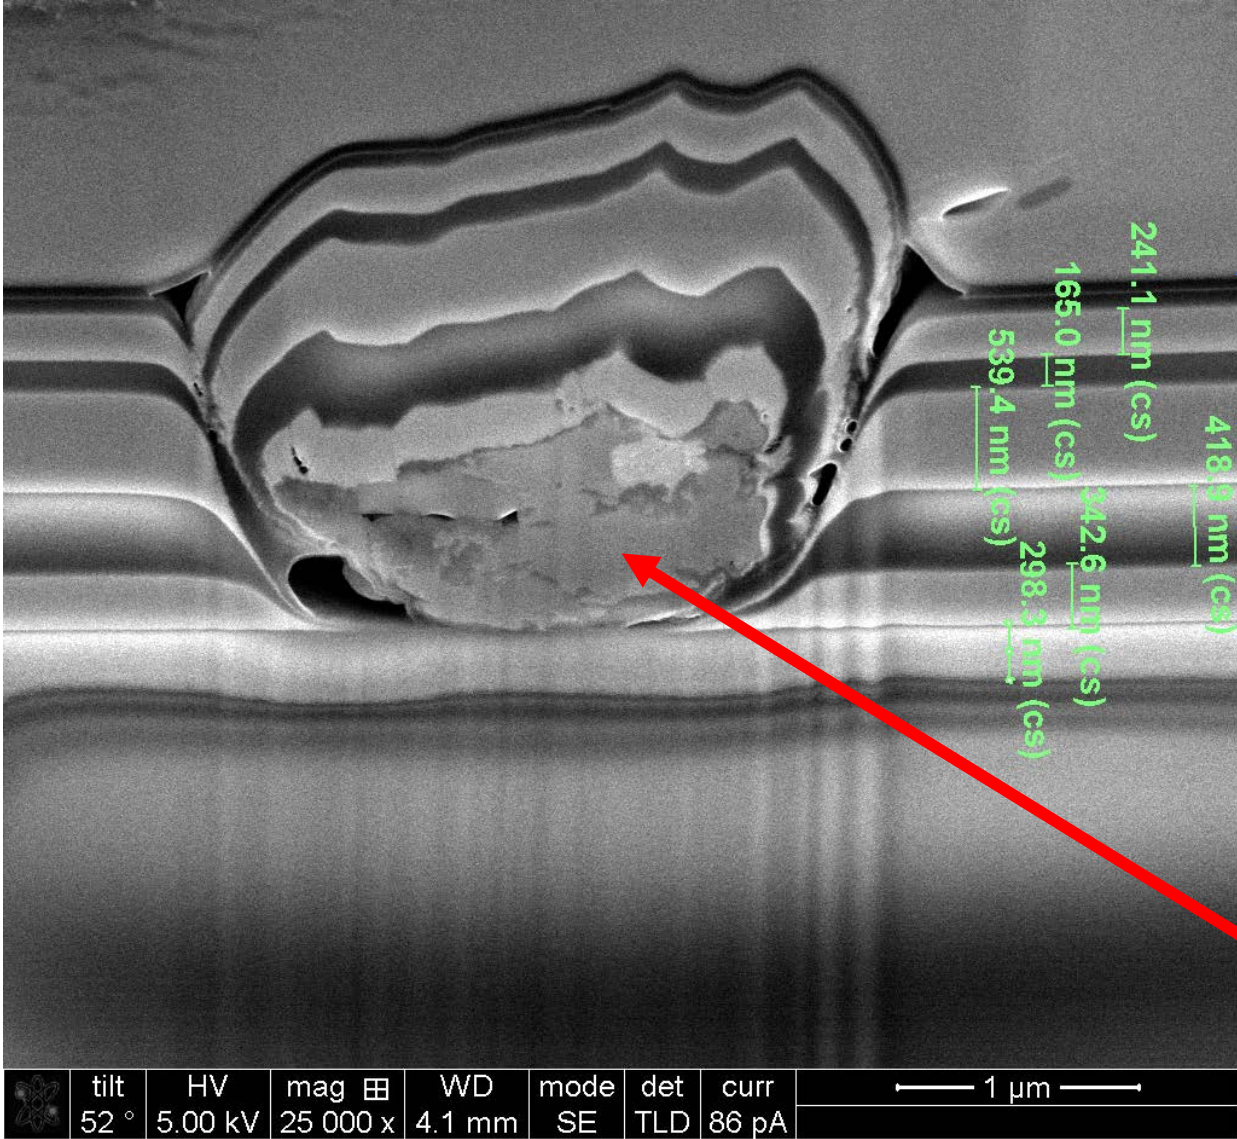
Area A, point absorber A1, cross-section analysis

Point absorber cross section

- Coating layer structure is evident
- The ~2 μm absorber was introduced after the first layer and the subsequent layers deposited on top of it
- Bright layers correspond to high index material; dark layers correspond to low index material

Remark: strange AR coating structure:

- Why are layers #1 and #2 made of the same material?
- Number and depths of layers is not consistent with any of the coatings specified by LMA.

Likely Al point absorber

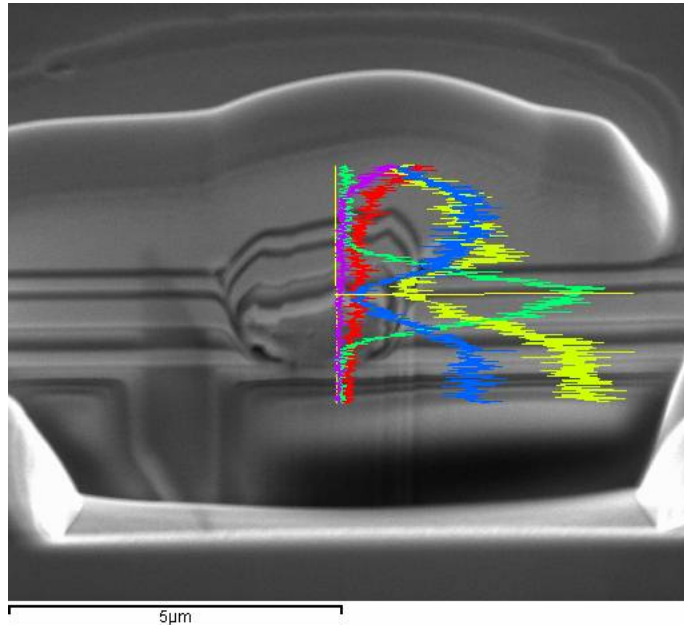
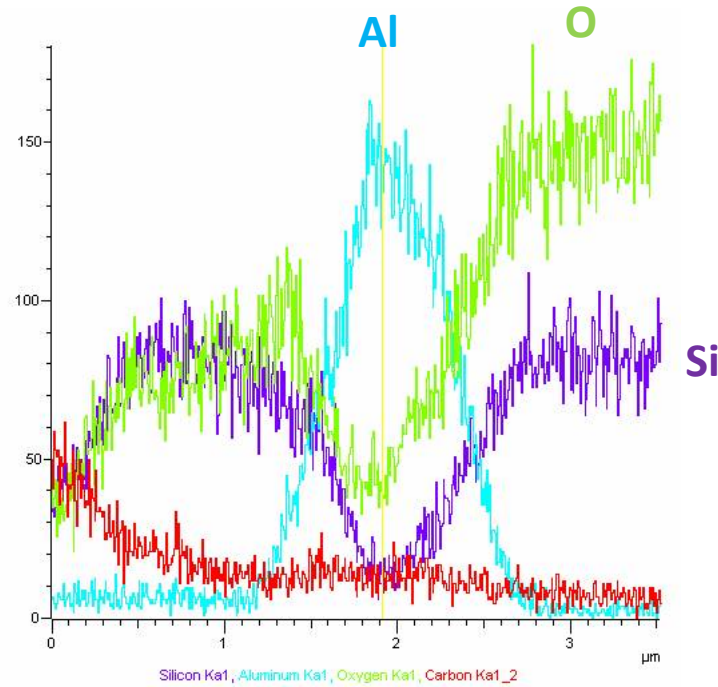
Area A, point absorber A1, line scan

- Strong Al signal at the location of the particle
- Oxygen depletion at the particle location may indicate that we are dealing with pure metal rather than oxide?

There are many more such defects in area A; see slide #7. Are they also caused by Al dust? We are planning to analyze them as well.

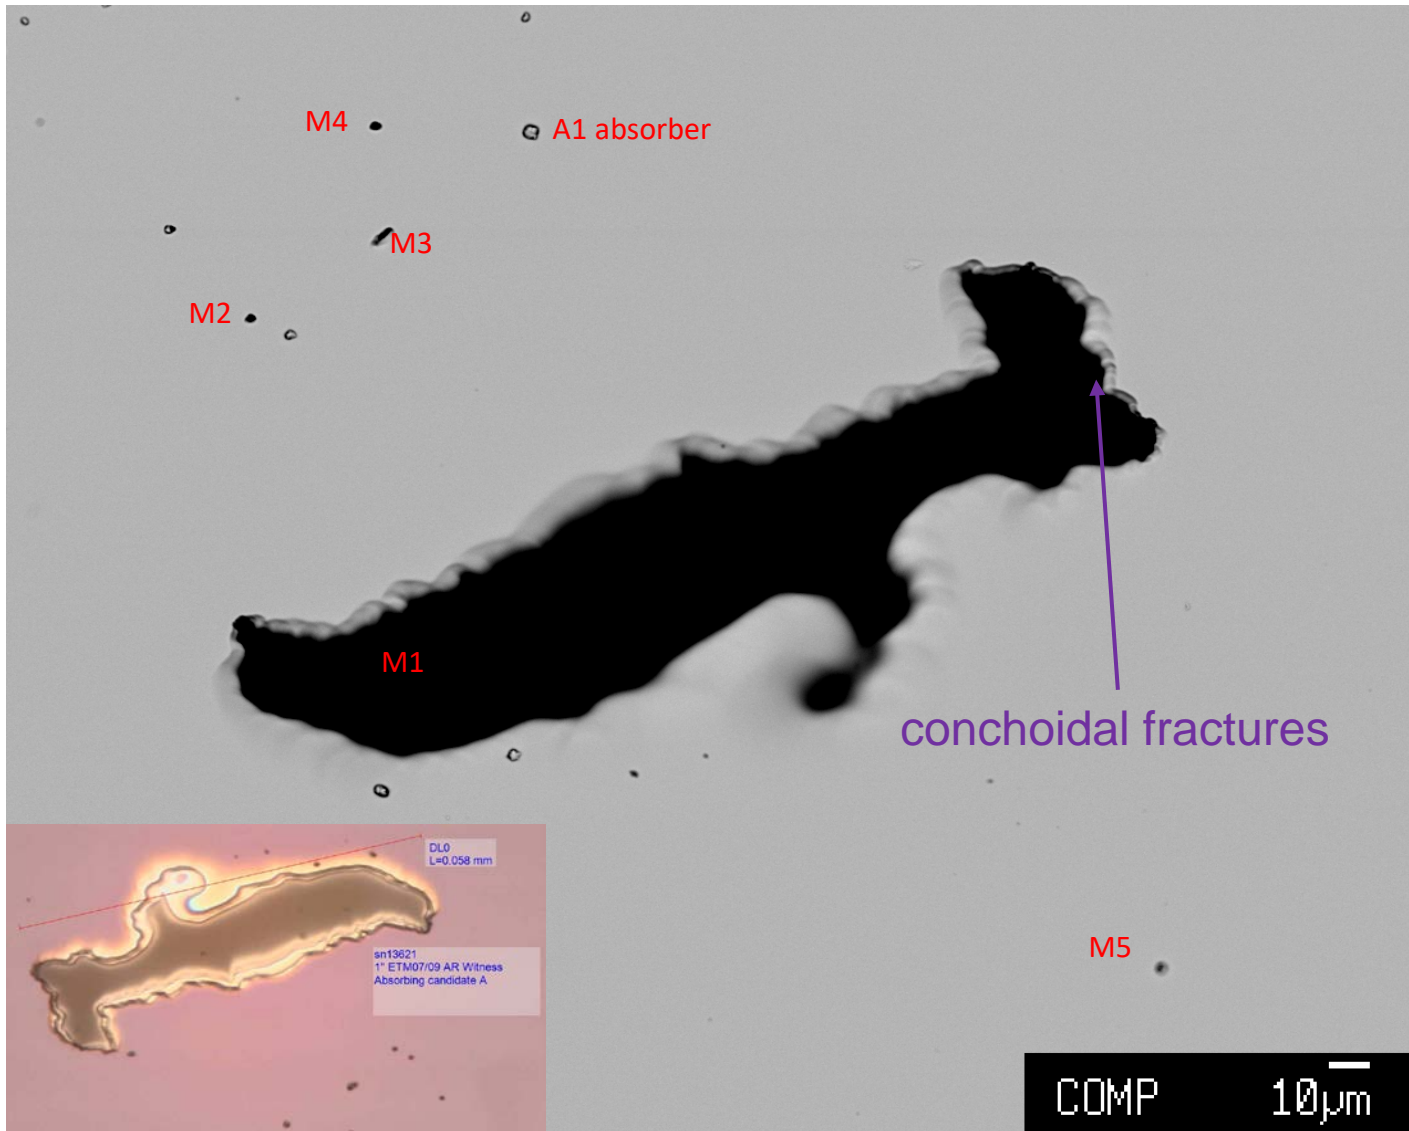
Area A, Missing coating

- The missing coating can be easily spotted on large contrast
- 5 places of missing coating with areas of various size, why?
- Conchoidal fractures due to the strain – burst during annealing process?
- Spectrum at M2, M3, and M4 show only Si above 1 keV – pure substrate, but... see next slide

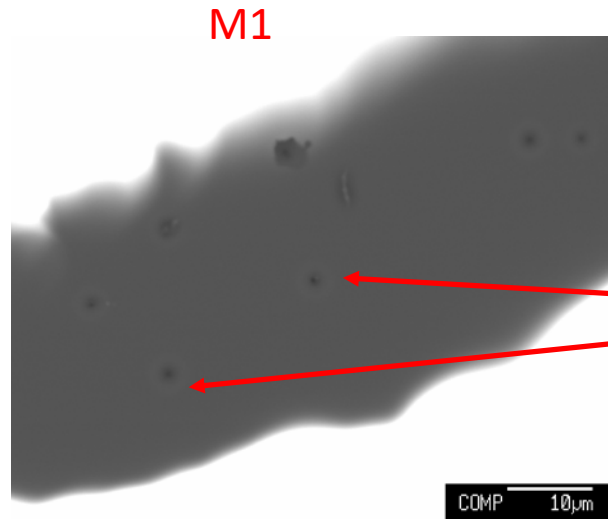
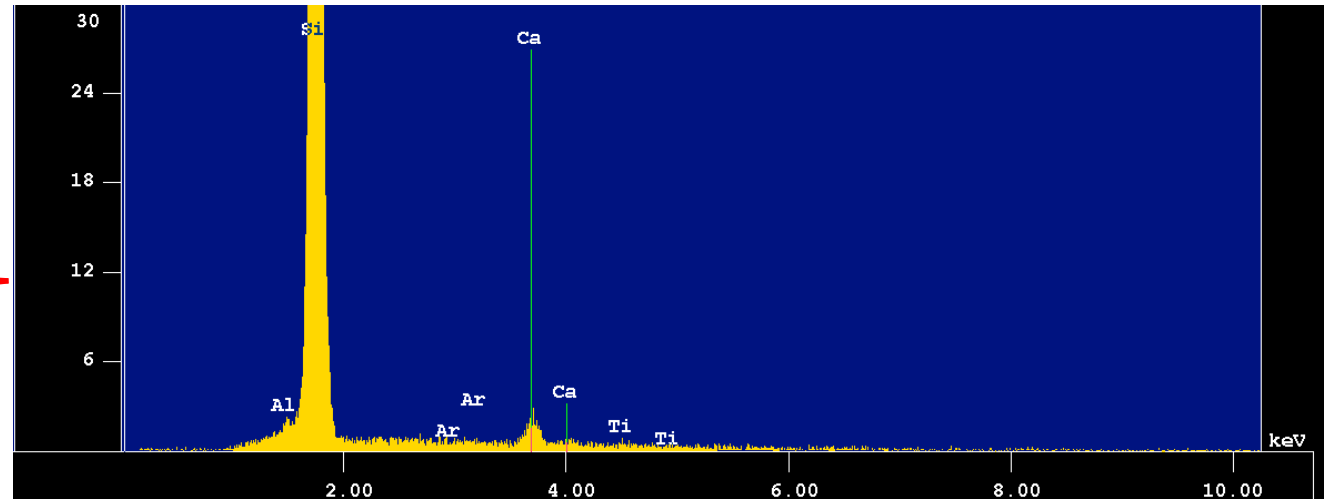
Area A, Missing coating, contamination

Ca compounds at the bottom of M1 at various locations

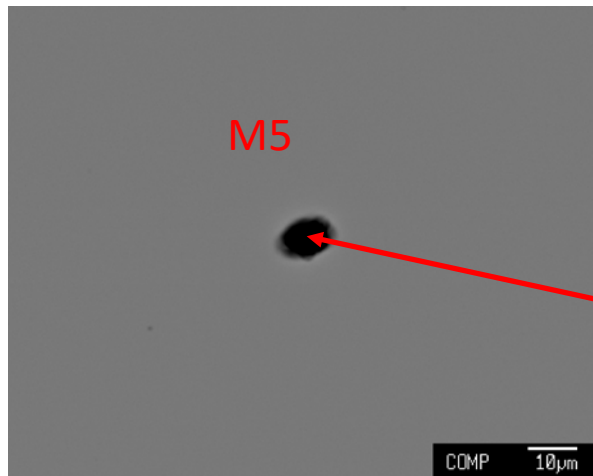
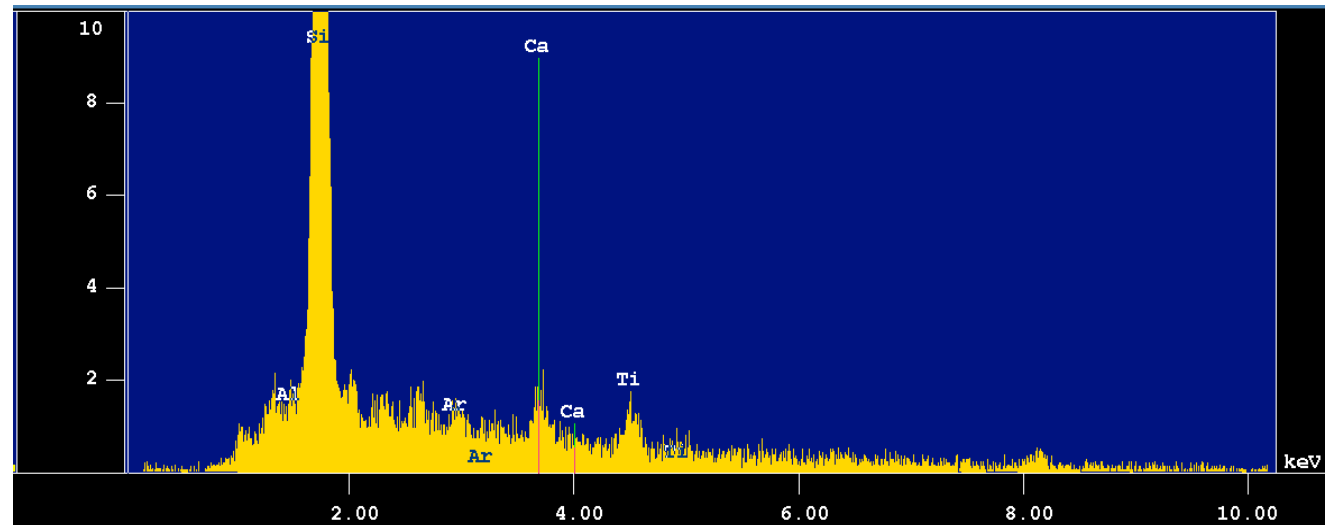
More complex compounds at the bottom of M5

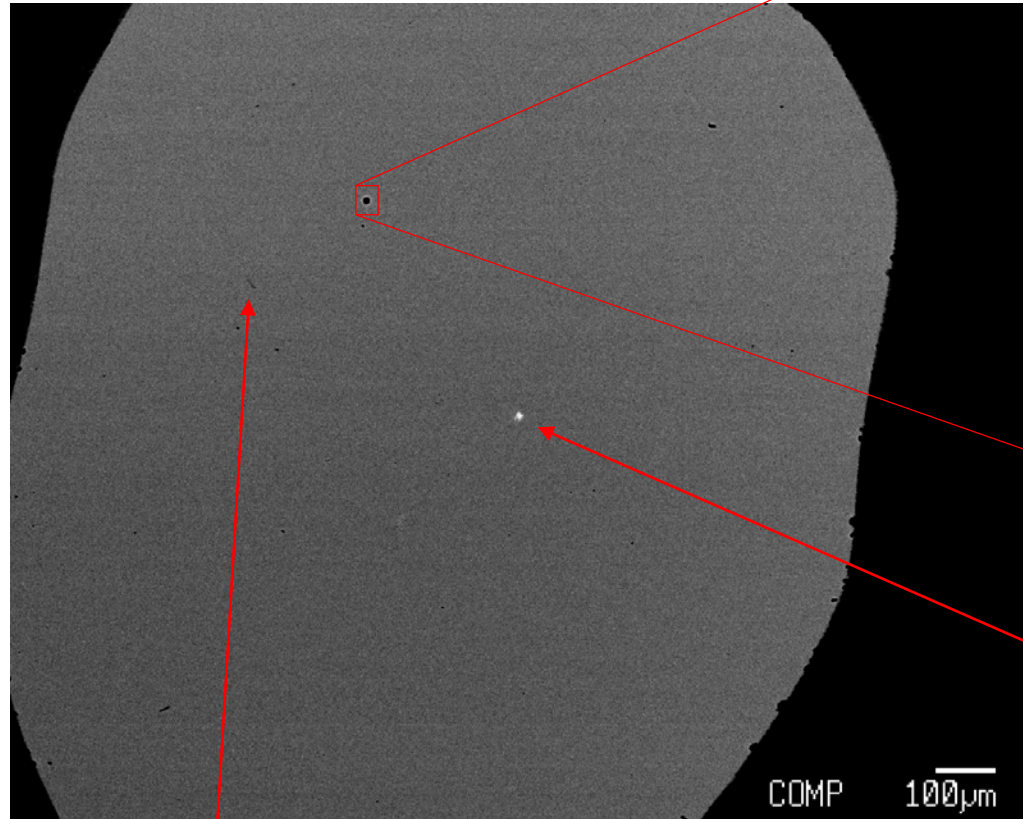
Overview of area C

Carbon rod; see next slide

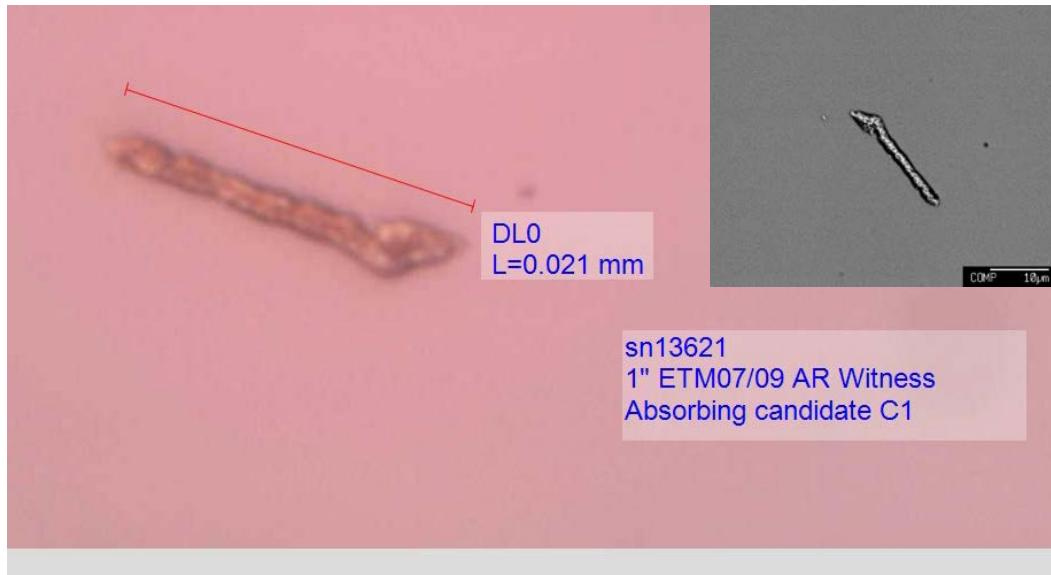
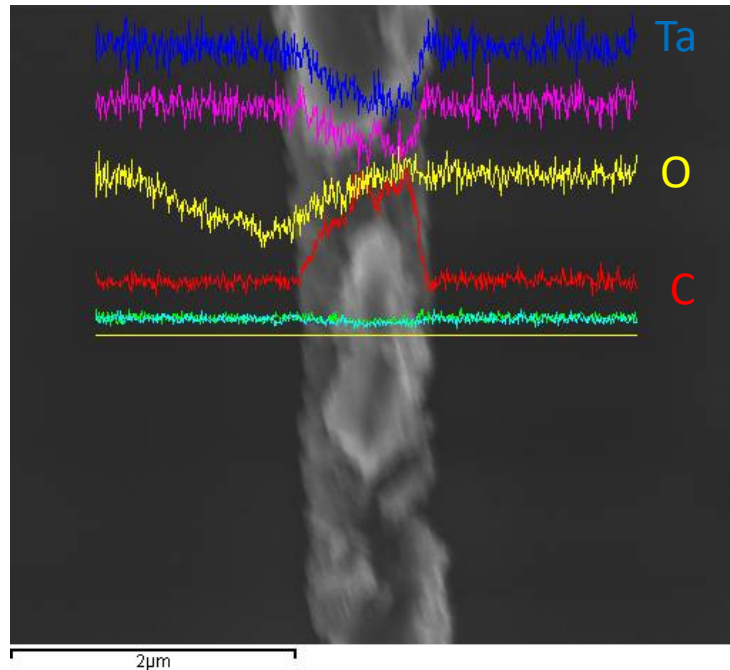
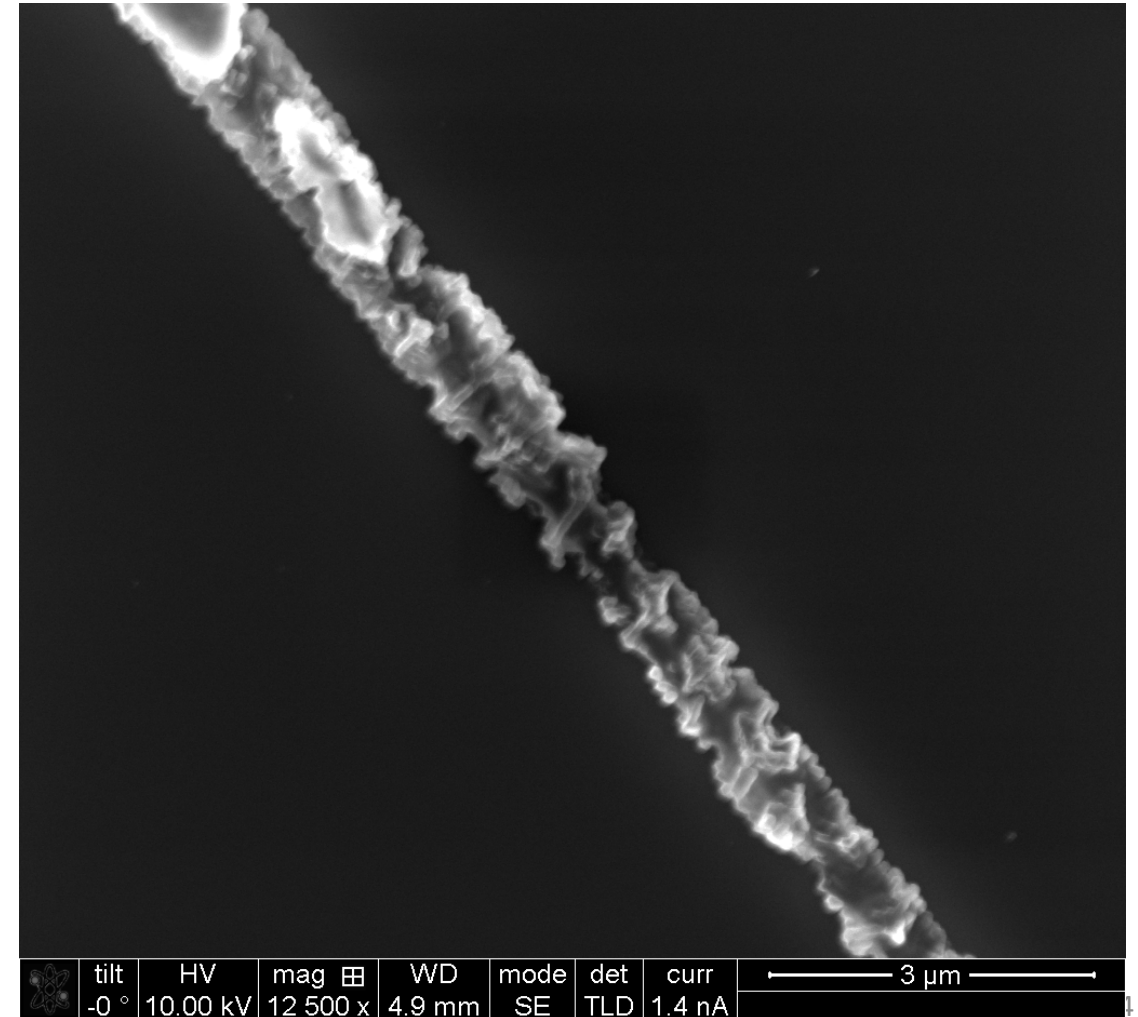
Area C carbon rod

- Absorbing candidate C appears to be a carbon rod
- No evidence of aluminum but we will cut in the future to confirm
