Ablation Evaluation

SN1535

[LIGO-T2100216](#)

Advanced LIGO Core Optic coating witness sample ETM 07/09

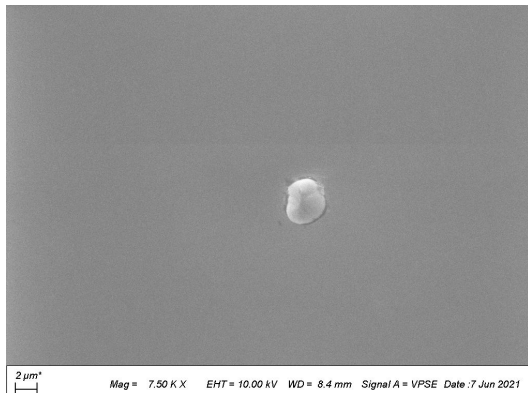
Liyuan found the mystery spot near f1a, it is a $\sim 5 \mu\text{m}$ dark spot, filed with this document at LIGO-[T2100216](https://www.ligo.caltech.edu/publication/T2100216)

SEM Image of the apparent absorbing feature in region F.
ref. image SN1535_f1c_01.tif

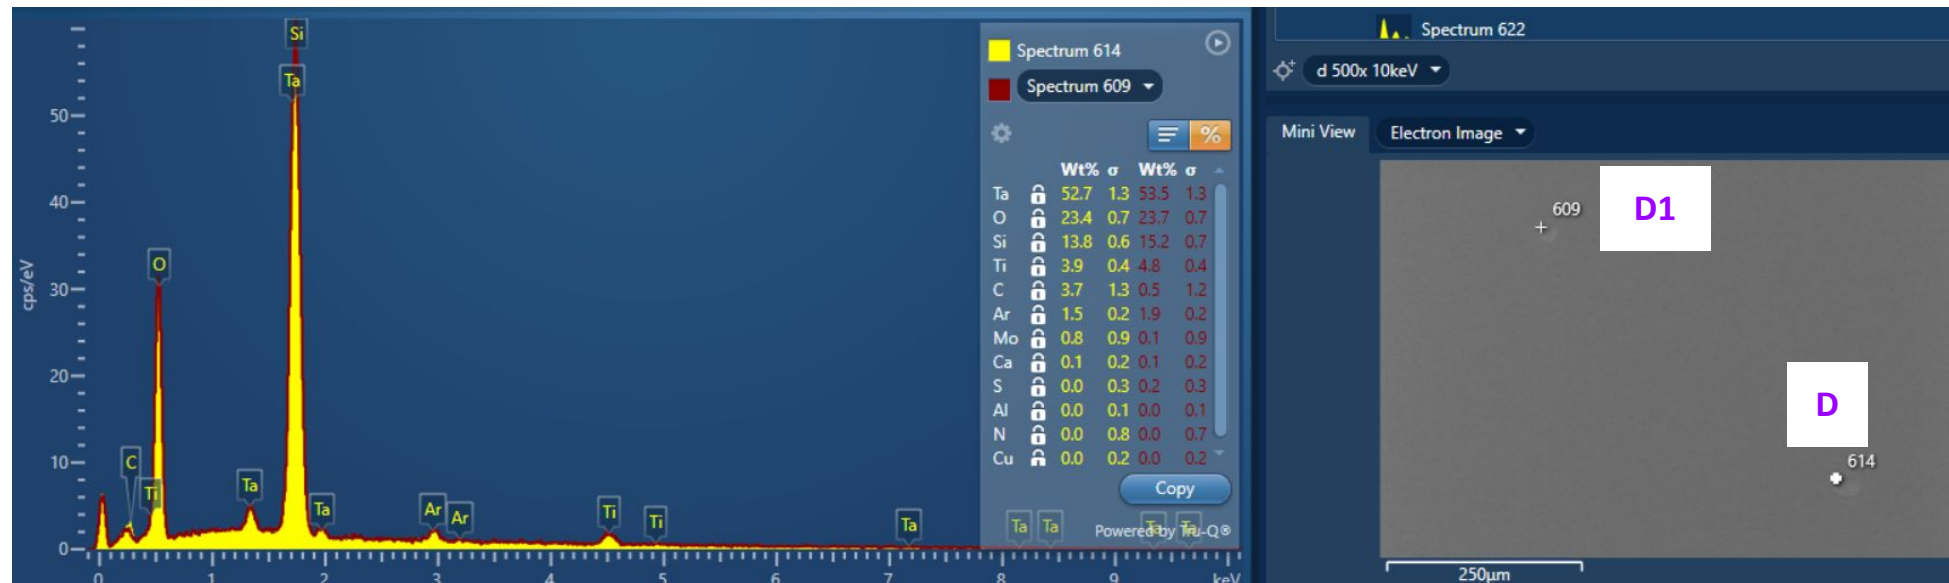
Feature D - image ref. SN1535_d_01.tif

SEM EDS spectra post-ablation - Feature D

No Aluminum identified in most spectra measured near Feature D on SN1535 (or near Feature F, either).

Typical spectrum comparing D (feature) to D1 (test ablation of clean coating) highlights absence of Al.

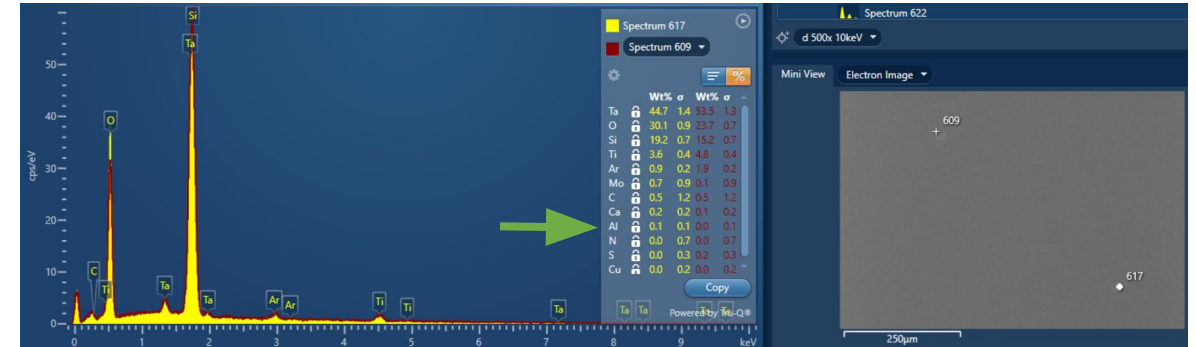
(right) trace of aluminum present in one spectrum, on level similar to error term.

(bottom) bumps of C and apparently Na, and maybe P and Ca, in one area.

0.1% Aluminum (sigma 0.1%) in this particular point spectrum - is this meaningful?

small spike in C at nearby locations, not present in the rest of the spectra throughout the region - meaningful? also appears to include elevated Na, Ca, maybe P (though I think it could be misidentified Ta)

I want to work with Chi to confirm and better understand these features.

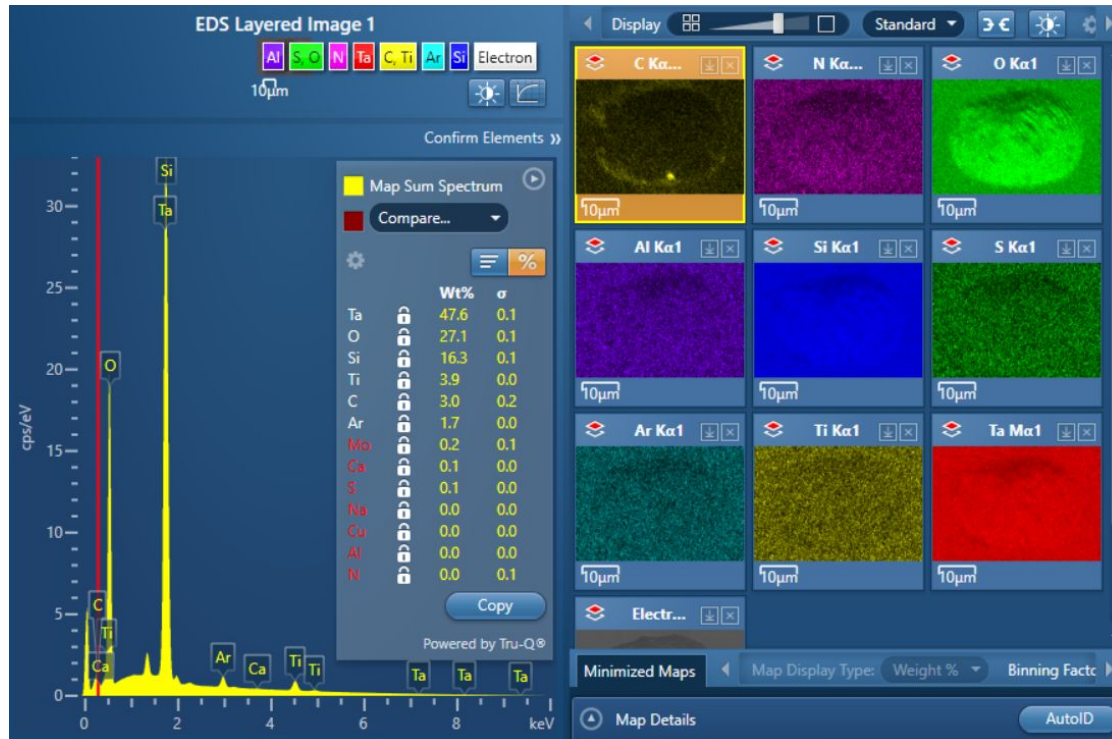
Right: High resolution mapping shows presence of **Carbon**. Yellow map shows Carbon signal which appears to follow the border uniformly except for one local subregion with greater signal, at 6 o'clock. This imaging does not indicate any trace metals of interest or any other signatures. Main ablation area composition is similar to coating.

(note shadowing effect is due to detector mounting off-axis at 12 o'clock position - indicates feature falls below surrounding surface, and artificially suppresses signal at 12 o'clock position)

Feature D - Backscatter detector shows contrasting subregion at 6 o'clock at border. Also, uniform contrast suggests we may not have reached substrate.
image ref. SN1535_d_21.tif

Feature D - standard detector, horizontal artifact lines due to charging at edges. image shows array of edges (layers?) (why apparently more than 8, per standard AR stack)
Image ref. SN1535_d_22.tif

Need to image "clean coating" ablations to compare and understand differences. - work planned for Tuesday 29 June.

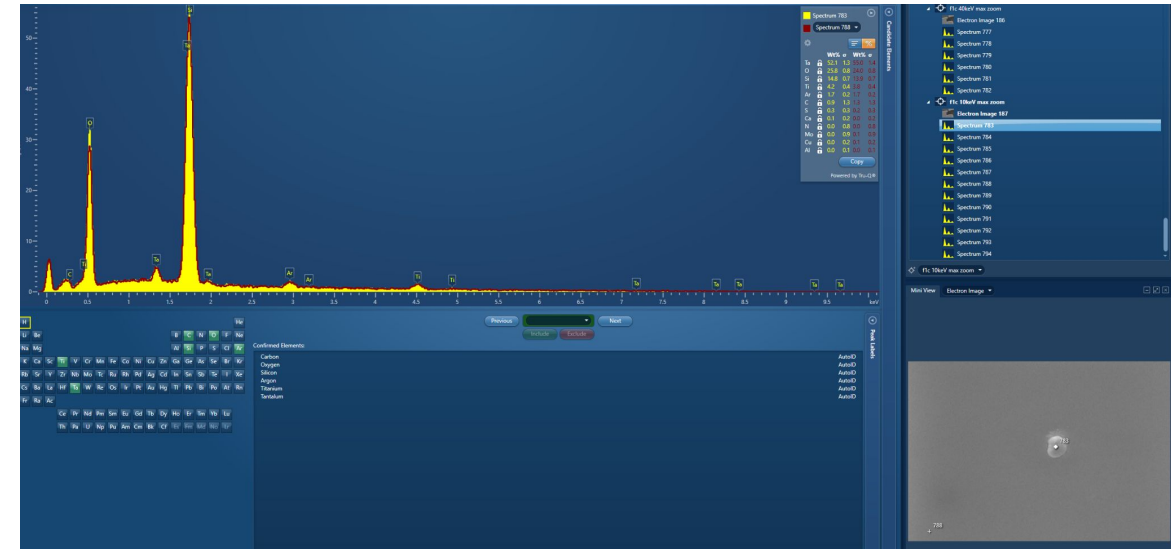
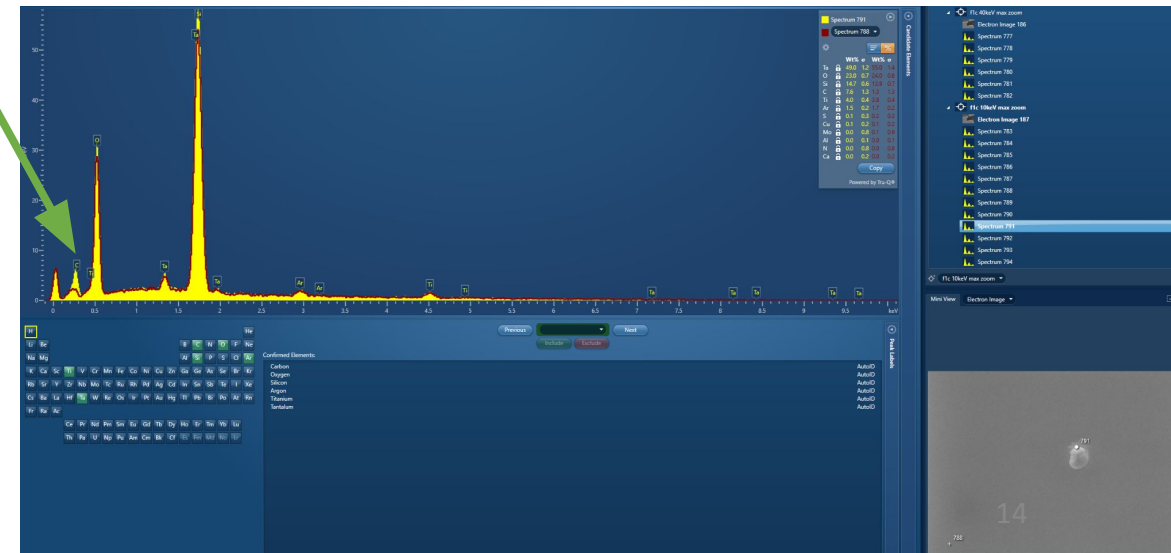
Ref. Slide 8 - apparent high absorber near clean-coating-ablation features F1A and F1B.

Top Right - spectrum showing typical scan, at center of 4 micron diameter feature. Red trace for comparison is adjacent “clean coating”. No signature of interest.

Bottom Right - spectrum showing localized Carbon peak (7.6% wt. compared to 1.3% wt.).

Localized Carbon signature warrants additional backscatter imaging to try to understand the extents of a potential subregion including Carbon.

SEM Image of the apparent absorbing feature in region F.
ref. image SN1535_f1c_01.tif

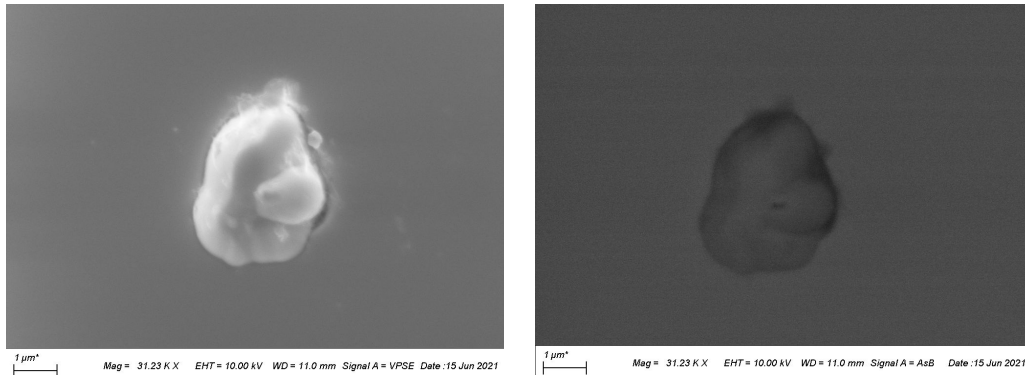
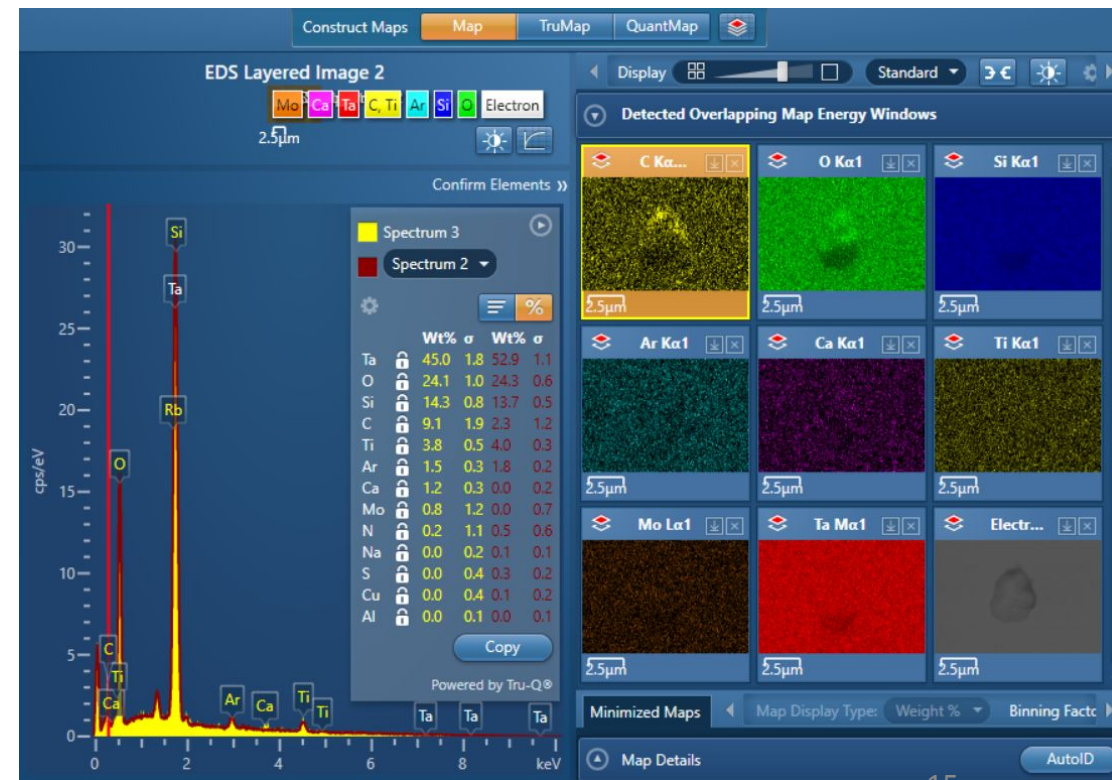
Right: High resolution mapping shows presence of **Carbon**. This imaging does not indicate any trace metals of interest or any other signatures. Main particle composition is similar to coating.

(note shadowing effect is due to detector mounting off-axis at 12 o'clock position - indicates feature protrudes above surrounding surface, and artificially suppresses signal at 6 o'clock position)

Below: Presence of contrasting material (such as Carbon) is indicated in Backscatter detector image around the border, consistent with map findings. Main particle seems to have composition similar to coating, based on contrast of BS image.

Feature F1C - SEM Images of the apparent absorbing feature in region F.
Left: VPSE detector (standard) Right: Backscatter detector
ref. image SN1535_f1c_22.tif and image SN1535_f1c_22.tif

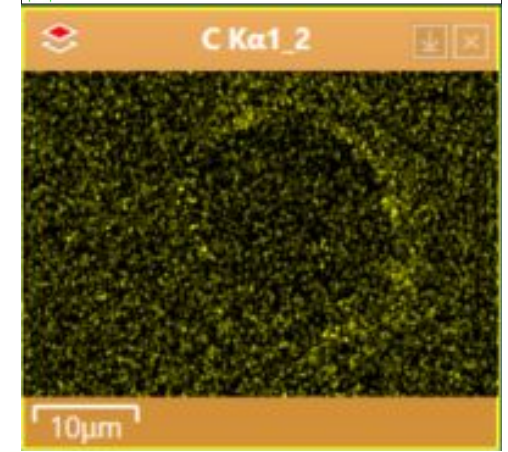
High resolution mapping shows presence of **Carbon** present in all ablations, around the border.

Carbon is more prominent in Feature D (including strong localized feature). Current speculation is that this could be related to conductive polymer coating applied by MIT. These results are consistent with this speculation, as all features show pretty similar C signature.

F1B
2.2% C sum

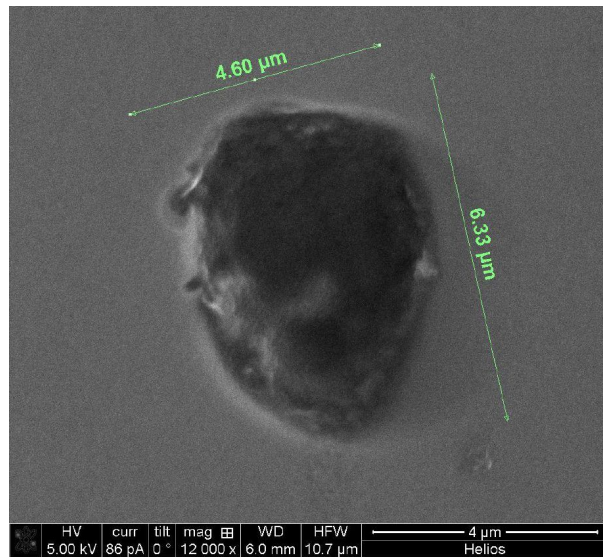
D from Kevin's
<https://dcc.ligo.org/LIGO-G2100805>
(slide 4)

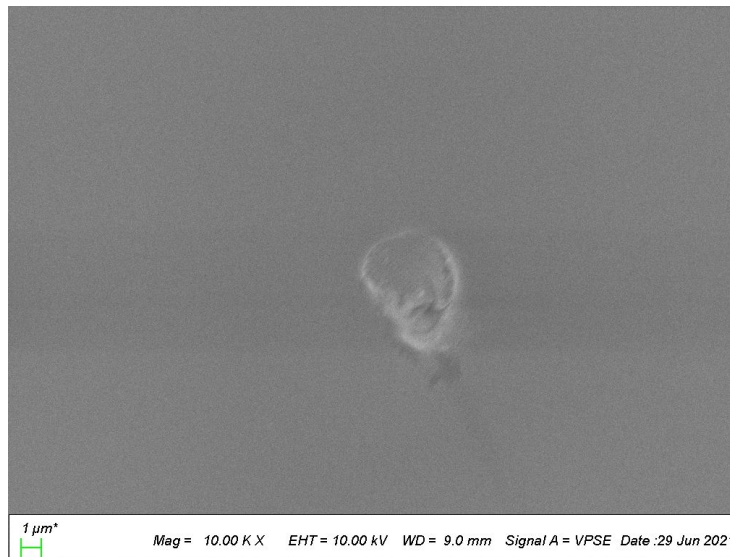
Stephen used the RTS coordinate system to navigate to the location of Feature D, and it turns out that Feature D is still present on the surface of this optic.

D from Stephen's
<https://dcc.ligo.org/T2000733> -
comparable feature size and
shape (ref. sn1535_d_52.tif)

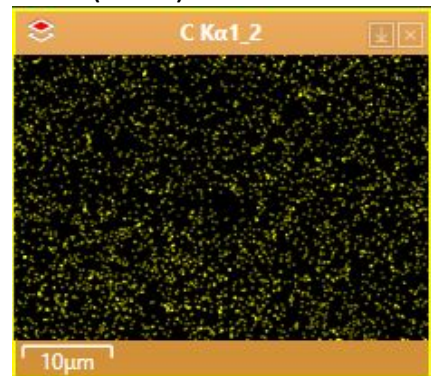
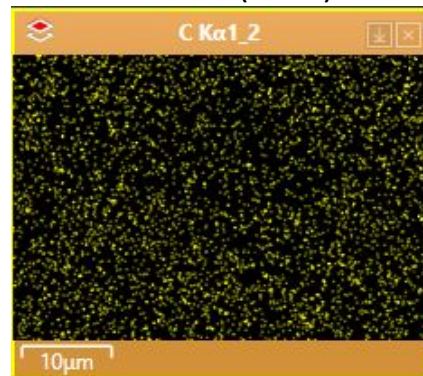
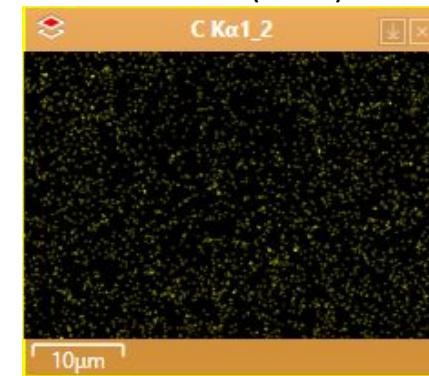
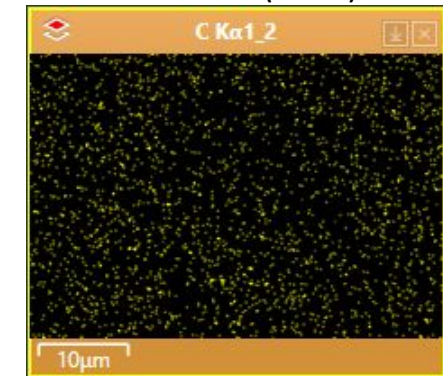
EDS Carbon Maps
(after clean)

O₂ Plasma Cleaning removed Carbon concentrations

To address 1), the witness sample was cleaned using an O₂ plasma. After, the concentrations of carbon were no longer present, with C levels reduced and now on par with “clean coating” areas. Absorption scan next, to attempt to address question 2).

2.6% C (0.3%) before

→ 3.0% (1.6%) (larger error, smaller peak by eye)

2.1% (0.2%) before

→ 1.8% (0.7%)

2.2% (0.3%) before

→ 1.6% (0.5%)

→ 1.6% (0.6%)

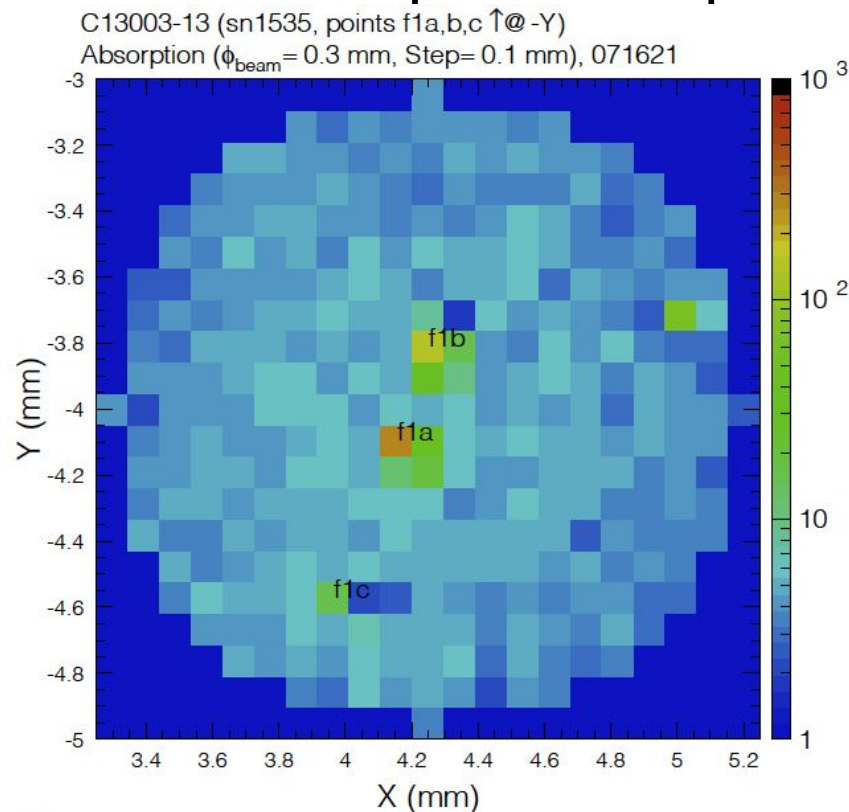
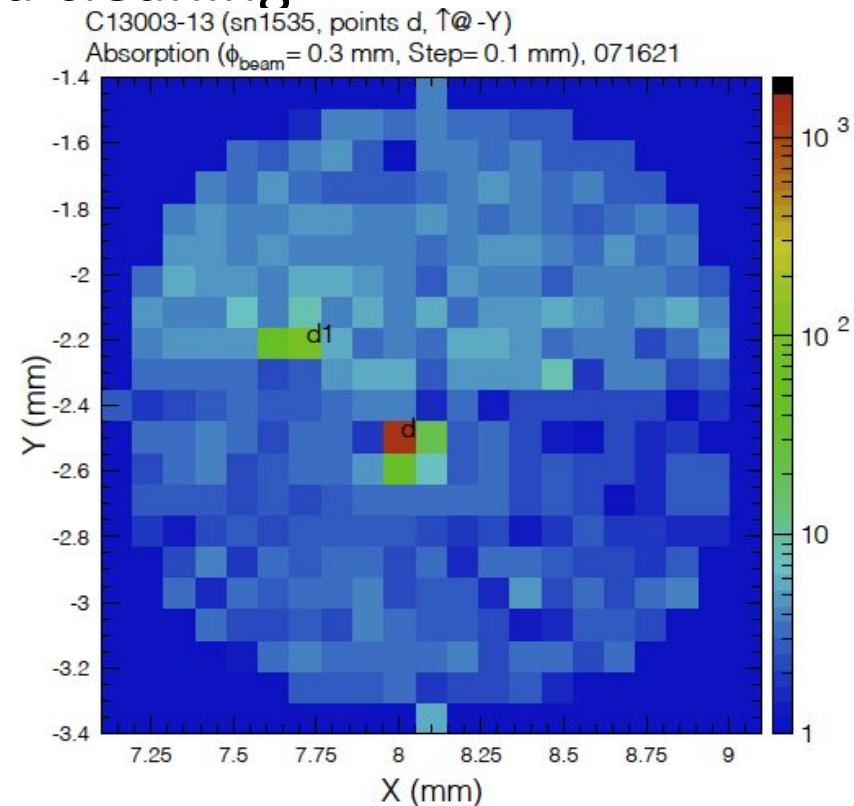
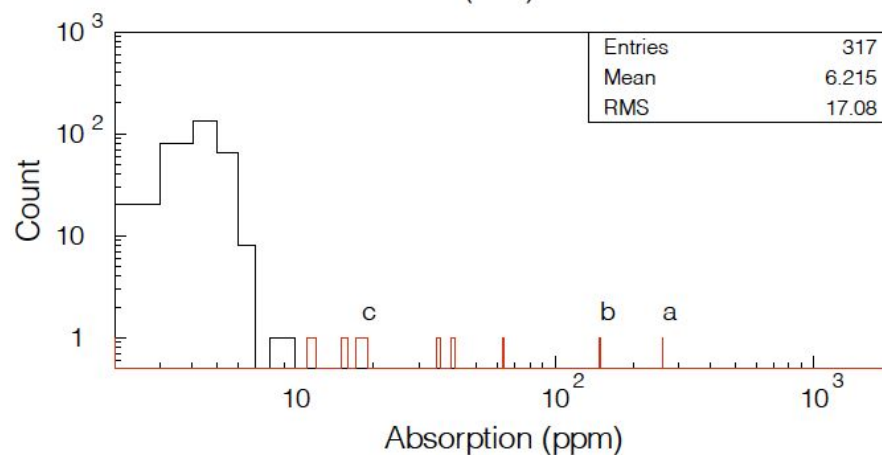
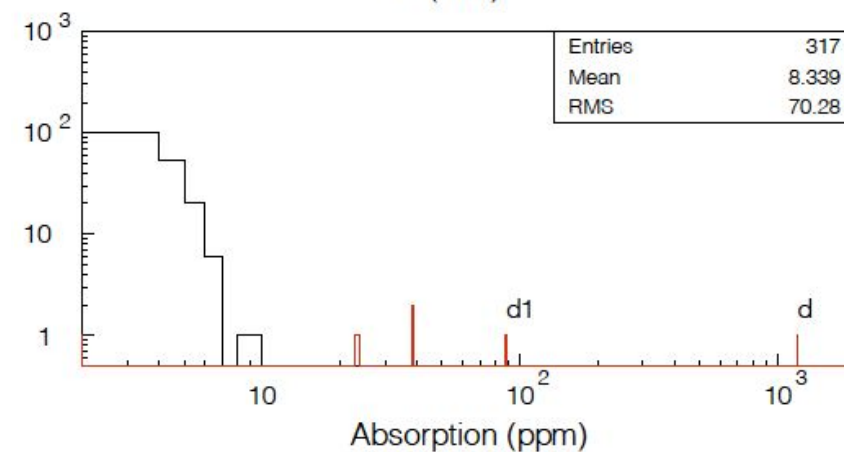
Absorption unchanged for ablated spots after plasma cleaning

Absorption at f1c is significantly reduced.

Absorption at all ablated spots remains the same.

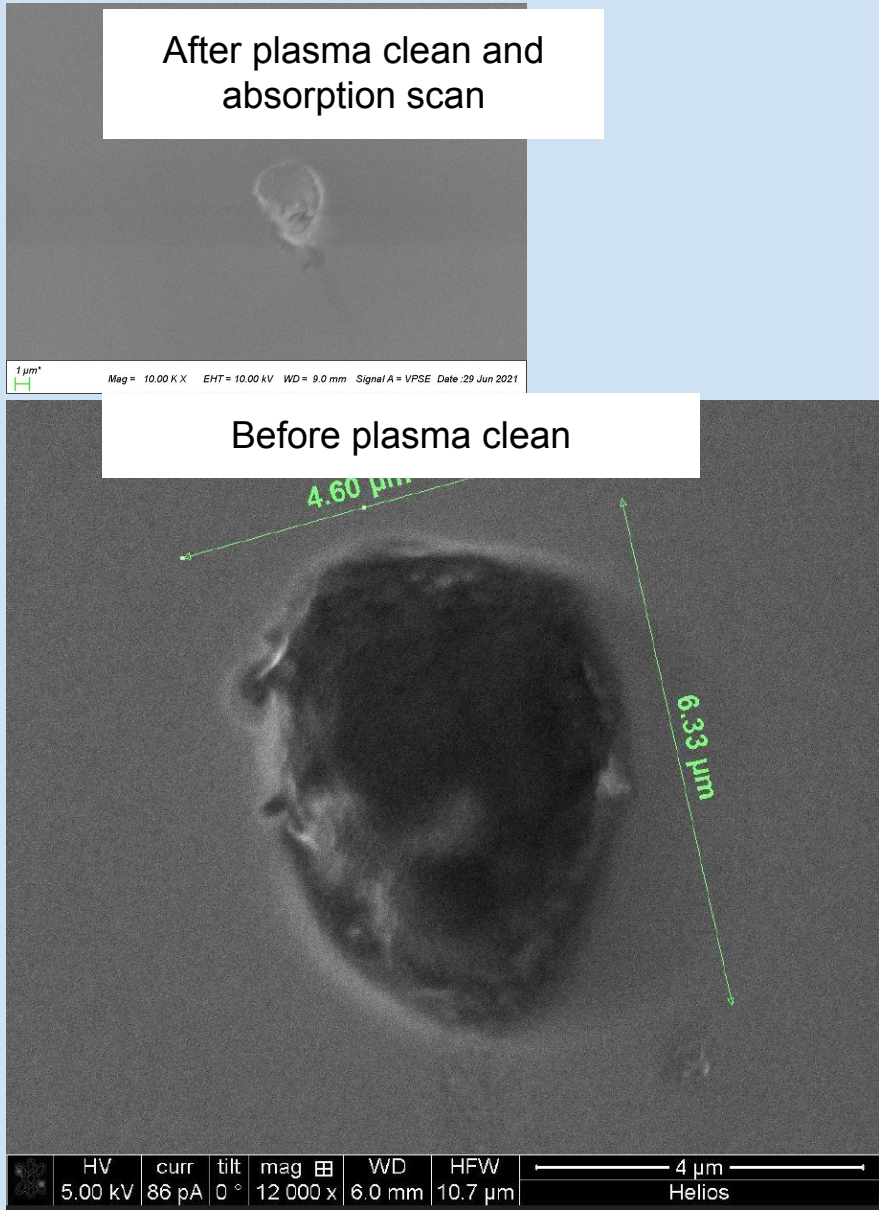
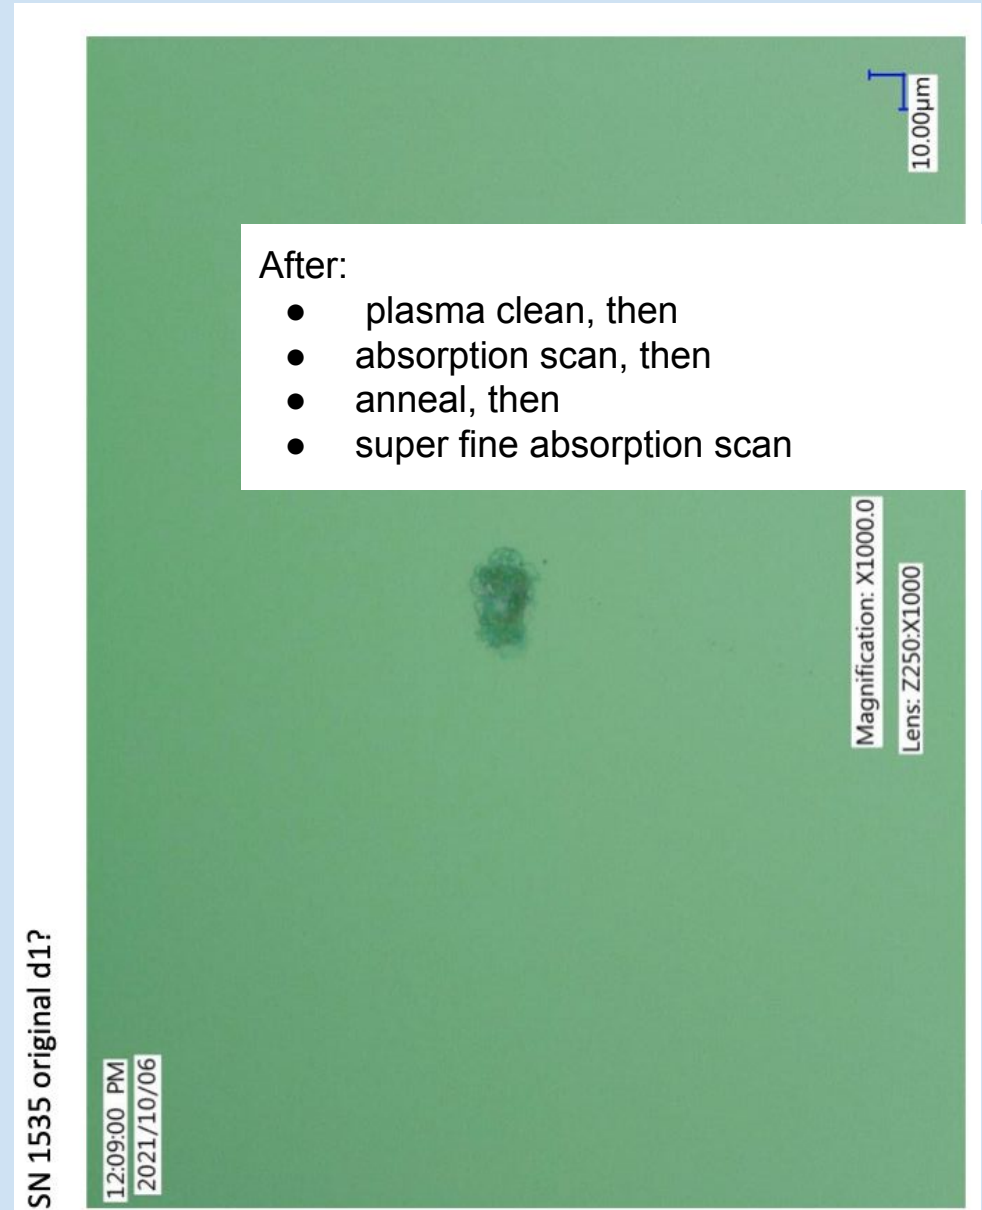
od after plasma clean then annealing (green background) from most recent [RTS scan](#) does not compare well to SEM images?

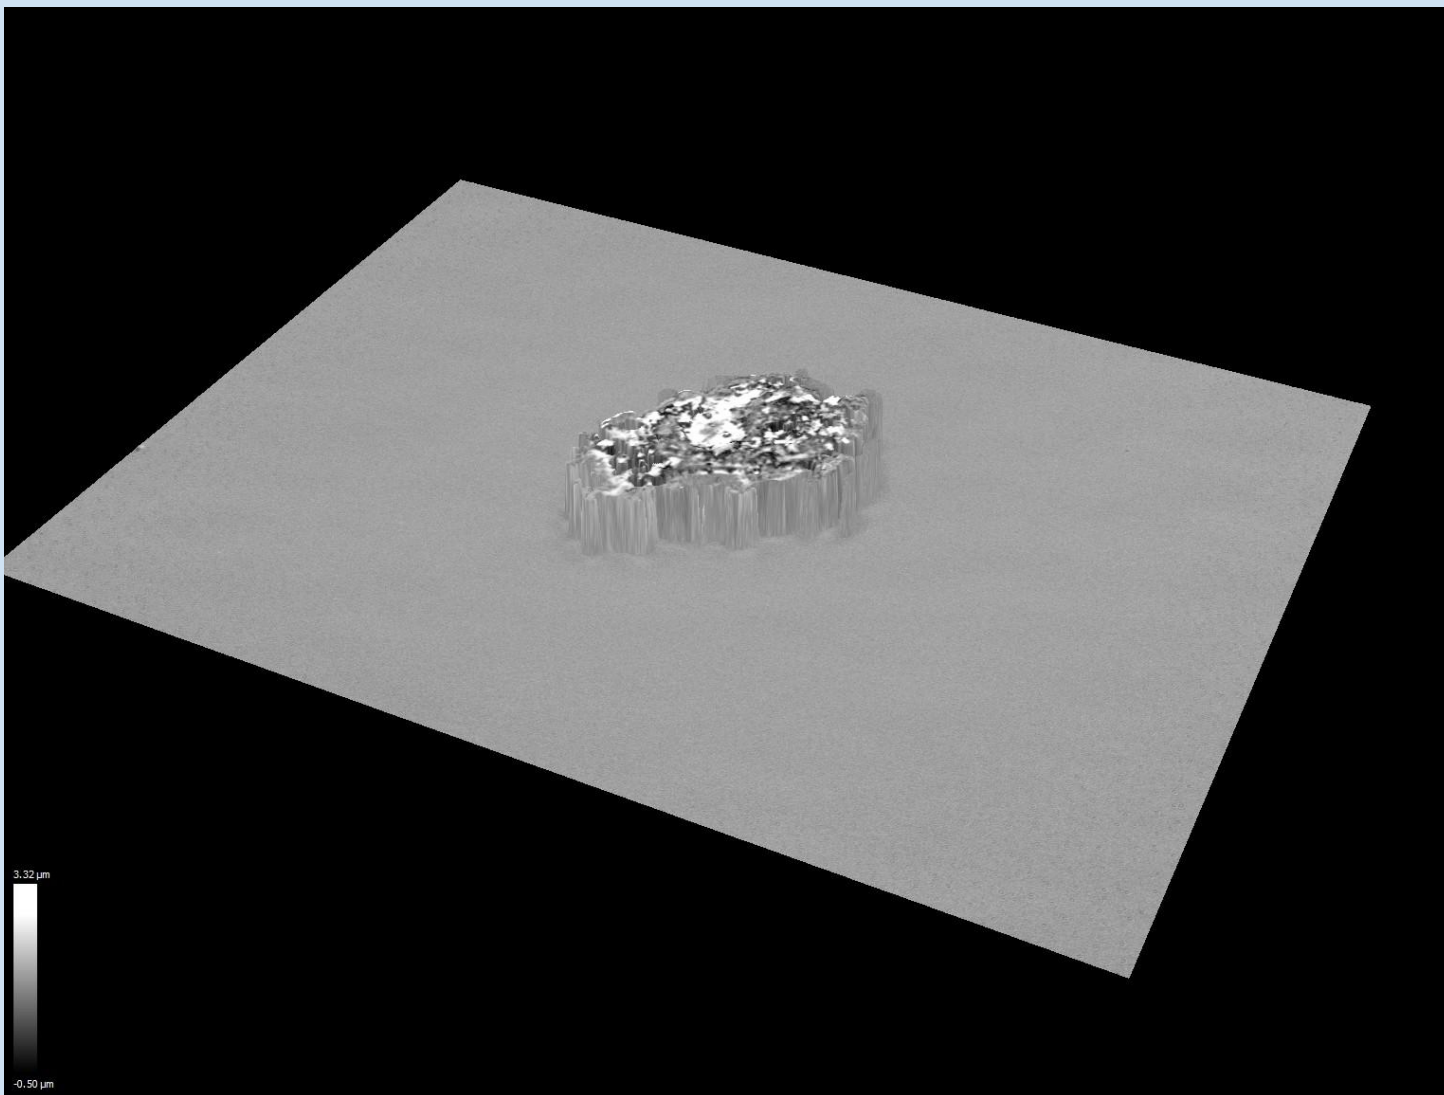
SN1535, od, before ablation

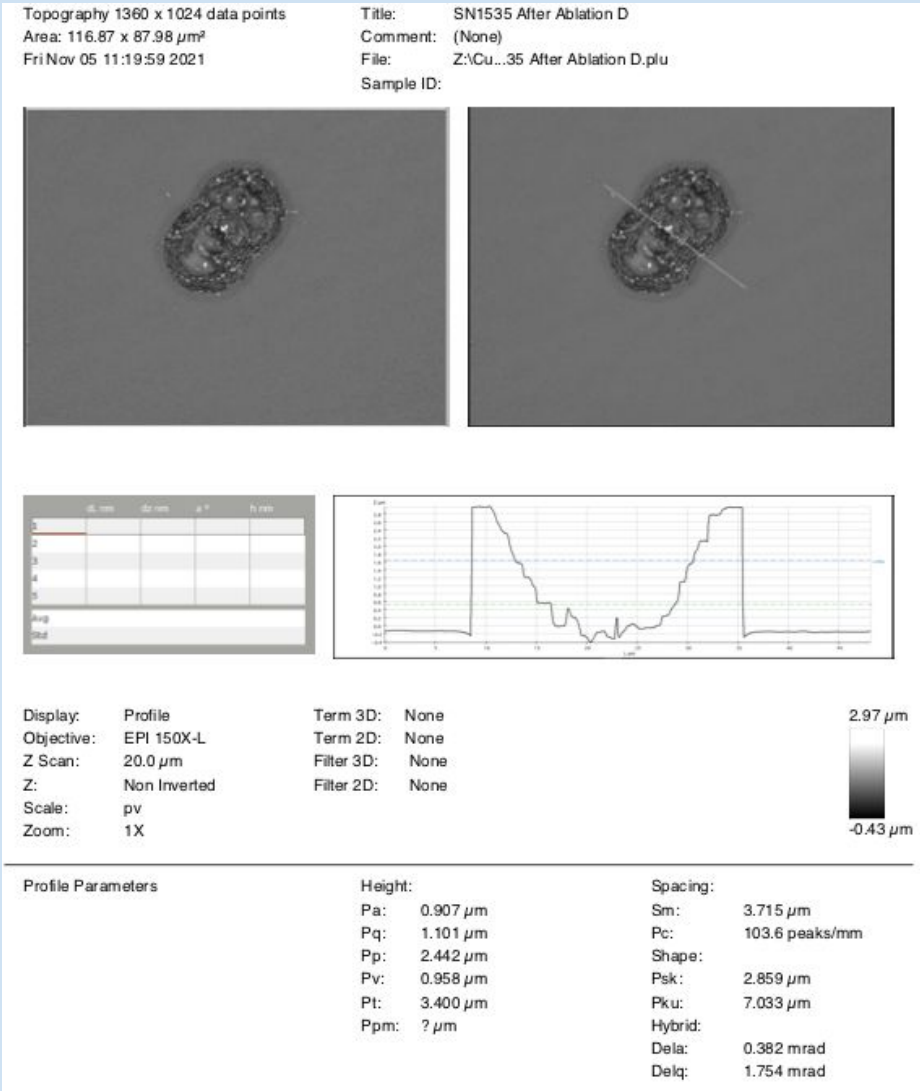
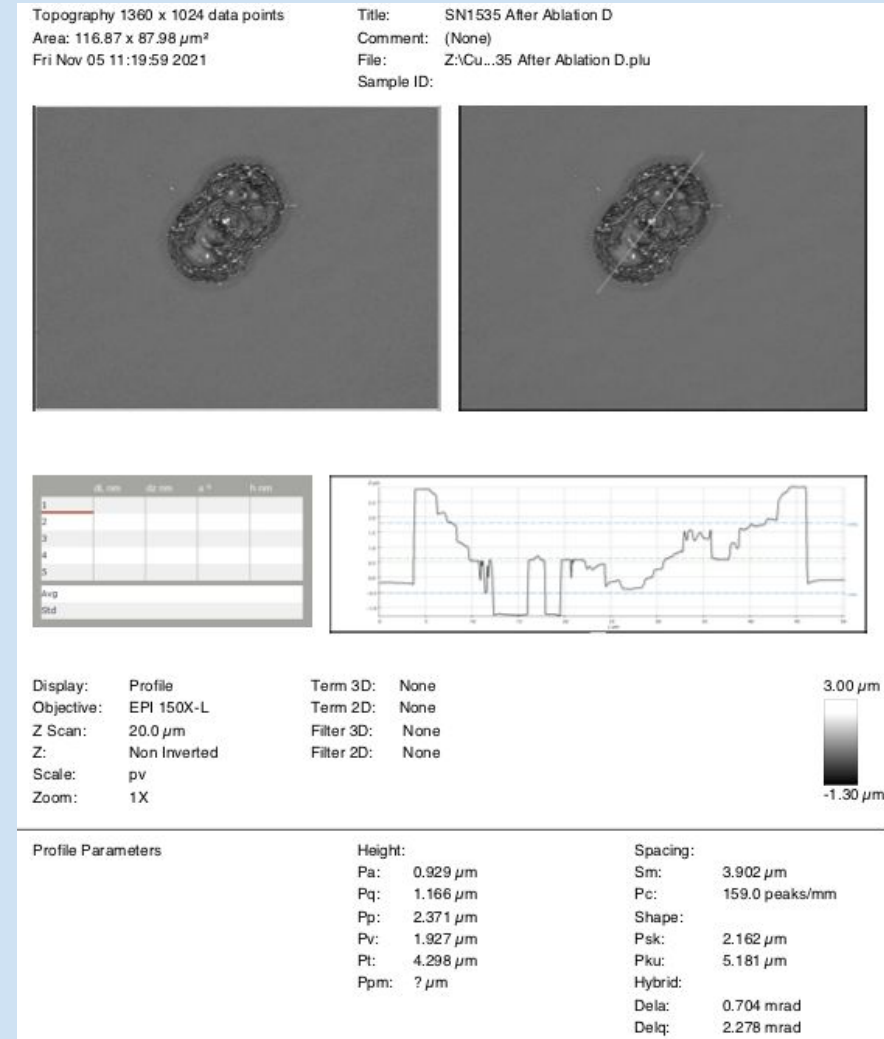
SN1535, od, after ablation: 8 pulses, 7 uJ each, in 2 partially overlapping spots
