LASER INTERFEROMETER GRAVITATIONAL WAVE OBSERVATORY
- LIGO -
CALIFORNIA INSTITUTE OF TECHNOLOGY
MASSACHUSETTS INSTITUTE OF TECHNOLOGY

Technical Note	LIGO-T0900513-v1-0	Date: 10/19/2009
Electrostatic Drive Redesign Suggestions from LASTI Experience		
Brett Shapiro

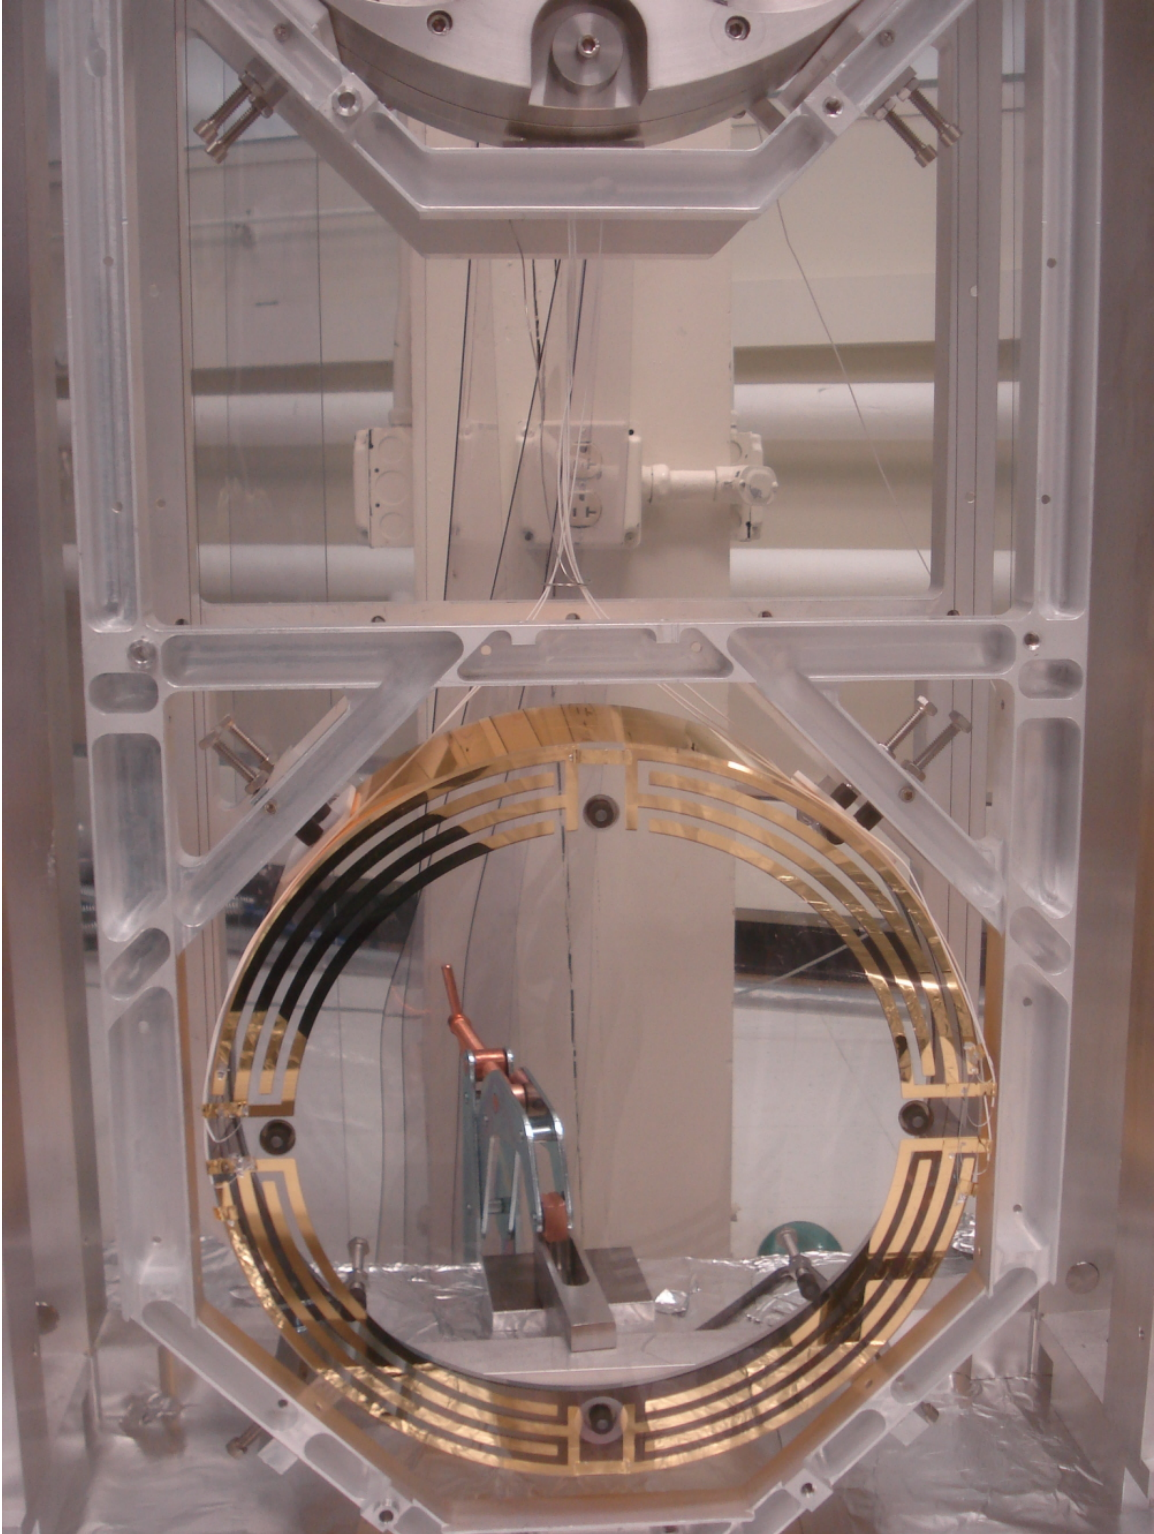
The current configuration has the cables traveling out to the sides of the reaction mass (3 and 9 O'clock positions). Since there is no intermediate clamp between the penultimate mass and the end points of the cables, they tend to flare apart on the way down, which risks bumping into earthquake stops, the structure, or falling in the gap between the test and reaction masses. The controls prototype ESD avoided this issue by tacking the cables directly to the barrel with Vacseal. At LASTI we improvised a makeshift guide wire hanging off the bottom of the penultimate mass that holds the cables together until they reach the top of the reaction mass.

The clearance is tightest right at the 3 and 9 O'clock points. Most of this issue is already solved by item 2 above. However, if the lower channels cannot be routed to the top of the reaction mass shifting the lower connections down below the 3 and 9 O'clock points will improve the clearance. The cables will still need to hug close to the barrel on the way up or they will run into the same clearance issue with the structure.

Figure 1: The LASTI ITM CP ESD. The cable terminate at the 3 and 9 O'clock positions. Note the proximity of the structure at those points. Also visible is an improvised guide wire holding the cables together in the gap between the penultimate mass and reaction mass.

A suggestion to fix this issue is to move the cable connections to the top of the reaction mass. The top of the reaction mass is less accessible to the two bottom control channels, thus only 3 of the 5 cables make it easily to the top. One possible solution is to run the two lower cables up the barrel and tack them down somehow on the barrel near the top. Another is to create an isolated trace in the existing gold barrel coating of the compensation plate. Experience at LAST did show the lack of robustness in the barrel coating. It rubs off extremely easily (the LASTI CP has smudge marks simply from handling), consequently this point should seriously be considered while designing the route of these lower channels. The gold pattern itself is much more robust since it is deposited on something other than glass, perhaps nickel.

The issue of falling in the gap can be further minimized by shifting the electrical connection of the cable onto the barrel. A previous proposal suggests folding a tab or the gold pattern itself over the bevel onto the barrel. Another suggestion I heard proposed was to attach a connector onto the center of the barrel's top surface, where the cables from above would terminate. Obvious considerations relate to the mechanical robustness of such a connector. For the compensation plate it might be prudent to leave a hole in the mechanically unreliable gold barrel coating where the connector will sit.
