# In-vacuum instrumentation reliability evaluation

## Evaluation Team and examples of information sources

# SEI - ISI

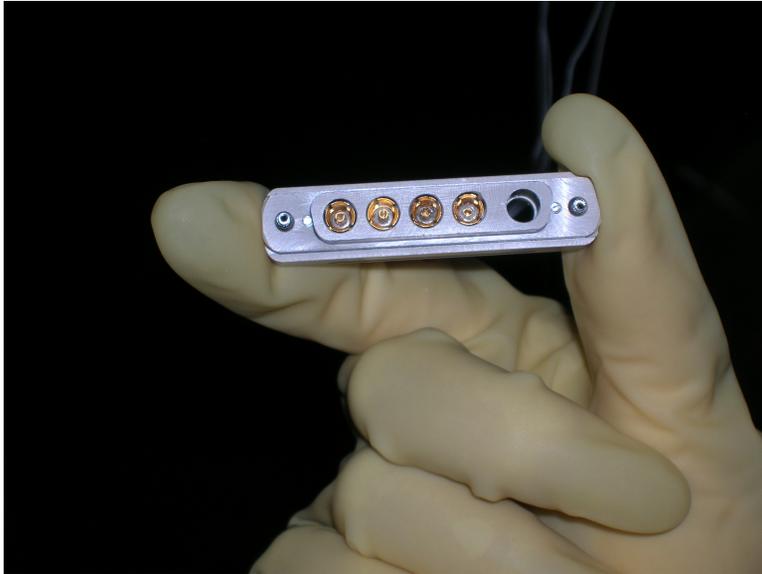
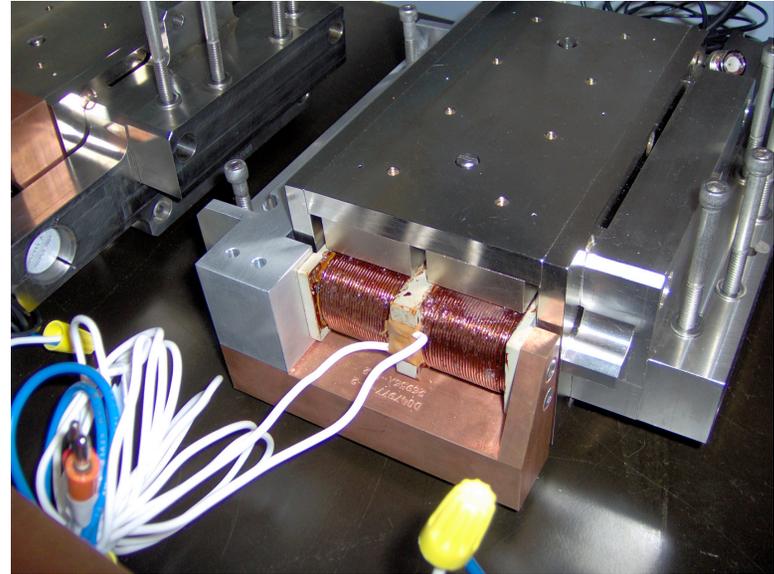
Concern: Notice the variety of polymers used in the fabrication

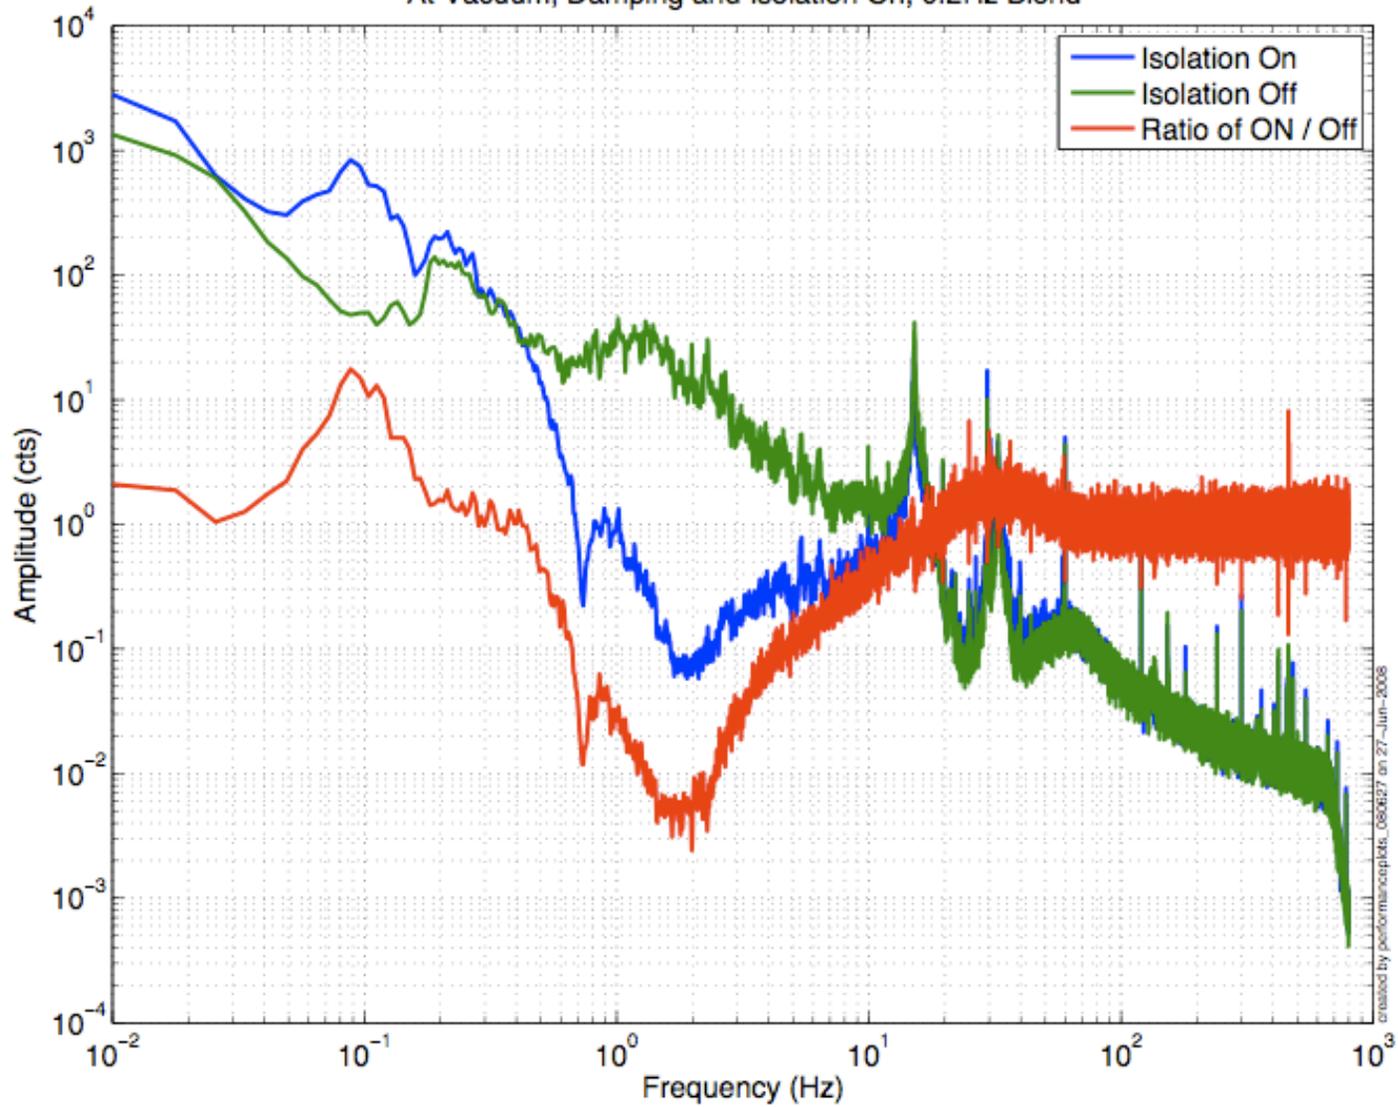
LHO HAM6 ISI, June 27 2008  
Witness STS-2 ASD, X Direction  
At Vacuum, Damping and Isolation On, 0.2Hz Blend

Attached here are the results from today's work. As you're looking at them, imagine the hours upon hours of frame builder reboots, awg failures, matlab crashes, dtt mismeasurements, and ENJOY VICTORY.

These plots were taken as a before and after, with isolation loops on, and isolation loops (and damping loops) off. The displacement sensors and geophones have been blended at 0.2 Hz (note that Z, RX, RY, and RZ were not the intended blend filters). Also remember the loops were designed to be good. Once we have models and requests from optics folks, we can tune and tailer the isolation to needed shapes. In addition, these plots are taken *\*without\** feed-forward sensor correction in place for these loops. This last feature will be implemented soon, and only give as more performance.
