LIGO-E080426-00-D

Advanced LIGO ERGO Arm Hazard Analysis

Tests at LASTI – January 2009

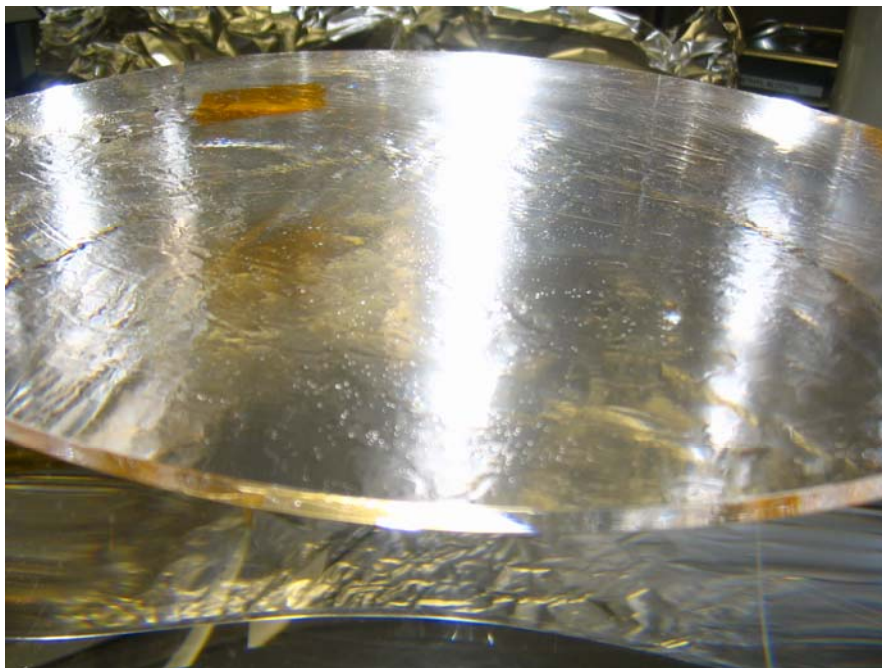
This figure shows a closeup of the surface of the First Contact before any ERGO arm tests.

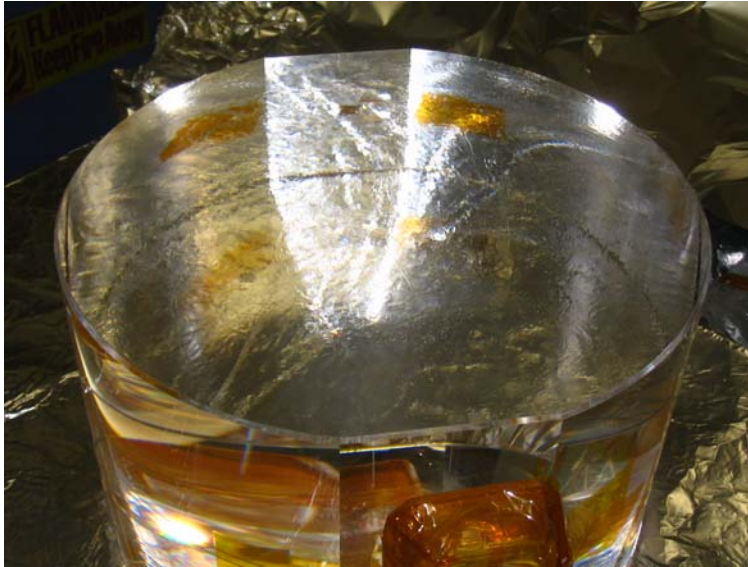
The figure shows the surface that was in contact with the face of the ERGO Arm and has the First Contact on it after the tests. The picture is not the best way to prove this, but there was no evidence that the O-ring permanently changed the First Contact.
