LIGO-T070233-00-D

LASTI Test Mass – Coating Characterization

Liyuan Zhang, Helena Armandula

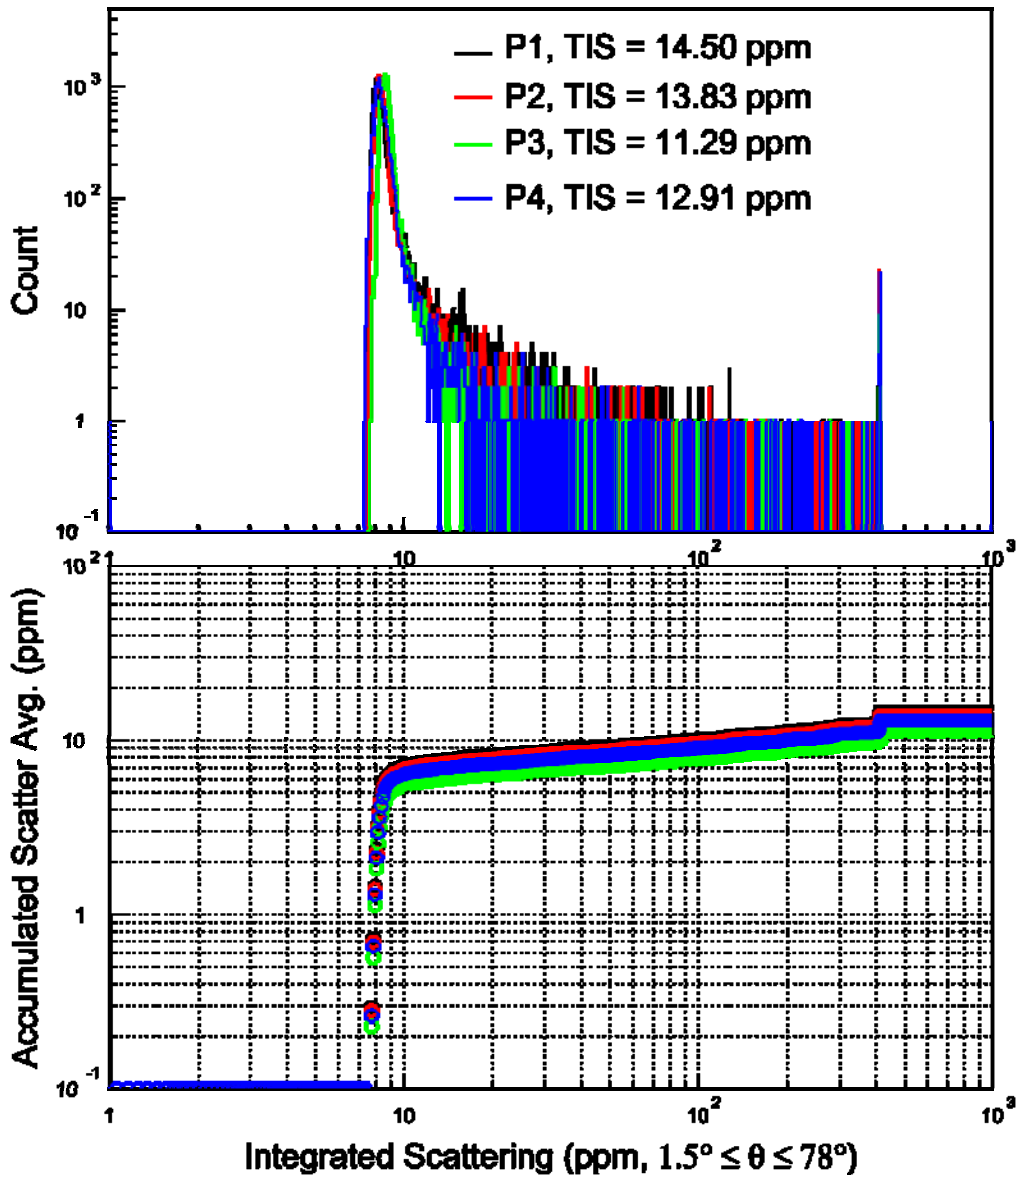
Fig. 2 Statistics of the four scatter measurements, upper: the histograms, and lower: accumulated scatter average.

The scatter of the LASTI LEM-1 HR side was measured on the RTS bench at Caltech by using a focused beam and an integrating sphere. The beam waist is about 125 microns and adjusted to be at the surface of the optic. The integrated polar angle range is from 1.5° to 78° , corresponding to a spatial bandwidth of $250 - 9200 \text{ cm}^{-1}$. Four scans of $10 \text{ mm} \times 10 \text{ mm}$ were carried out at the center part with a scan step of 0.1 mm, so the total scanned area is $20 \text{ mm} \times 20 \text{ mm}$. Fig. 1 shows the maps of the four scans and fig. 2 summarizes their statistics. In addition to a uniform background, which is decided by the micro roughness scattering, there are some non uniform high scattering points. Because the optic was cleaned by using the First-Contact before the scan, these points are thus believed to be more or less ‘permanent’, caused by some sort of defects in the coating or bulk.

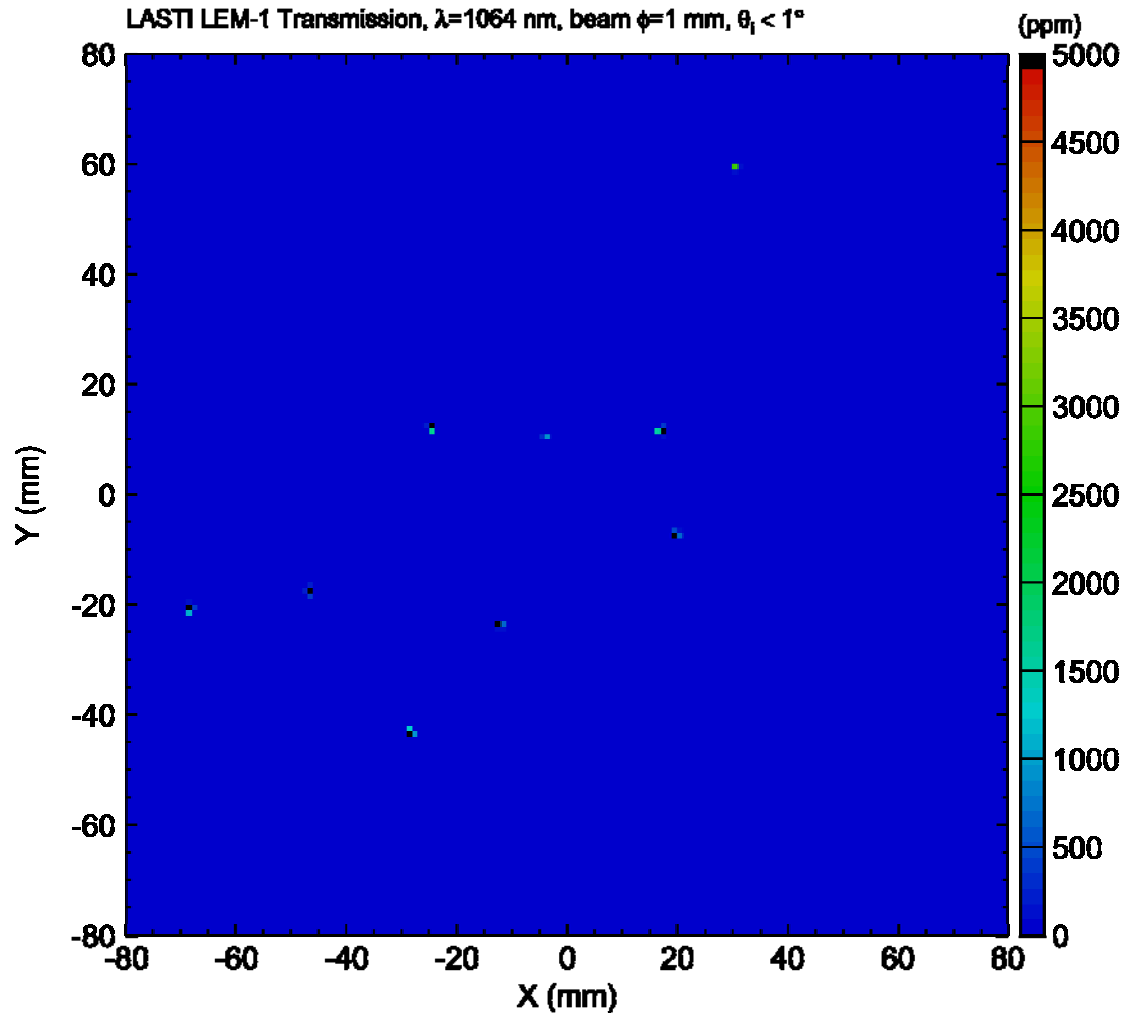
Fig. 6. Transmission map of the LASTI LEM-1 optic.

The transmission was measured by using a collimated beam of 1 mm in diameter and an 1 mm scan step at the center part of $160 \times 160 \text{ mm}^2$. While most of points were within 9-10 ppm, indicating a very good uniformity, nine very high transmission points were found, as shown in figs. 6, in which seven of them were saturated in the lock-in amplifier. To get an overall average, each of these 9 points or ‘holes’ was individually calibrated and put in the histogram, as shown in fig. 7. One can see that the contribution of the points is about 1/3 of the overall average of transmission and is non-negligible. Then all of the 9 ‘holes’ were marked by the First-Contact and observed under a dark field microscope, more information and discussion will be given in later part.

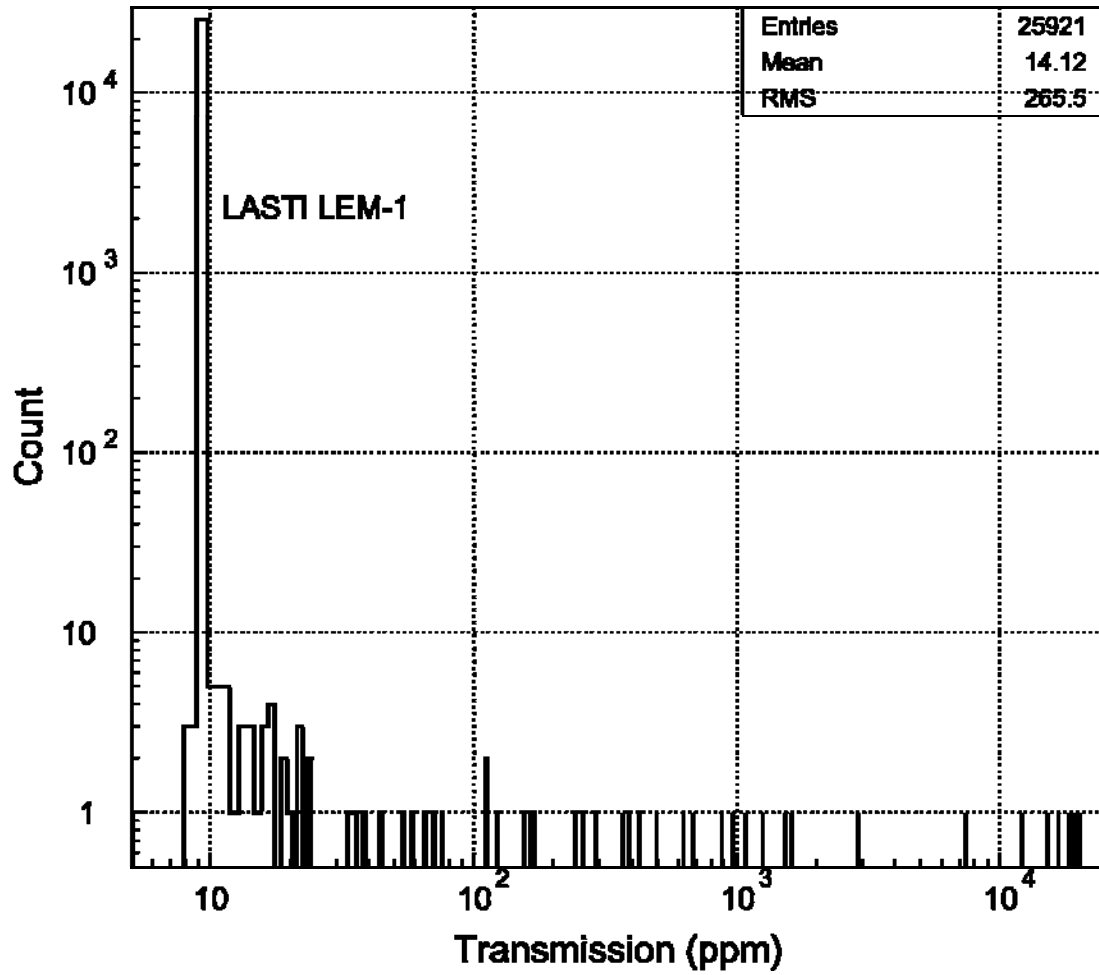
Fig. 7. Histogram of the measured transmission of the LASTI LEM-1 optic.

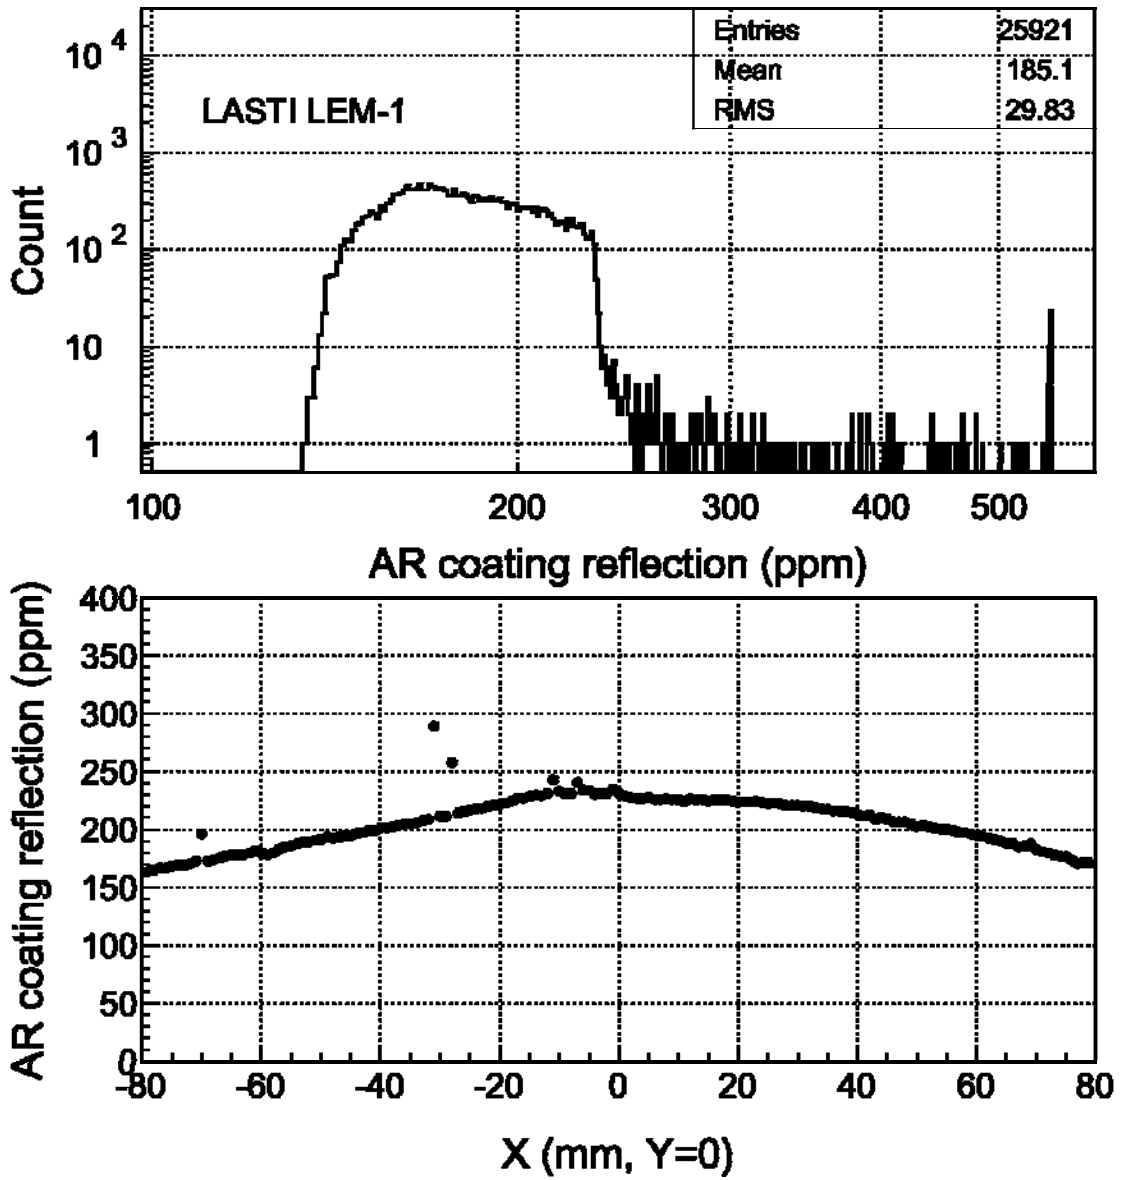
Fig. 9. Upper: histogram of all the measured points of the AR reflection; Lower: variation of the AR reflection along the X axis.

The reflection of the AR coating was also measured with the collimated beam of 1 mm in diameter at the central part of $160 \text{ mm} \times 160 \text{ mm}$. The AR coating doesn't show the good uniformity as that of HR coating, with about 230 ppm at center, 160 ppm at edge and an average of 180 ppm. Fig. 8 shows the map, and fig. 9 the histogram of all measured points and the variation along the X axis. One can also note that, in addition to this spherical distribution, there are some high reflection points, among which about 20 are saturated at 550 ppm limited by the scale setting of lock-in amplifier in the readout. Unfortunately, we had no time to further investigate these points before delivering the optic.
