Detector Construction & Installation Overview and Status

NSF Spring Review
27 - 29 April 1999

LIGO Livingston Observatory
Livingston, LA

LIGO-G990029-00-D

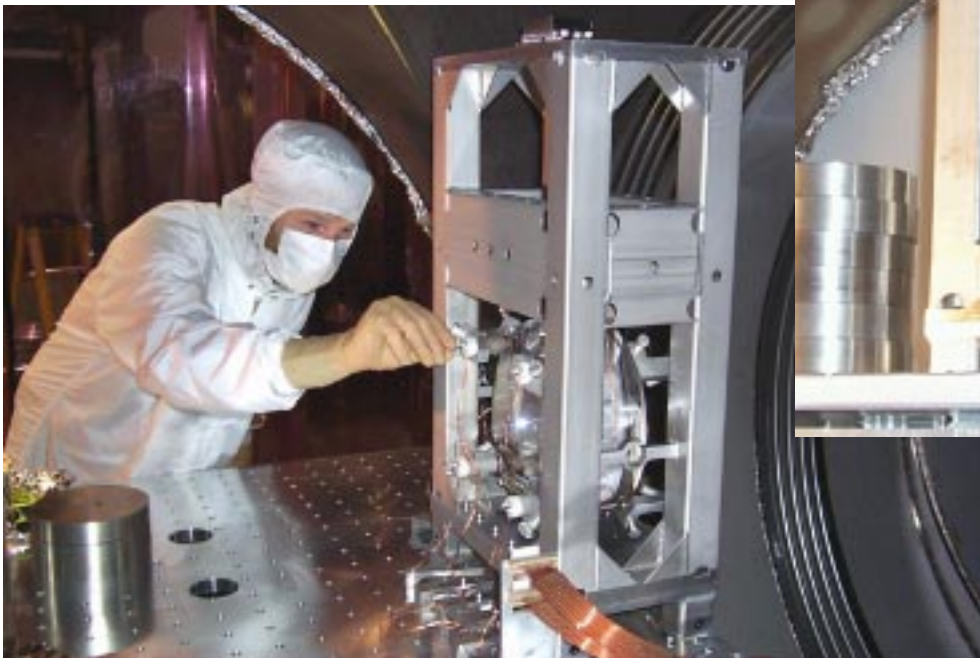
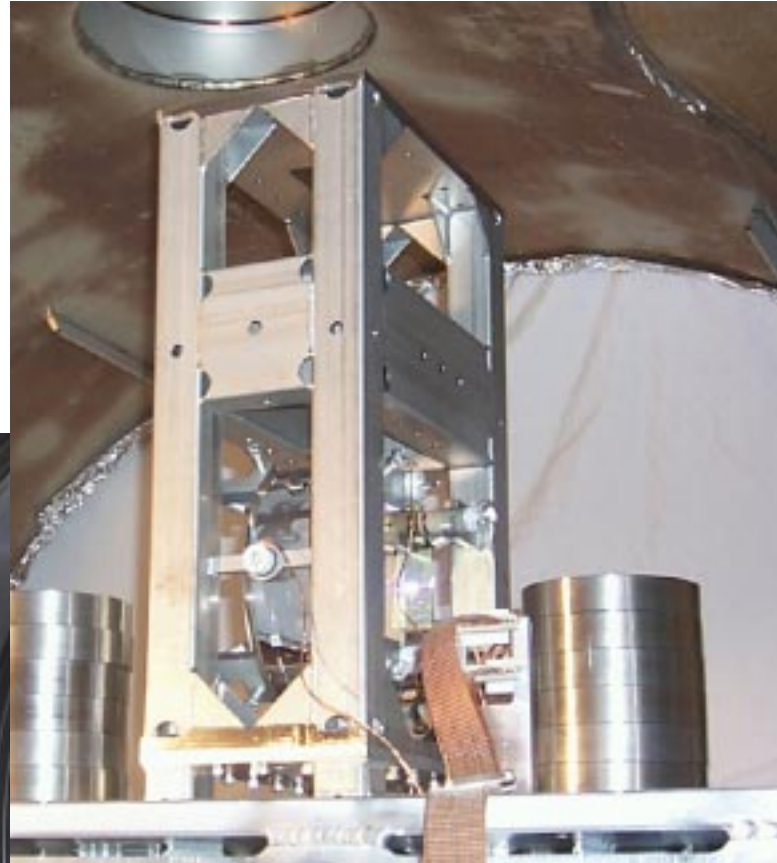
- Large Optic Suspension (LOS) structures:
 - ›› Resolved initial welding, dimensional control, QA and cleanliness problems
 - ›› All height adapters have been delivered (28 units)
 - ›› 26 LOS structures have been delivered; Balance of 2 LOS structures to be delivered by 6/99
 - ›› Most structures are in the queue for vacuum baking

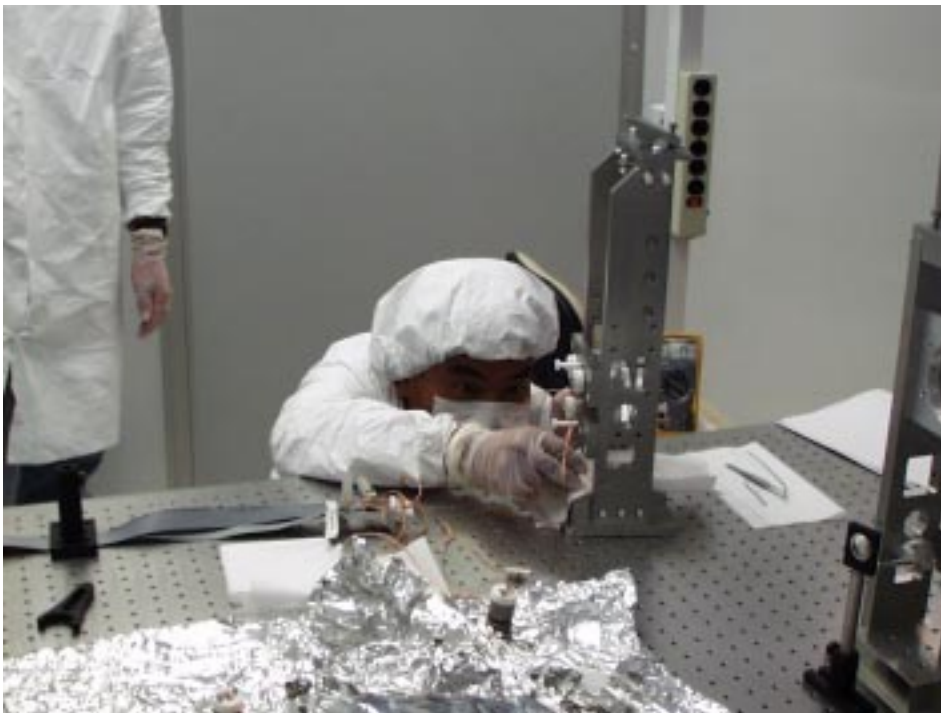
- Small Optic Suspension (SOS) structures:
 - ›› All 2km interferometer SOS structures fabricated & assembled (UFL)
 - ›› Most SOS structures fabricated for the 4km interferometer at Livingston (in vacuum bake queue)

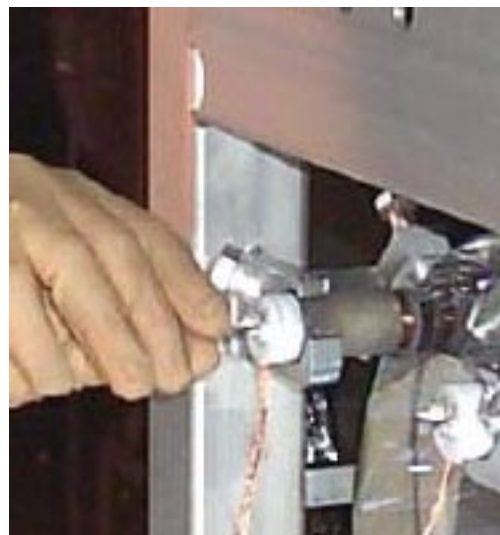
- Sensor/Actuator Head fabrication:
 - ›› Sufficient quantity fabricated for the 2km interferometer Input Optics and Near-Michelson (plus spares)
 - ›› Production for the balance is keeping pace with schedule

<i>ISSUE</i>	<i>UNITS AFFECTED</i>	<i>RESOLUTION/STATUS</i>
<i>COIL SHORTING DUE TO COIL WIRE TEFLON INSULATION FAILURE & ELECTROSTATIC MOLYBDENUM COATING ON BODY</i>	ALL UNITS PRODUCED TO 3/99 (~40 SOS, ~20 LOS)	-ALL UNITS REWORKED (SELECTIVE REMOVAL OF MOLYBDENUM COATING & ADDITION OF TEFLON TAPE TO INSULATE COIL FROM BODY) -FUTURE UNITS CONTINUITY CHECKED AFTER VACUUM BAKING & BEFORE INSTALLATION
<i>DEGRADATION OF PHOTODIODE/LED PAIR (UNBLOCKED VOLTAGE LEVEL)</i>	UNITS SUBJECTED TO MULTIPLE & EXTENDED VACUUM BAKE CYCLES	ALL FUTURE SENSOR/ACTUATOR HEADS WILL BE BAKED IN 2 STEPS TO MINIMIZE TEMP & TIME FOR PD & LED
<i>PHOTODIODES USED IN THE PRODUCTION UNITS HAVE AN OPTICAL FILTER WHICH WAS NOT VACUUM COMPATIBILITY & PROCESS CHECKED</i>	ALL FABRICATED TO DATE	PENDING VACUUM COMPATIBILITY TESTING

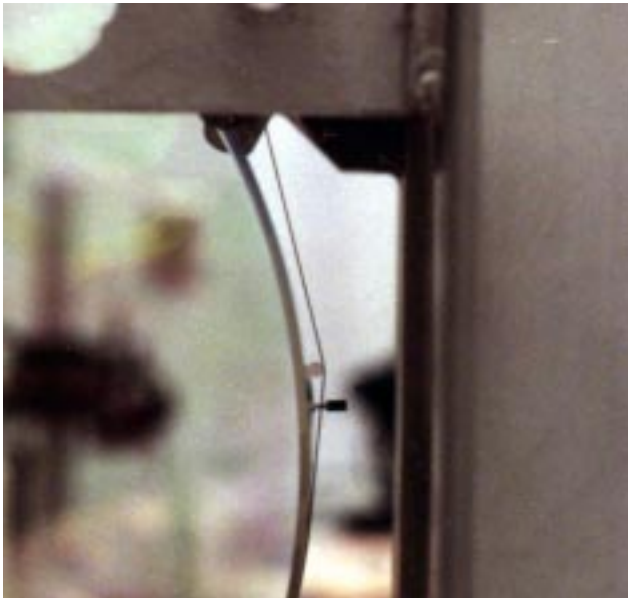
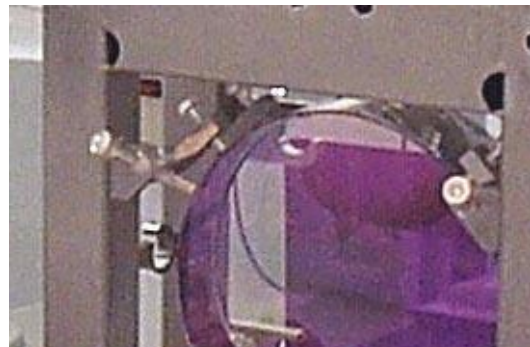
- Experienced significant problems in achieving reliable & robust adhesive bonds between the optic/standoff/magnet
- Initially thought to be a process control, yield problem -- realized the problem is more fundamental and the “patched” solutions introduced additional problems
- A “tiger team” was formed to address the problem:
 - find solution to immediate adhesive bond problem
 - seek a longer-term, non-epoxy bonding solution
- “Stop Work” as of 4/13 for all suspension bonding until a revised procedure and fixturing are available
 - expected restart is ~4/28 for SOS and ~ 5/10 for LOS

- Teflon screws were discovered to shed unacceptably
- Implemented new design (flourel tipped, Ag/SS screws)

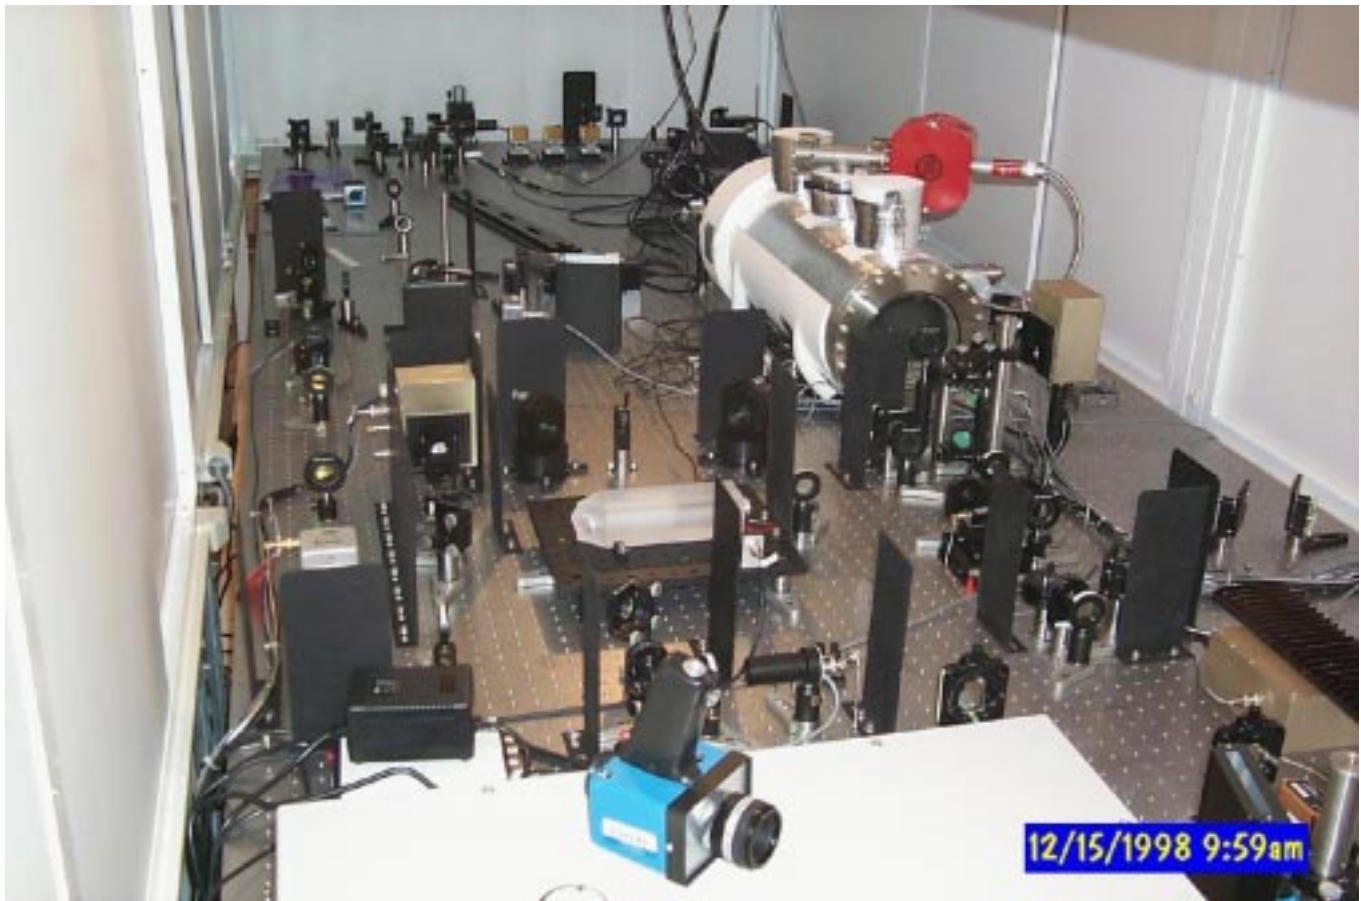
- ›› PSL FDR held Mar 99
- ›› PSL installed and functioning at Hanford 2k
 - performance testing is nearly completed and results are under study
 - further PSL characterization will be done with mode cleaner
 - all servo loops are functioning
 - some tweaking needed (pre-mode cleaner finesse, etc.)
 - diagnostics under implementation
 - beam handed off to the Input Optics (IO) group
- ›› PSL installation at Livingston began April 5

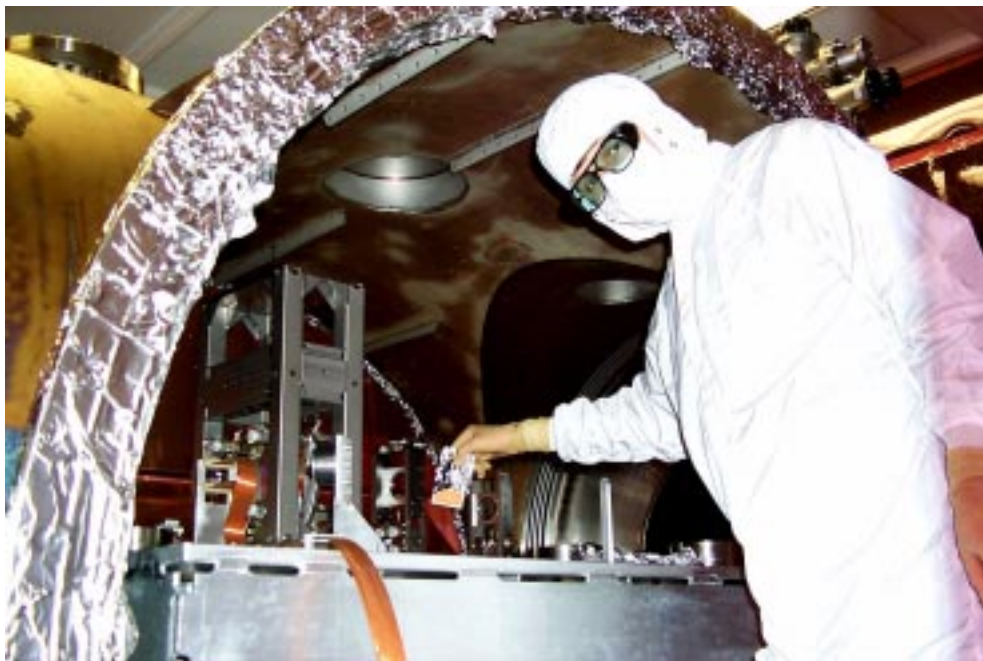
- ›› All optics polished and coated
- ›› IO installation at Hanford proceeding
 - in air table optics installed and aligned
 - Most SOS installed in vacuum system (balance pending resolution of the magnet/standoff/optic adhesion problems)
 - The Mode Matching Telescope (MMT) 3rd optic (a LOS) is installed
 - mode cleaner shakedown to start May
- ›› IO installation at Livingston begins May 99
- ›› Mode match WFS experiment proceeding
 - taking and analyzing data now
 - doughnut WFS to be delivered to Hanford ~ June
- ›› Preliminary IO Alignment with Attenuated PSL beam in chamber HAM7 (under LVEA “Laser Hazard” Condition):

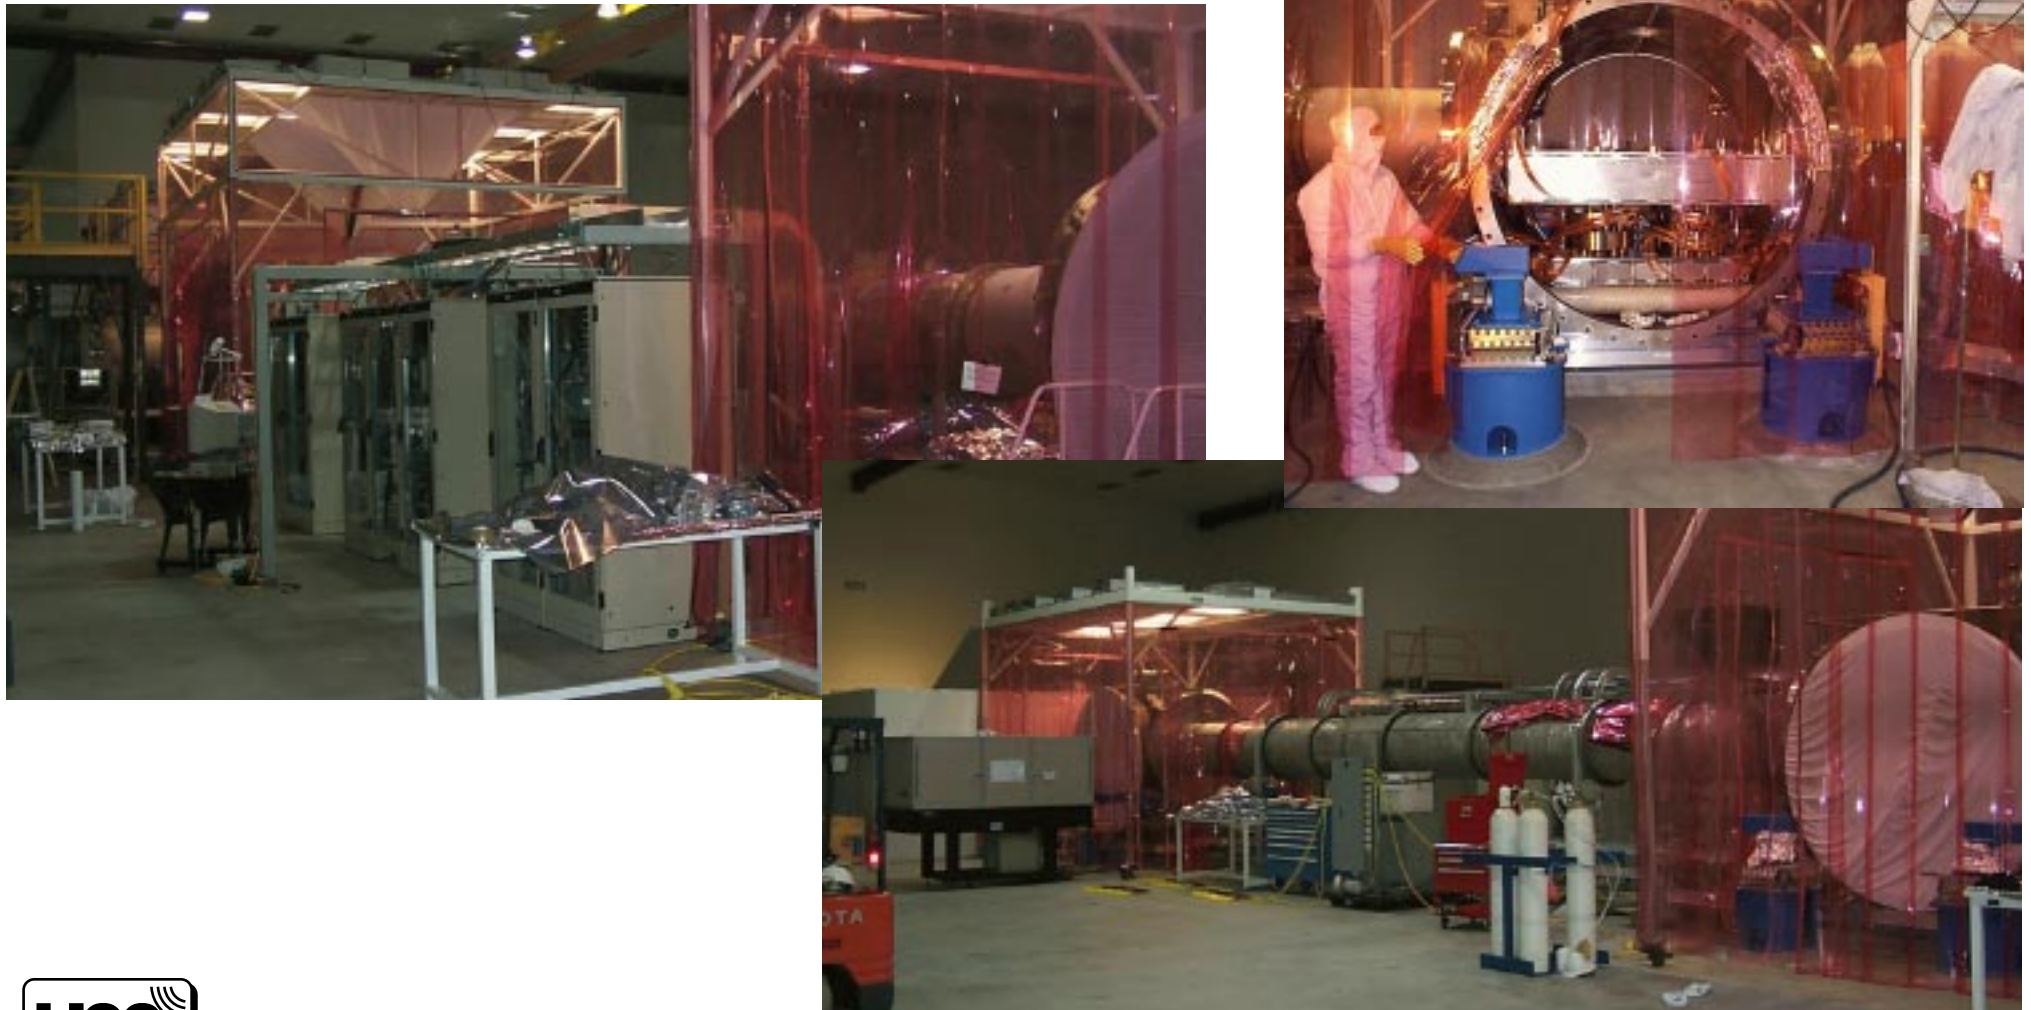
- 2km Interferometer installation has progressed to the point of the first major integrated system test 5/99: Mode Cleaner lock and length/alignment control (involving 9 subsystems)!

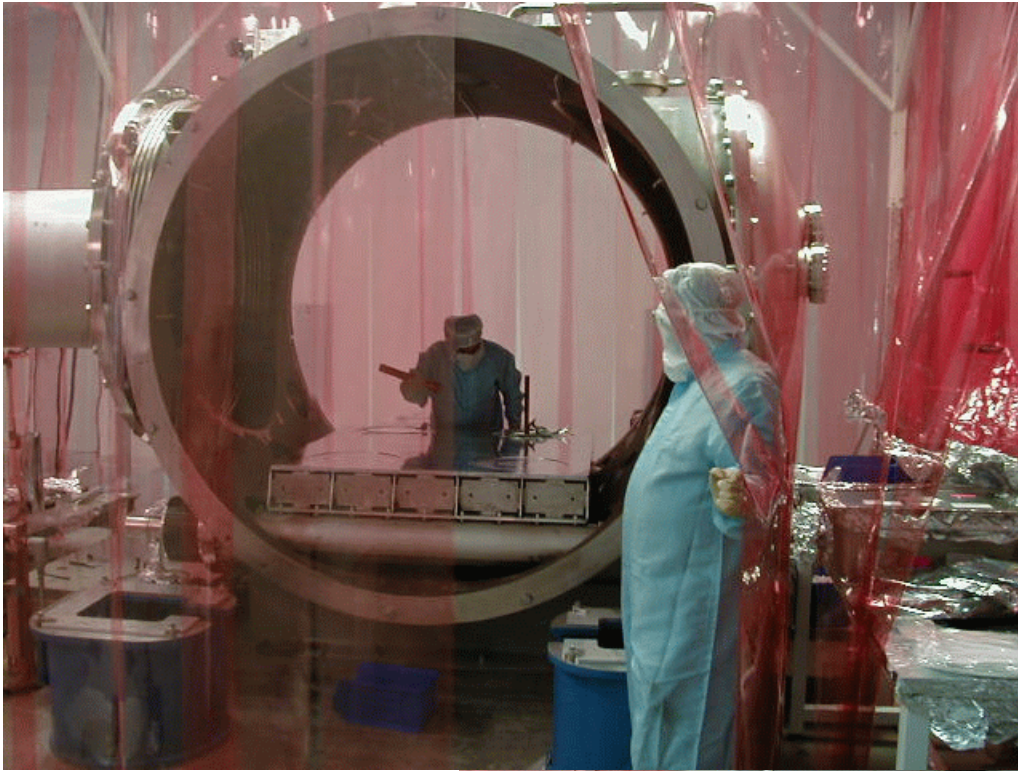
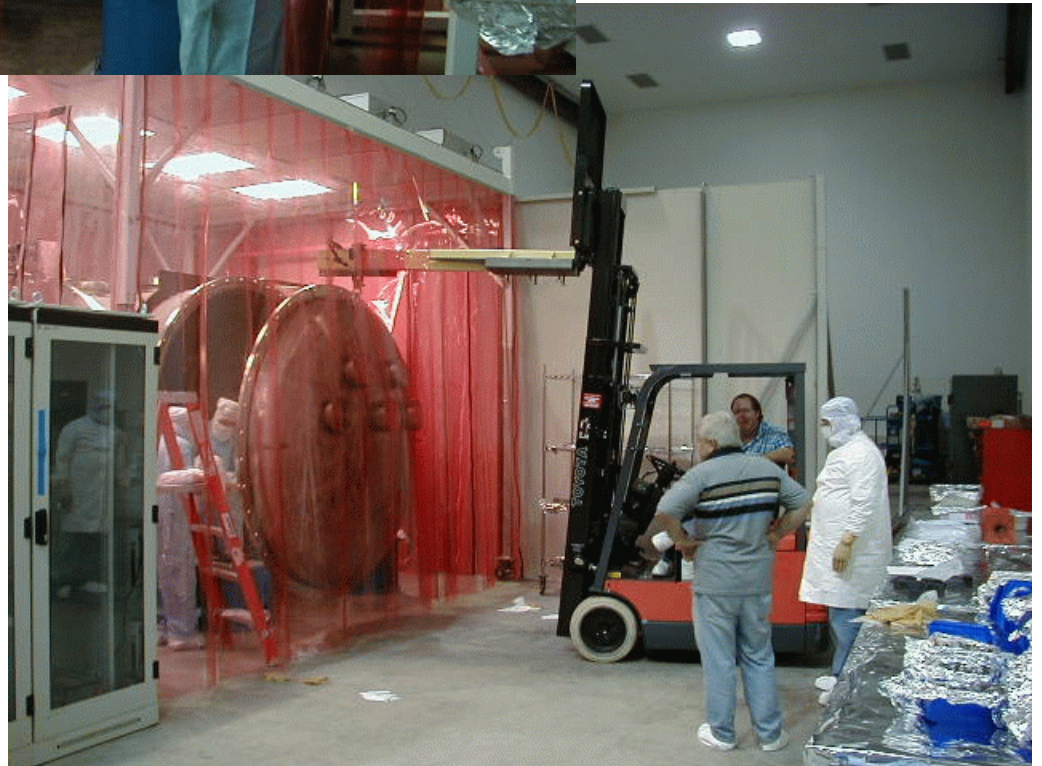
- Pre-Stabilized Laser and Seismic Isolation installation well underway at Livingston
