LIGO-T1100238-v2

**ADVANCED LIGO**

**Report on hydroxide catalysis bonding at LHO in March  
and April 2011**

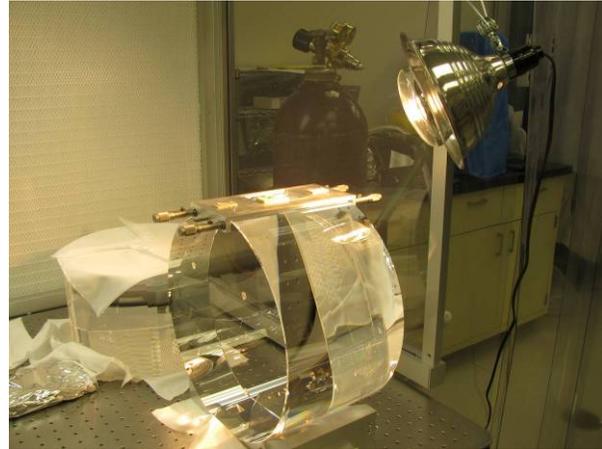
**Figure 3.1** Some images of the gluing of prism 39 to surface S3 of PM ITM04.

Prism 39 on side S3 was glued on Tuesday afternoon the 8<sup>th</sup> of March 2011 by applying a cross figure of adhesive to the bonding surface using a copper wire while it was inserted into the prism holder and then glued on. The heat lamp was immediately switched on approximately 30 cm above the surface. This helps the adhesive run across the entire surface area initially and speeds up the curing. The heat lamp was switched on for approximately 12 hours (overnight). After removal of the prism holder and jig the next day a cross shaped figure was observed in the glue but very few bubbles. In the cross the adhesive looked somewhat hazier than in the rest of the joint. This same feature was observed with the prism joints made at LASTI using Vac-Seal as well and is not thought to negatively influence performance. Also the positions of both the ear and prism with respect to the front and back surface (S1 and S2) of the mass were measured. More details about this in section 3.4.

a) Prism and copper wire for applying the adhesive

b) Heat lamp above the mass with prism glued on

c) Close-up of prism 39 in prism holder and jig on surface S3

d) Imaging showing cross shaped feature in glue joint

Gerardo Moreno applied the adhesive and did the gluing of the prisms. We observed three points that required a redesign of the prism holder. The first point is that the prism holder has the same width as the ear, which means the jig can interfere with the ear when placing the jig for gluing the prism. The required change in design involves making the prism holder 1 mm wider so that there is a gap of nominally 1 mm between the ear and the jig when gluing the prism. The other point was that Gerardo Moreno found it hard to hold and control the prism holder while placing it down onto the surface. The solution to this was to redesign the prism holder making it a bit higher, such that it sticks out more above the jig and is therefore easier to place down in a controlled way.

The third point involved the clamping screw. It didn't have a ball shaped end, which meant the prism wanted to move during clamping into the prism holder. The redesign solution is to machine the screws to a ball shaped end. **(FLAG)**

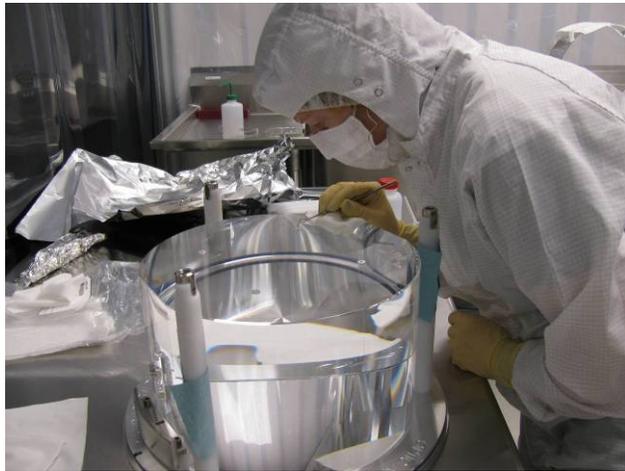
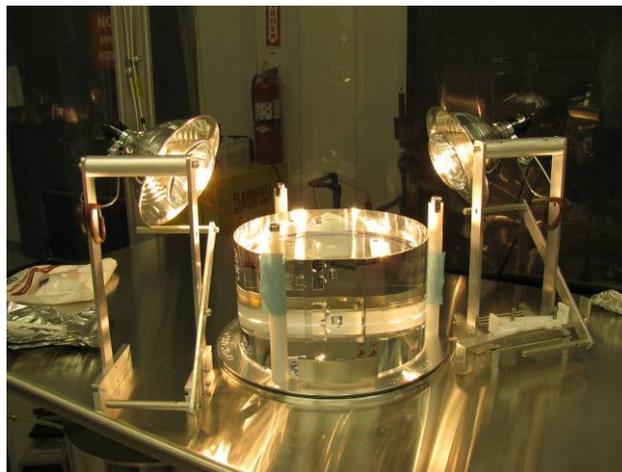
Figure 3.2 Some images of gluing magnet flag mount discs

a) Betsy gluing a steel ring onto a mount disc on PM ITM04

b) Close-up of gluing in a steel ring onto a mount disc using a pointy dental tool

c) Two heat lamps on stands over PM ITM04 to help cure the adhesive

Betsy then glued the magnet flag mount disc by applying a dot of adhesive to the back of the mount disc and carefully placing the mount discs into the holes. She then applied a tiny dot of adhesive to the magnetic steel ring and used pointy dental tools to place the ring inside the mount disc. She repeated this 4 times for all mount discs. Two heat lamps were put on stands over the mass to help cure the adhesive overnight. See Figure 3.2 for some images. The gluing of the magnet flag mount discs was done on Thursday morning the 10<sup>th</sup> of March 2011.

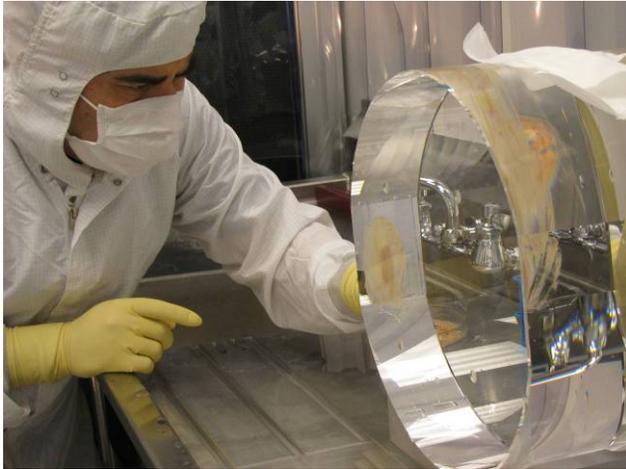
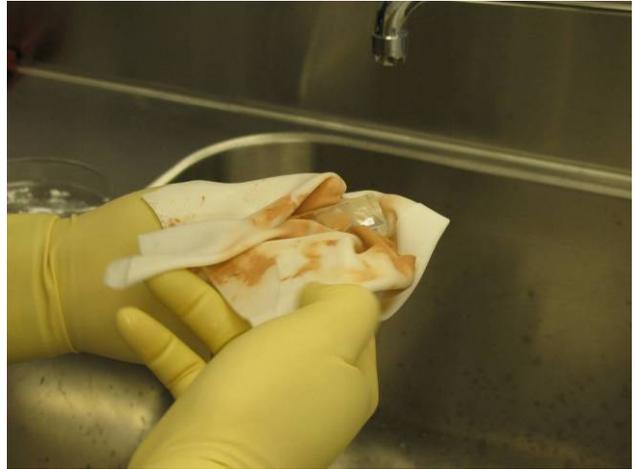
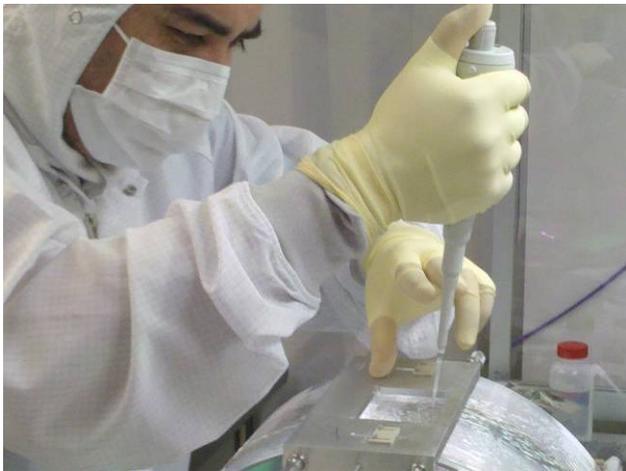
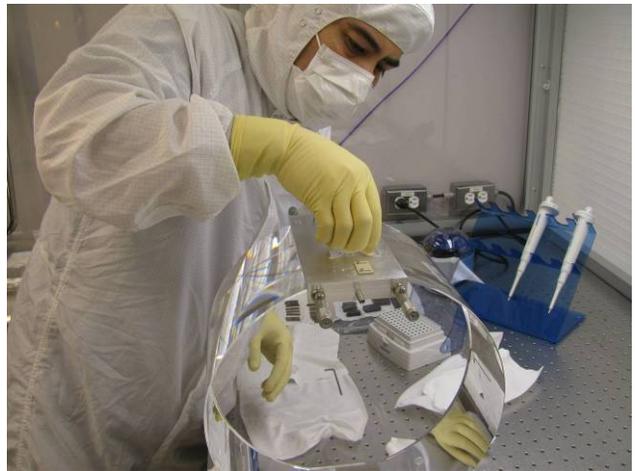
Figure 3.4 Some images of the bonding procedure

3. Cleaning the bonding surface on the mass by rubbing with a cerium oxide: DI water paste twice followed by rubbing with a bicarbonate of soda: DI water paste. The cleaning procedure is finished by rinsing and a wipe with methanol. The mass is then transferred and turned onto the V-block in the flow bench (see Figure 3.4 a).

4. Cleaning the entire ear but particularly the bonding surface is cleaned using the same technique as for the flat on the mass (see Figure 3.4 b).

a) Cleaning the bonding surface with cerium oxide

b) Cleaning the ear with cerium oxide

c) Pipetting bonding solution onto the bonding surface

d) Placing the ear onto the bonding surface

e) The ear curing against the top left surface of the jig

f) Measuring the position of the ear

5. The bonding flat is wiped one more time with methanol and blown dry with ultra-pure nitrogen. The surface is then inspected closely using a high intensity light and eyes.
6. The bonding jig is placed onto the surface.
7. The ear is wiped on more time with methanol and blown dry with nitrogen. The bonding surface is then inspected.
8. The bonding solution is pipetted from the medical filter and placed onto the bonding flat on the mass after which the ear is placed onto the flat against the top left corner of the bonding jig (see Figure 3.4 c and d).
9. The bond is closely monitored while it settles in the first few minutes and the possibly existing bubbles are noted down with 30 minute intervals (see Figure 3.4 e).
10. After 2 hours the bonding jig is removed and the position of the ears along the optical axis is measured with respect to surface S1 and S2 (see Figure 3.4 f).

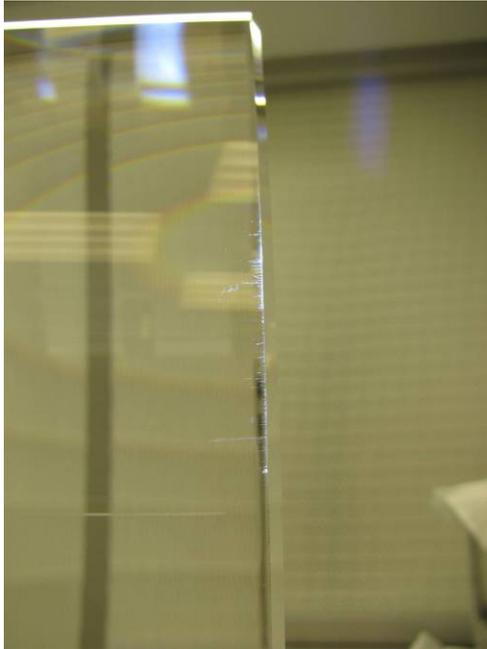
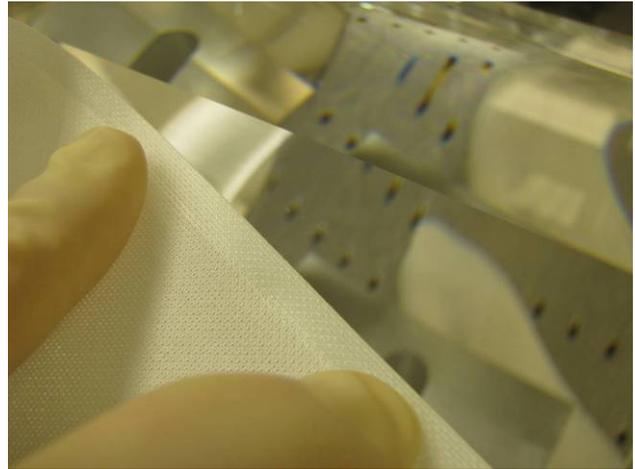
Figure 4.1 Flaws on the barrel and chamfers of TM ETM02 (with ITM coating)

After lifting TM ETM02 out of its container the surfaces of the TM were inspected. The flaws on surface S1 and S2 corresponded largely to the flaws reported by the vendor. The polishing vendor had however not reported on the flaws on any of the other surfaces, particularly the barrel and the chamfers. We noticed quite a few large scratches and digs and even a crack on the barrel and the chamfers (see Figure 4.1). It is not clear if these flaws were there after polishing or after coating (by a different vendor). Some of these flaws are serious. **(FLAG)**

a) Scratches on the barrel at the chamfer

b) Scratch on barrel near one of the flats

c) Scratch on the barrel near one of the flats

d) Crack in the chamfer area on the corner of a flat and the barrel

5. Scratches found on the barrel near the chamfers of ETM02. The presence of these scratches was noted by Margot Phelps and flagged to the COC team. Subsequently this has been flagged with the polishing vendor as well. It is unknown at this point where these scratches are created (polishing vendor or coating vendor). (Action: GariLynn)

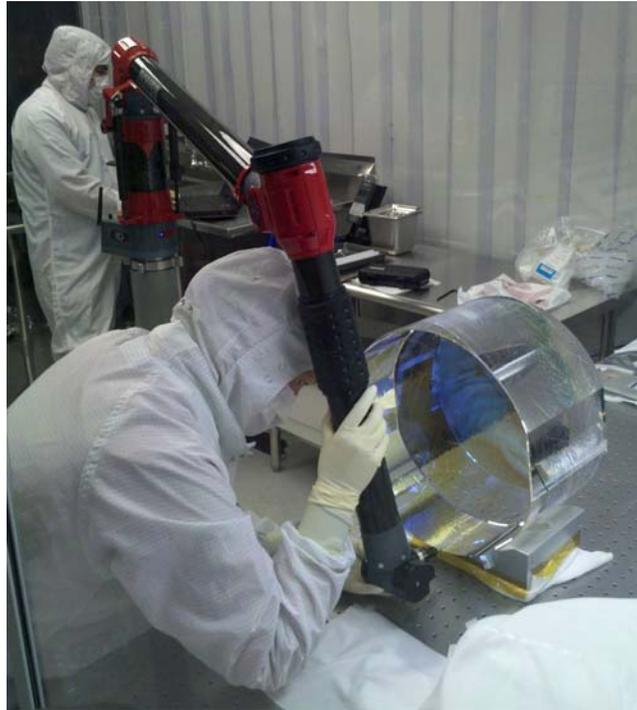
**Figure 4.2 Using the Romer arm to measure the width of TM ETM02**

The first attempts to do this were made on Tuesday the 19<sup>th</sup> of April 2011 using the Romer arm. The initial attempts made a surface measurement of surface S1 and then took 4 point measurements on the 12 o'clock (thinnest side), 3 o'clock, 6 o'clock (thickest side) and 9 o'clock positions on surface S2 to determine the distance between surface S1 and each of these points. The results

consistently came back with 1.5 mm to large a width; 1.500 mm being the radius of the sapphire ball tip of the Romer arm. The results are shown in Table 4.1.

The wedge was determined by using the angle calculation option between two planes in the Romer arm software. Surfaces S1 and S2 were measured in 6 locations each and the calculated angle from the software was  $0.078^\circ$ , corresponding to within  $0.001^\circ$  with the value measured by the vendor. The average width on the widest point was 200.144 mm, corresponding to within 0.006 mm with the value measured by the vendor.

On Wednesday morning the 20<sup>th</sup> of April, Gerardo had received advice on how to measure the distance between a point and a plane without getting the 1.5 mm error. This is done by first measuring the location of both planes S1 and S2. Then points on plane S2 were defined and projected on measured plane S2. The distance between the projected points and S1 could then be calculated and one had to specifically select to measure the distance between “point:centre” and plane S1. Measurement results from the 20<sup>th</sup> of April are shown in Table 4.2.
