SN1549 images after precision RTS scan after micromachining (laser ablation)

[T2000125](#) snapshot

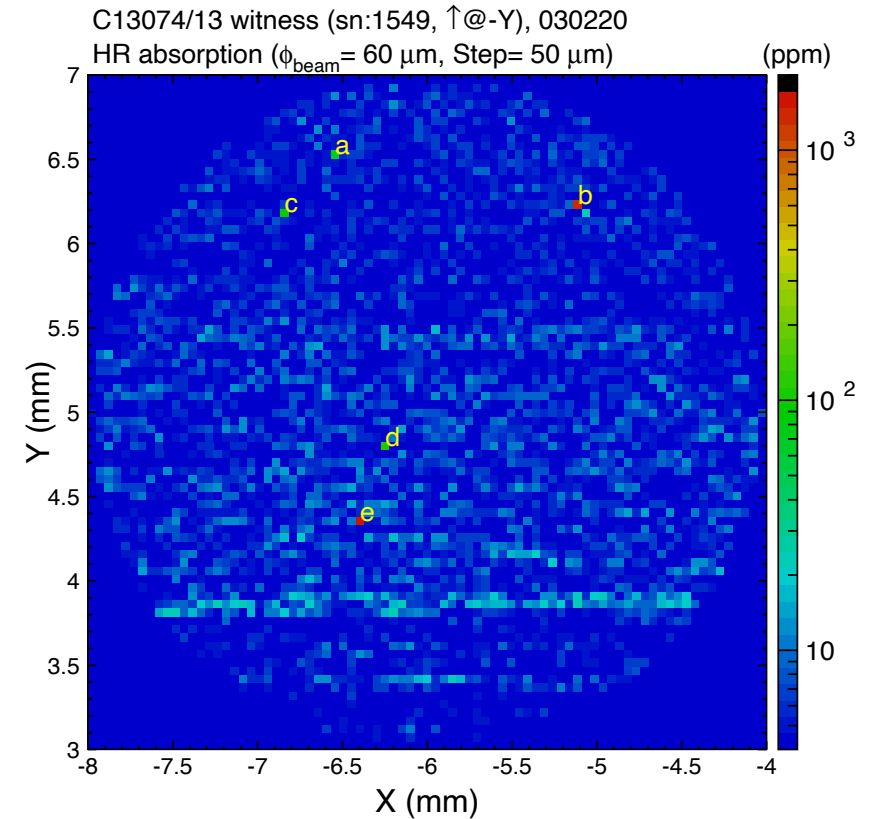
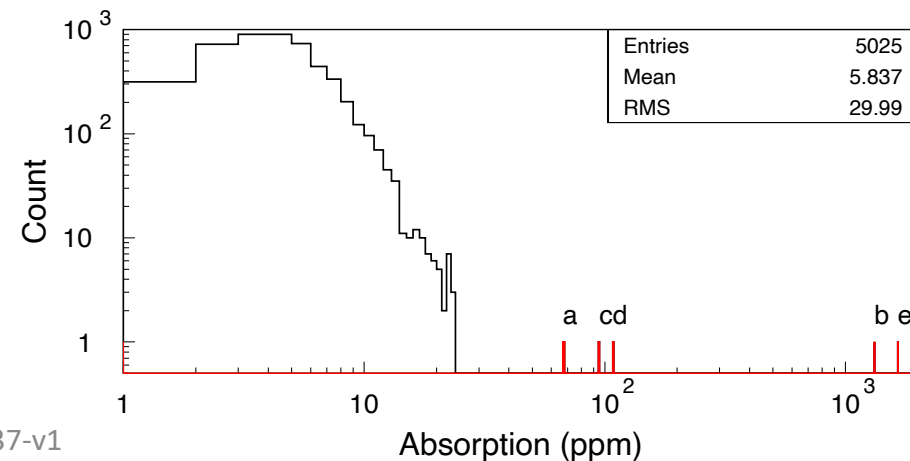
This high resolution absorption scan is done near the estimated laser ablation position. The scan is 4 mm in diameter at about the same intensity ($\sim 25 \text{ W/mm}^2$) as aLIGO. Five points are confirmed absorbers as they do not change after a drag wipe. None of these points were found in the gentle absorption scan [T1900901](#)

The point e location was adjusted manually to obtain the maximum absorption signal. This point showed the brightest scatter from the probe beam, and so is presumed to be the location of the laser ablation described in [G2000212](#)

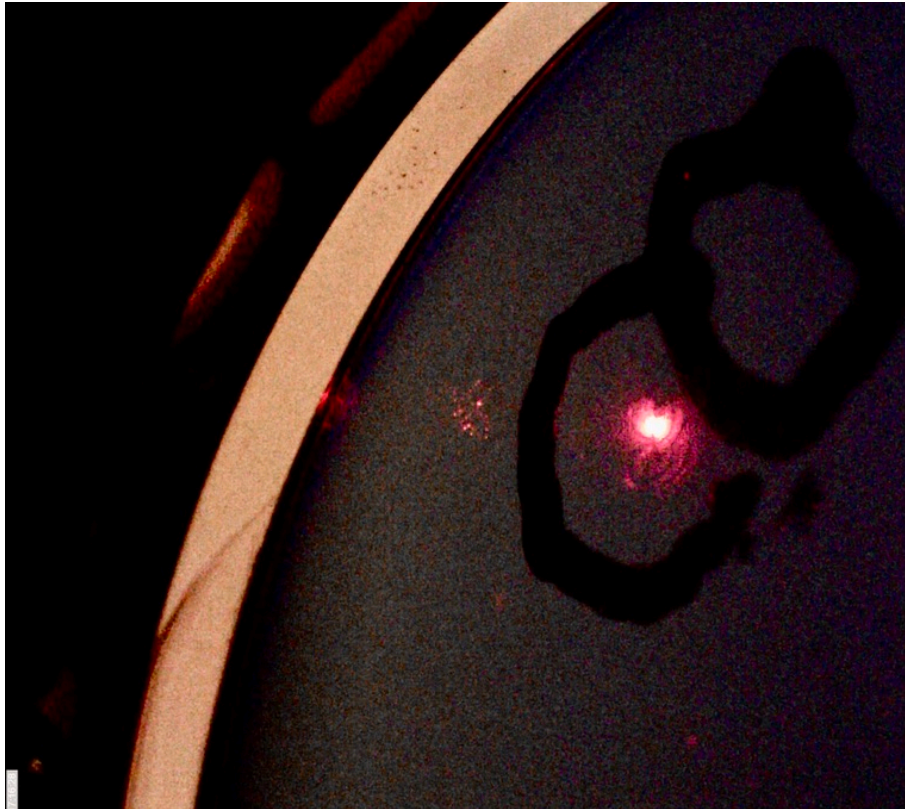
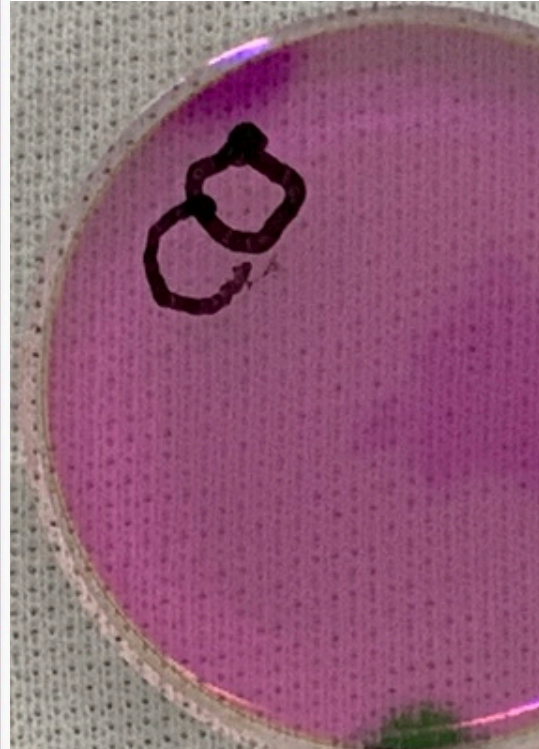
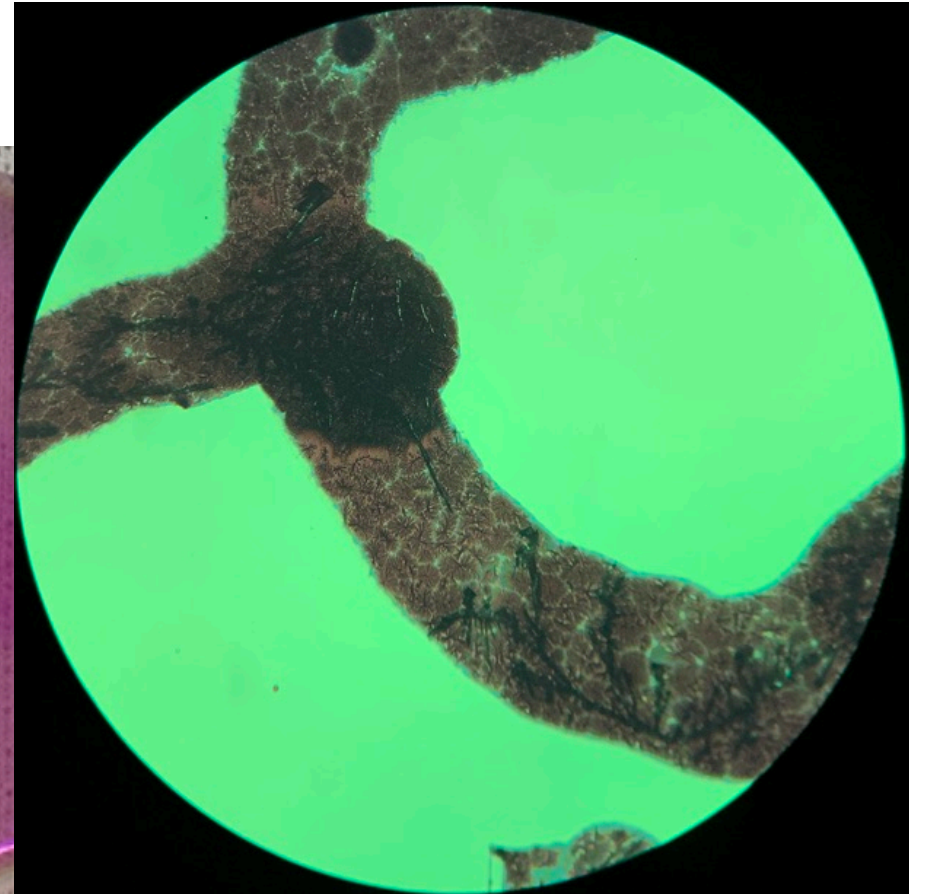
Point e location relative to ink at RTS

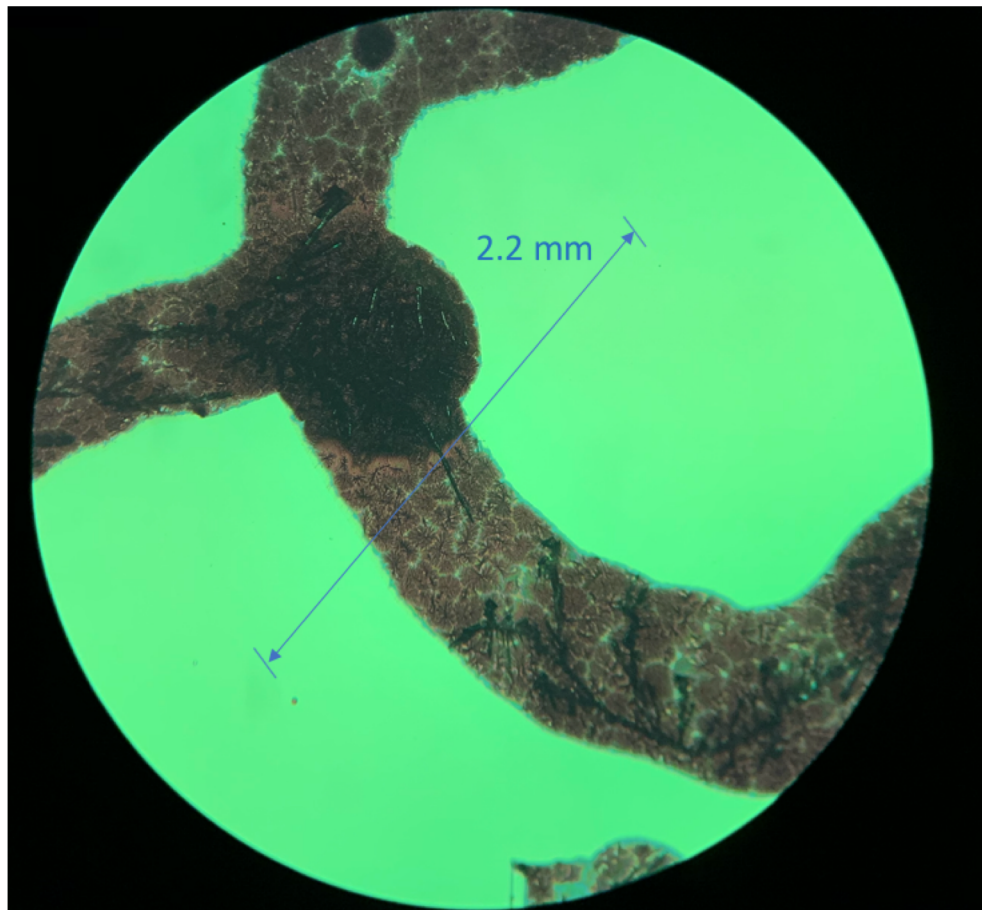
Tie RTS location to microscope image

2.25 mm measured between point b2 and the ablated spot using the microscope.

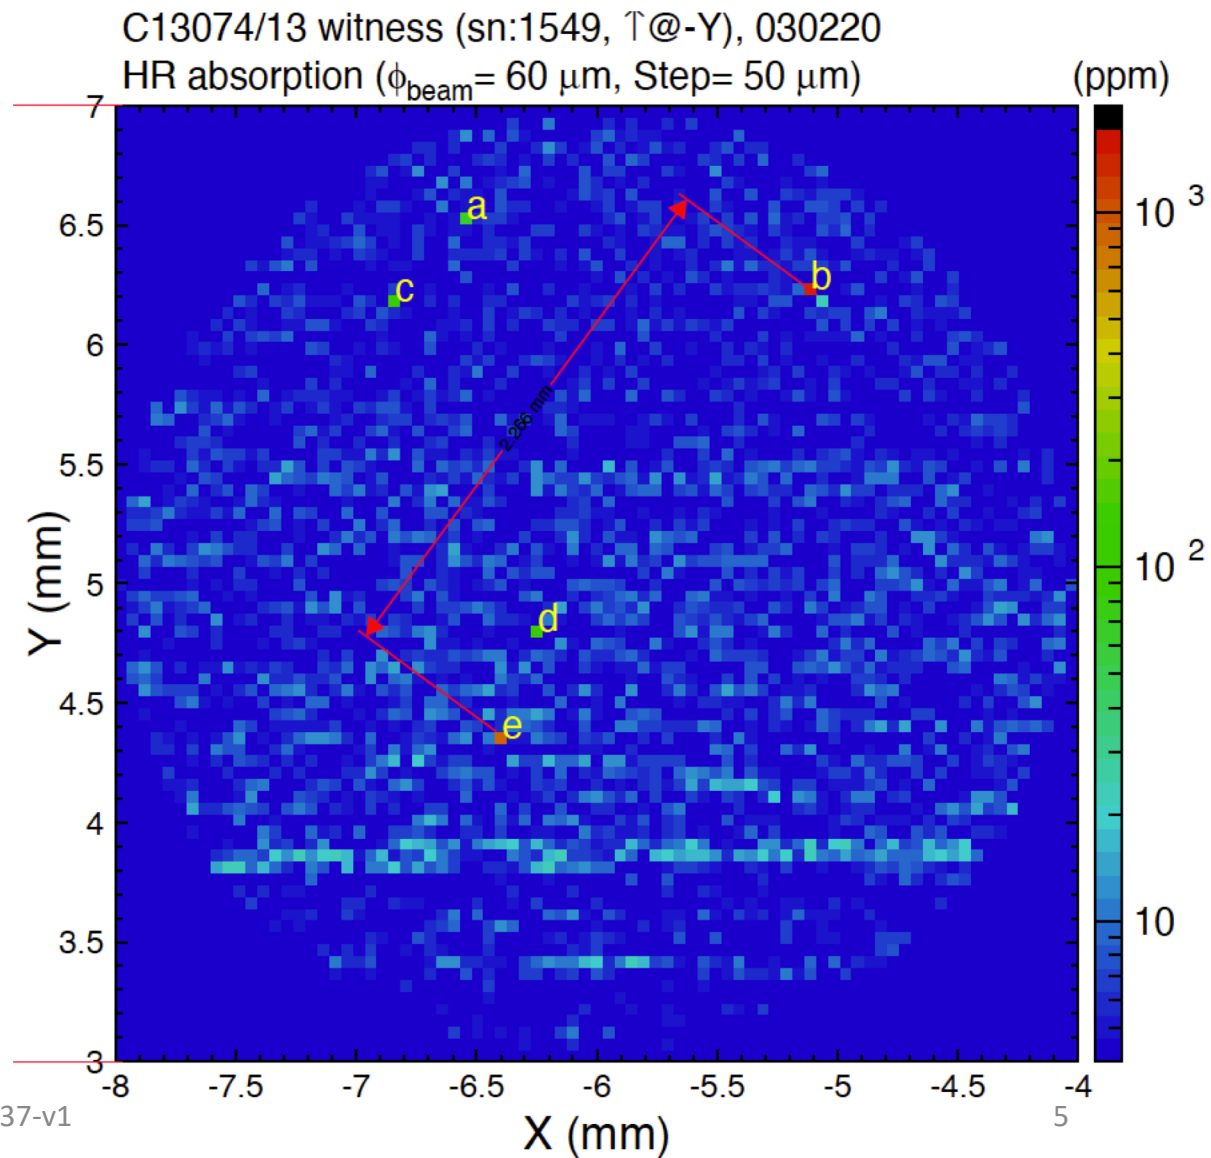
2.266 mm distance between point b and e as scaled in acrobat.

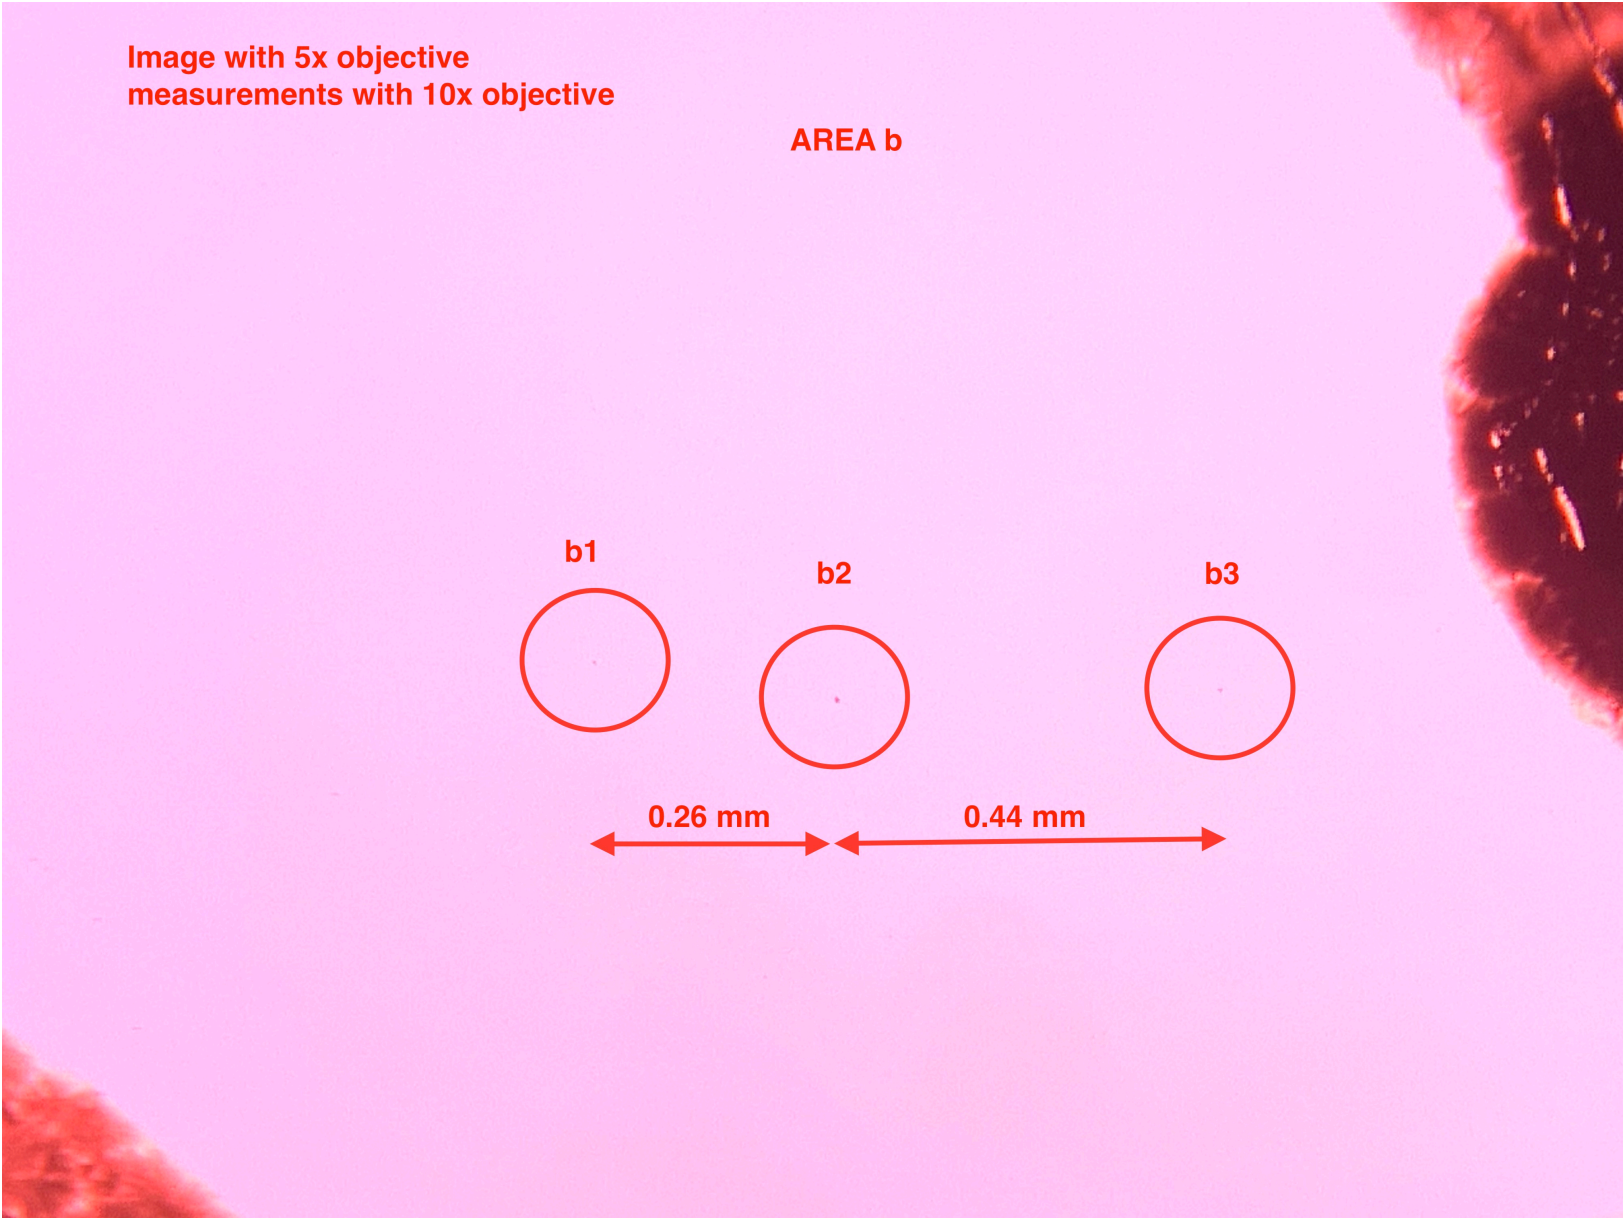
Area b overview

Assume that b2 is the absorber found by RTS

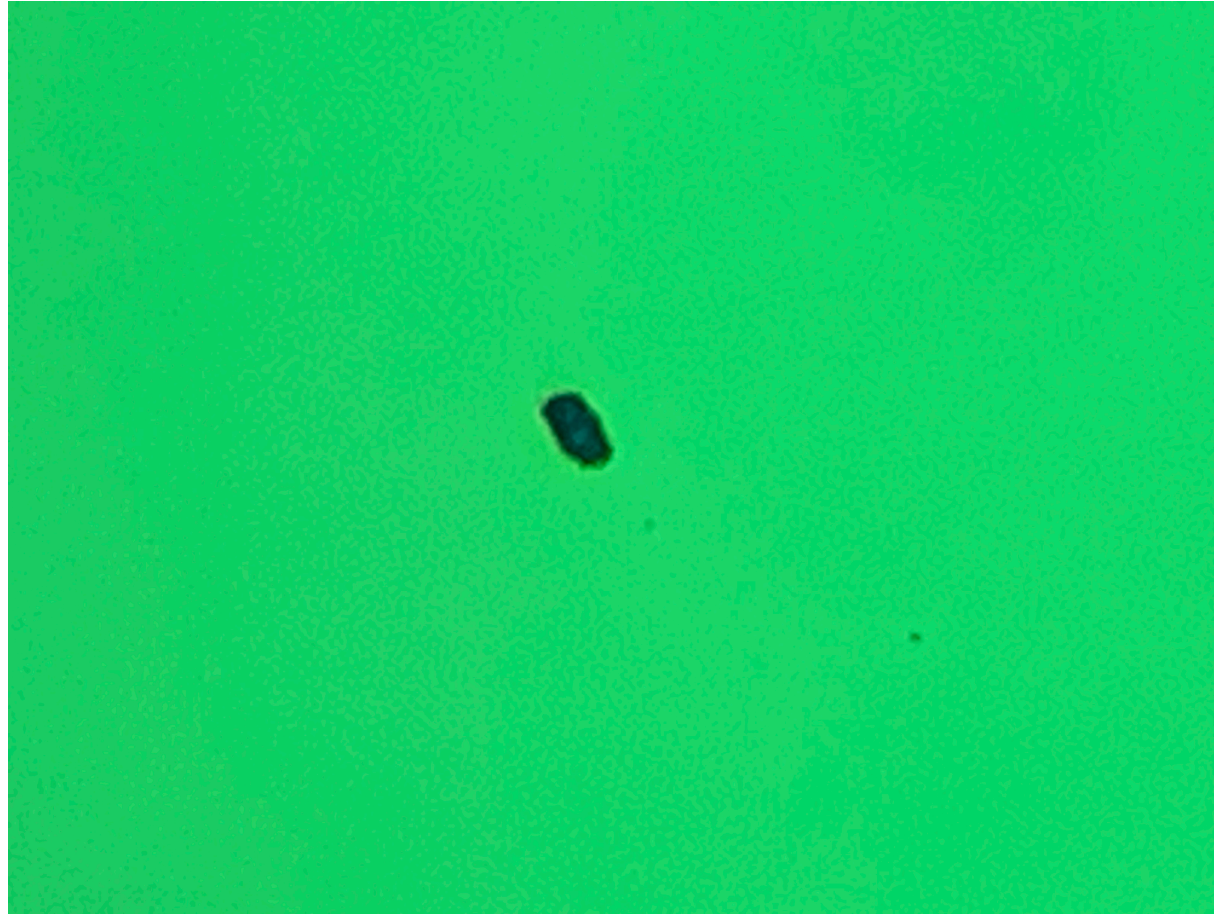
Point b2, about 5 μm long

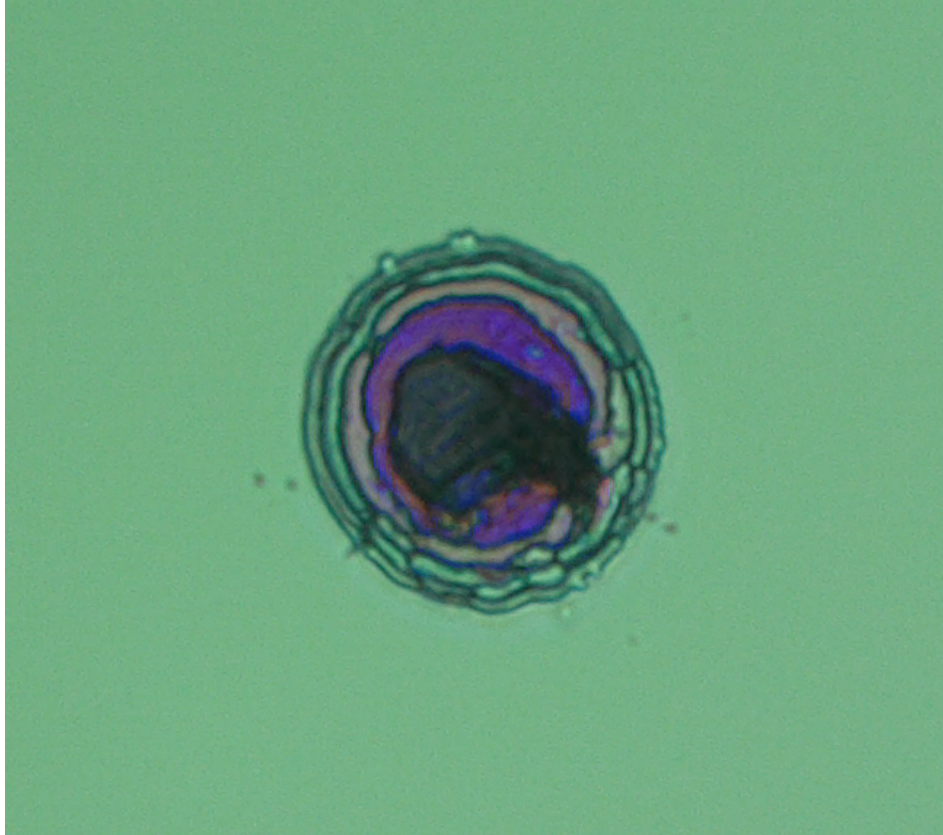
Point e – no apparent damage from scan

- As received

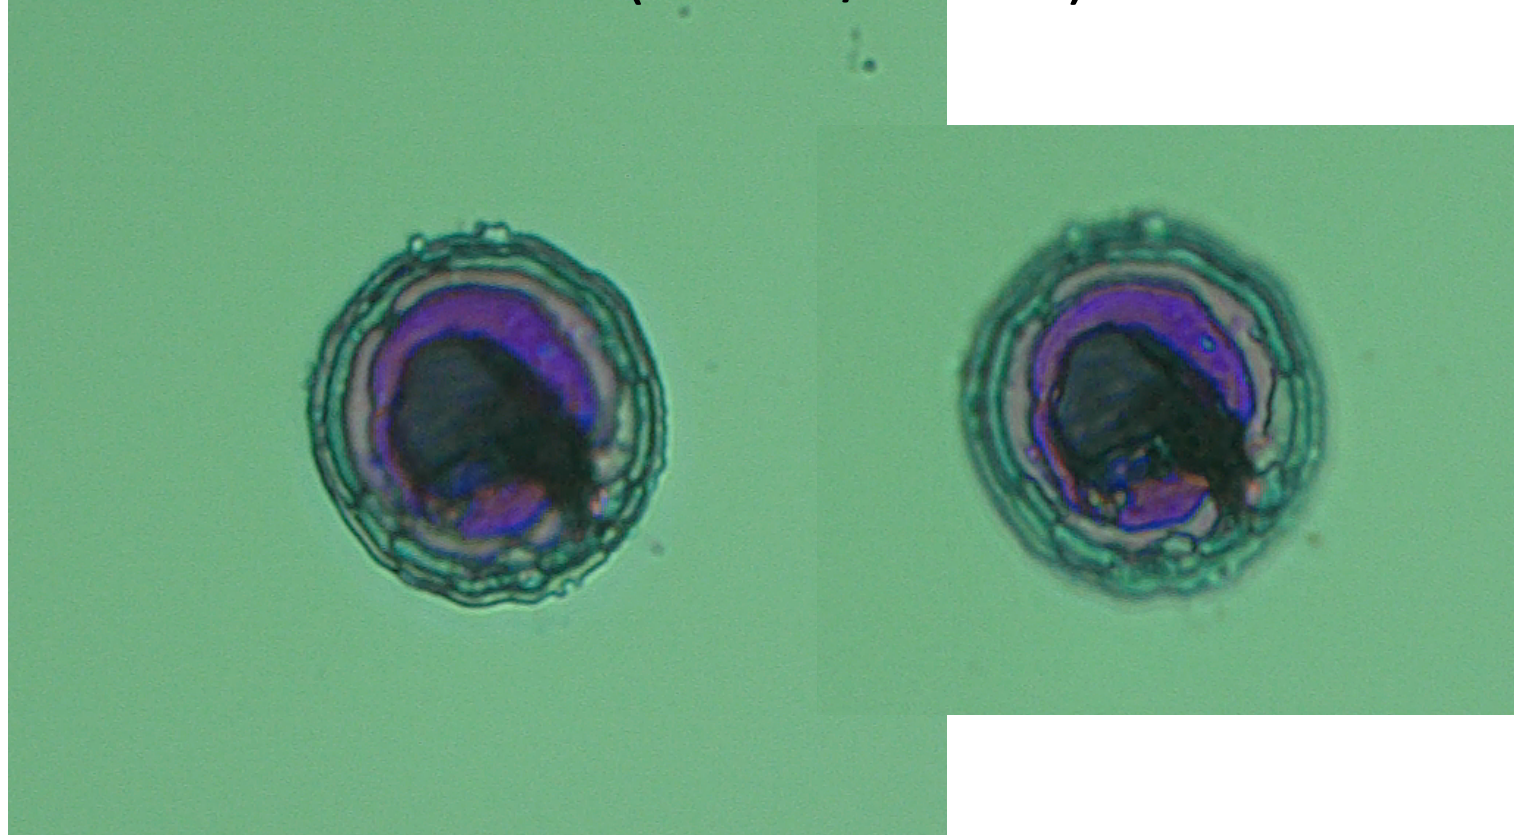
- After RTS scan ($\sim 25 \text{ W/mm}^2$)

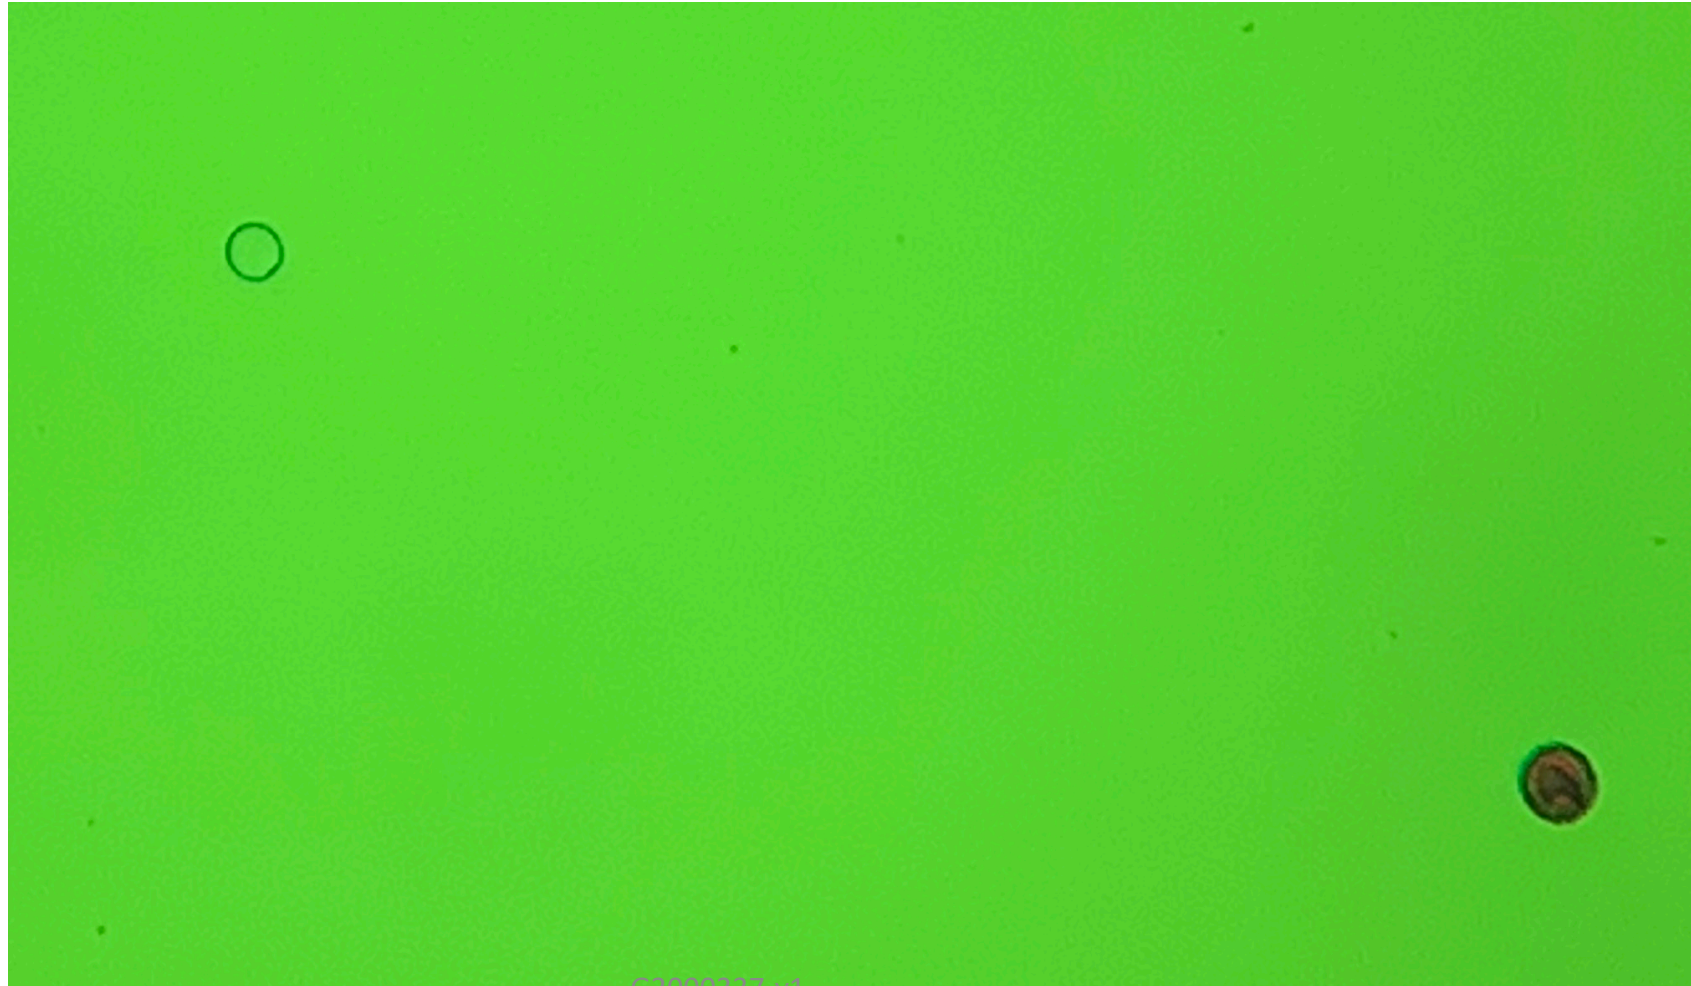
Also of interest: a retroreflection in the ablation system? $\sim 425 \mu\text{m}$ separation.

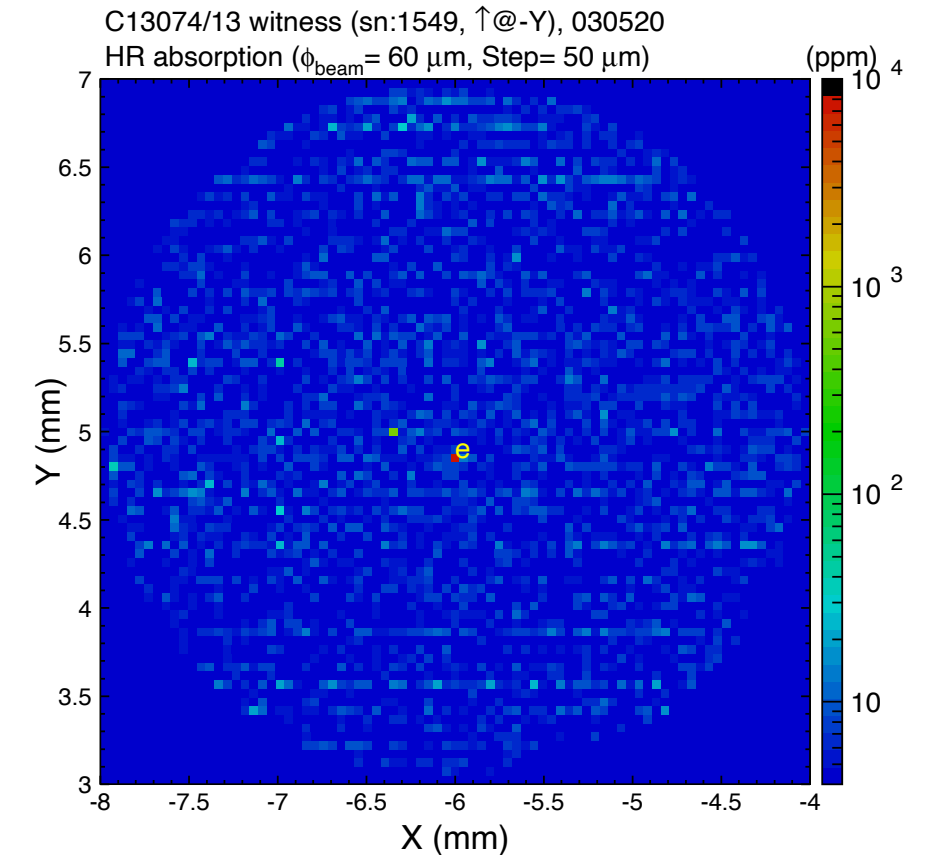
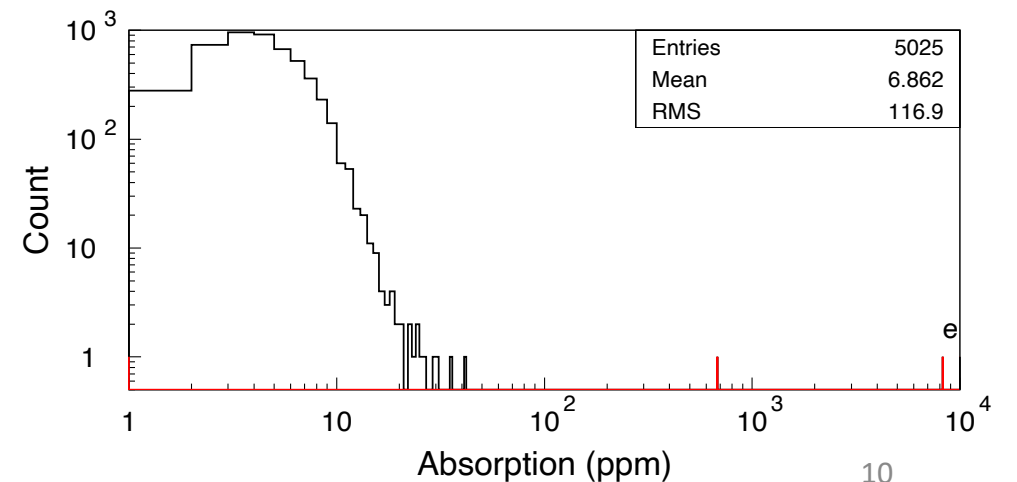
This scan was performed after the sample was wrapped in an alpha wipe placed in a small beaker the beaker was filled with isopropyl alcohol The beaker was placed in water in an ultrasonic cleaner for 10 minutes The sample was removed and drag-wiped with acetone using berkshire paper lens tissue.

There was some damage of the sample during the latest scan, this does not interfere with the ablation test site, they are separated by ~ 1.5 mm see [T2000149](#)

The point e location was adjusted manually to obtain the maximum absorption signal. This point showed the brightest scatter from the probe beam, and so is presumed to be the location of the laser ablation described in [G2000212](#)
