# Investigation into the Breakdown Voltage of a Wire LIGO

Reeya Chenanda

May 4, 2020

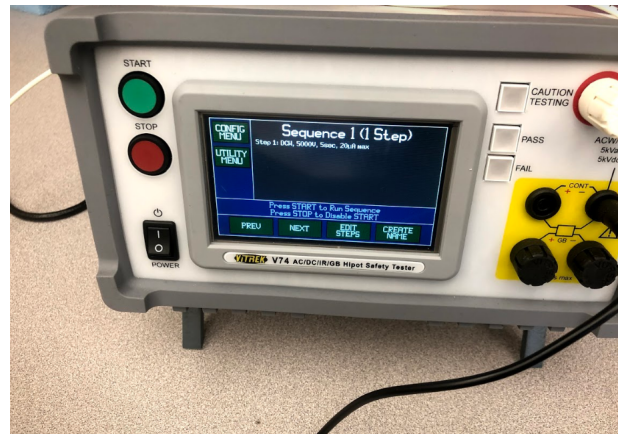
Figure 2: Hipot Tester used, Vitrek V74 Hipot Safety Tester. Notably, the maximum voltage able to be applied is 5000V.

The BDV of the wire was tested using the Vitrek V74 Hipot Safety Test, given in Figure 2. A hipot test, also known as a dielectric withstand test, determines the breakdown voltage limit of wire insulation. Thus, testing the wire with the Hipot Tester will tell us at what voltage the wire breaks down (i.e. when its insulation fails). The Vitrek HIPOT tester has a maximum output voltage of 5000VDC. As such, the predicted 11kV breakdown threshold cannot be explored using this piece of test equipment. An additional research goal will be to design a way to make some relatively measurable reduction in the thickness of the wire insulation that might offer insight into coil winding damage. Therefore, the wire will need to be modified by decreasing its insulation thickness to observe sparking. Then, results can be applied to the actual diameter of the wire to calculate its BDV.

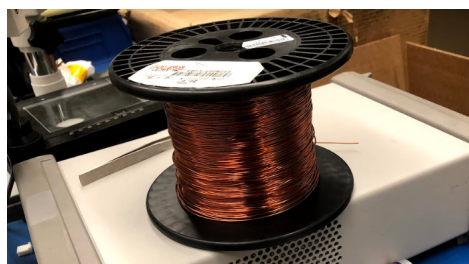
Figure 3: Wire used. The properties of the wire are listed below.

The wire, BAE Wire & Insulation HEAVY ALLEX (HML) MW16C 240C (Figure 3), is used at LIGO. The manufacturer lists the BDV as 11kV. It is important that the BDV matches that given by the manufacturer to mitigate the chances of issues in the field.

Minimum	Nominal	Maximum
Wire	31.7	32	32.3
Insulation + Wire	34.1	34.6	35.1

Table 1: The properties of the wire used at LIGO are the following: 20 AWG, Heavy insulation, Polyimide. All dimensions given are measured in mil.

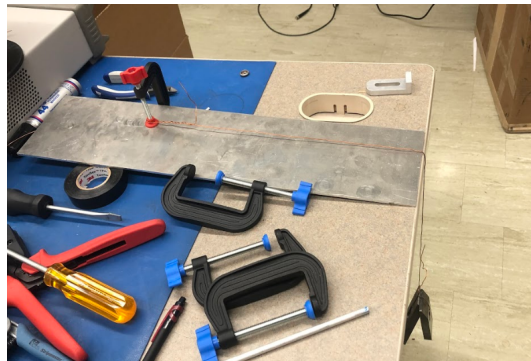
Figure 4: Apparatus Diagram for First Experimental Setup. The wire is wrapped around the C-clamp clamped to a metal sheet. It then hangs off the sharp edge.

1. C-clamp was clamped onto a thin metal sheet.
2. Wire was first wound around rod on C-clamp, then hung off the side of the metal sheet.
3. Two hanging weights were tied to the end of the wire hanging off the sheet. Afterward, the weights were measured with a scale as 350 g and 355g, respectively. The final setup is seen in Figure 4.
4. The wire was tested 5 times with the Hipot Tester at 5000VDC. One lead is grounded to the metal plate and the other is hooked up to the wire. The results are given in the next section.

On the third test, sparking was encountered. After that, the wire was tested twice more. For the latter tests, the wire shorted and would fail almost immediately at 49V. This implies a permanent change has occurred to the wire.

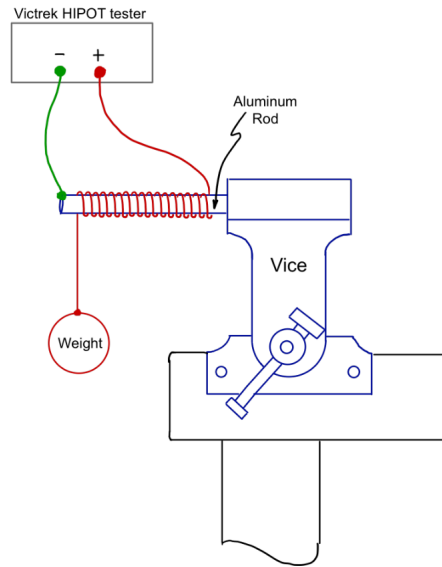
Figure 5: Wiring Diagram for Experimental Setup. Wire is wrapped around a thin rod and clamped in a vice, which provides a negligible force. The tester leads are then hooked up to the wire and the rod, enabling the wire to be tested.

The next objective was to design a setup that is similar to that of the one used at LIGO. The setup design, as seen in the wiring diagram in Figure 5, is similar to the way the wire is wound around a curved surface there. Notably, the wire experiences insignificant local dielectric damage, unlike it did in the latter experimental setup. This procedure was conducted on March 11, 2020.

1. A thin metal rod was clamped in a vice.
2. Wire was wrapped around the rod by hand 6 times. Tape was placed on the wire to keep it from detaching from the rod. It was first tested, with no weights, for a baseline test. One lead is grounded to the metal rod and the other is hooked up to the wire. The wire was tested and a BDV was not encountered.

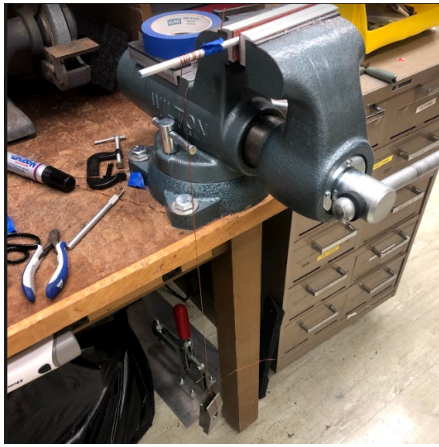
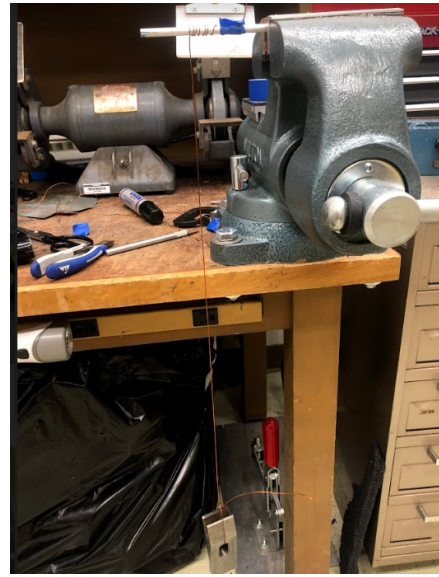
Figure 6: Apparatus Diagram for first test.

(a) Setup view from diagonal above.

(b) Setup Front view

3. Two hanging weights, 350g and 355g, respectively, were then hung from the wire. This setup is seen in Figures 6. The wire was tested and a BDV was not encountered.

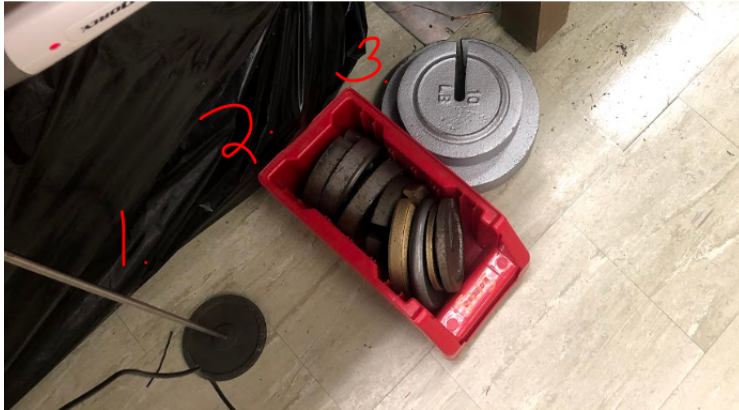
Figure 8: Weights used in second setup: 1. the 1 lb stand used, 2. is the standard weights, 3 the heavier weights, 10 lbs+.

5. The two hanging weights were again placed on the wire and it was tested. No BDV was encountered.
6. The weight on the wire was gradually increased and then tested. A 1 lb weight stand was used from here on out. The weights used are seen in Figure 8. The results are given in the following section.

Note that a 1b stand (0.454 kg) was used from trials 2-10 to hang the weights on the wire. The weight of the stand is included in the total mass added. Each weight used came labelled with its weight, so they were not weighed (except for the weights in trial two, which, as was previously noted in the first experimental setup's procedure, were weighed on a standard weighing scale).
