LIGO- E1000312 *LIGO* February 6th, 2011

aLIGO HAM-ISI, Pre-integration Test Report, Phase I,

LHO Unit #1 (post-assembly, before storage, after replacement of faulty parts)

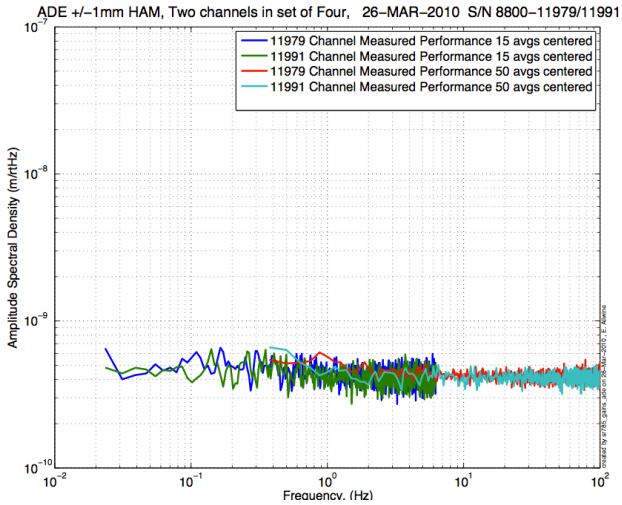
Figure - H1 and V1 sensor noise

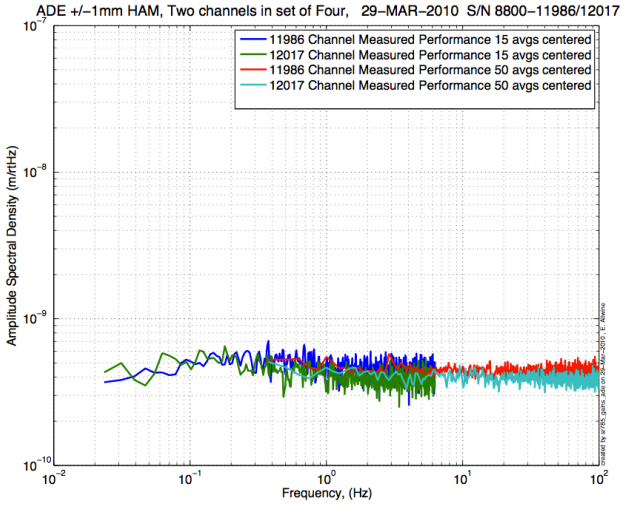
Figure - H2 and V2 sensor noise

Issues/difficulties/comments regarding this test:
The CPS #12033 and the CPS #12038 (H3, V3) are borderline.

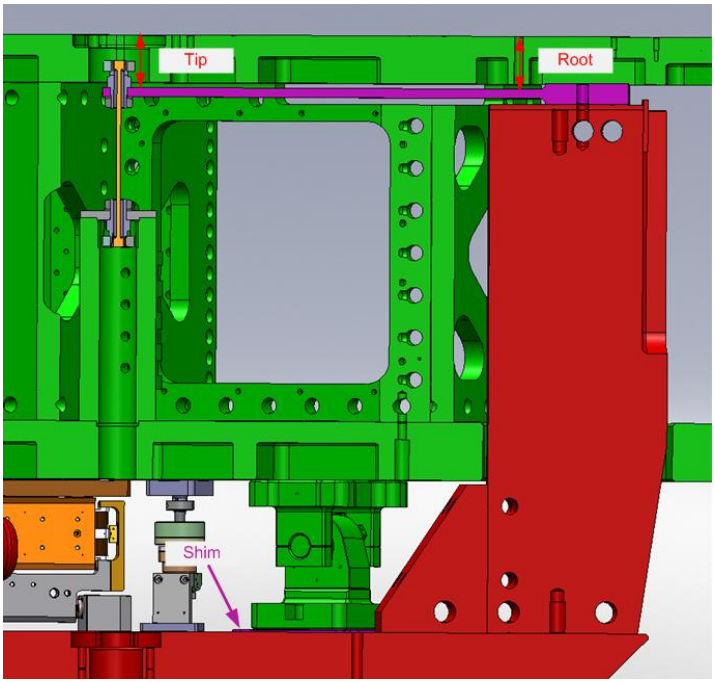
figure – Blade spring profile measurement points

Blade #	Root (")	Tip(")	Flatness (mils)
1	651	667	16
2	651	662.5	11.5
3	649	661	12

Issues/difficulties/comments regarding this test:
The weight of the plunge micrometer lowers Stage1 by up to 0.002". This should reduce the Root level making the flatness over-evaluated by 0.002". Hence, the result on blade #1 should be discussed.

Test result: **Passed:** ____ **Failed:** __X__

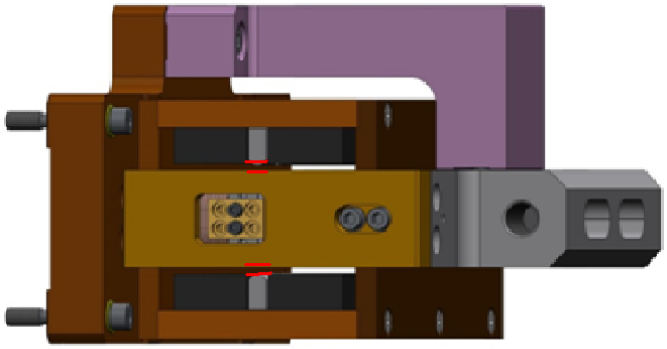
Figure - Showing gaps that need to be checked on actuators.

Issues/difficulties/comments regarding this test:
Actuator alignment was lost during disassembly/storing and had to be redone (aligo entry # 1851)

The gaps on the back side of horizontal actuators are hard to access. Horizontal actuators appeared borderline on that side.

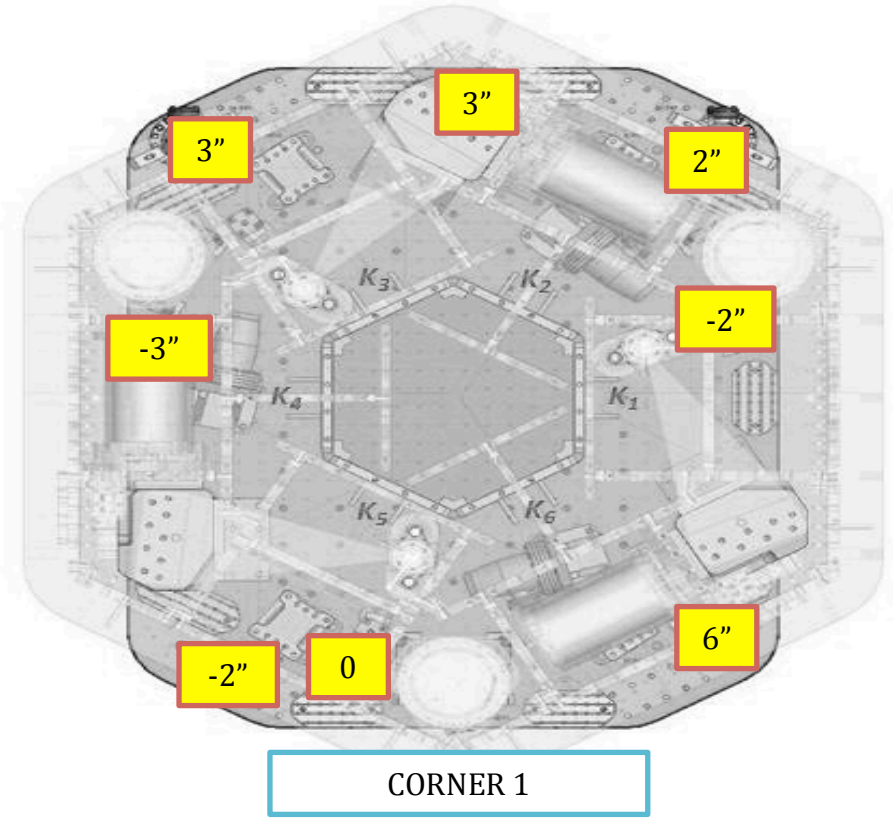
Figure – Level measured on Stage 0

Issues/difficulties/comments regarding this test:
Accuracy of measurement limited by measurement tool: optical lever + ruler on a block. The ruler only has 1/64” graduations. Values are deduced from the relative distance to graduations. The uncertainty is about 1mil.

Max angle=0.008/57 (± 0.002/57) = 140.3 (± 35) µrad

Test result: **Passed:** ____ **Failed:** __X__

Note:
This test doesn't meet our stringent requirement, however this leveling value is sufficient for all the tests being performed.

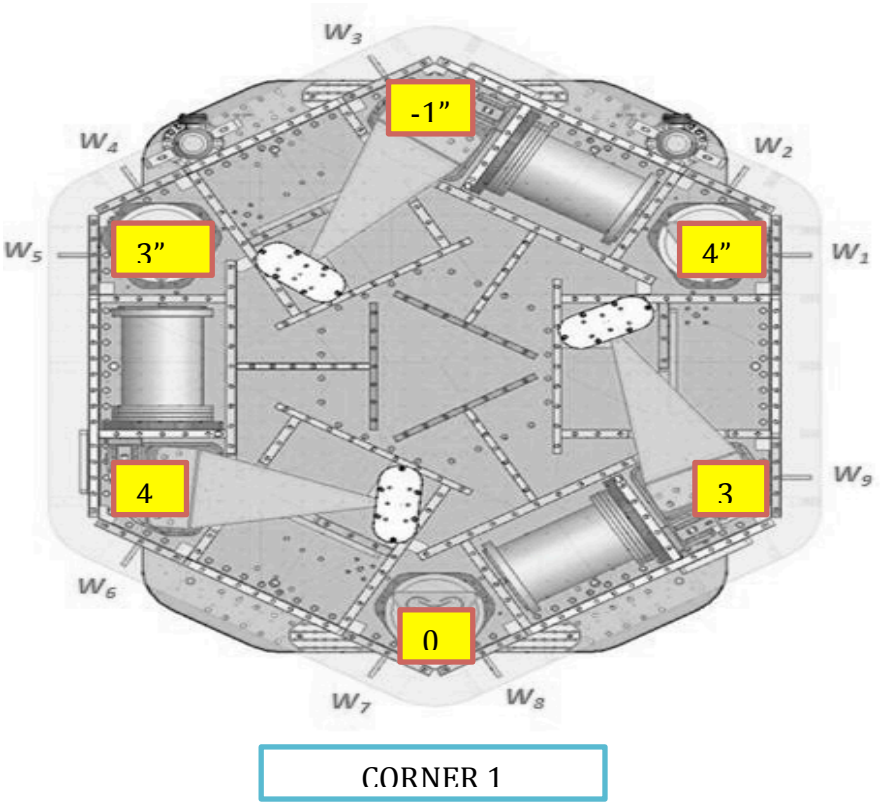
Figure – Level measured on Stage 1

Issues/difficulties/comments regarding this test:
Accuracy of measurement limited by measurement tool: optical lever + ruler on a block. The ruler only has 1/64” graduations. Values are deduced from the relative distance to graduations. The uncertainty is about 1mil.

The previous version of this report featured a maximum angle of 210 µrad. The top-mass has been re-centered since then which could affect the bending pattern of stage 1. However, the result was mostly modified by the fact that we only look at the distance between opposite sides of stage 1.

The test does not pass at the extreme of out uncertainty range.

Max angle = 0.007/ 76 (± 0.002/76) = 92.1 (± 26.3) µrad

Test result: **Passed:** ____ **Failed:** __X__

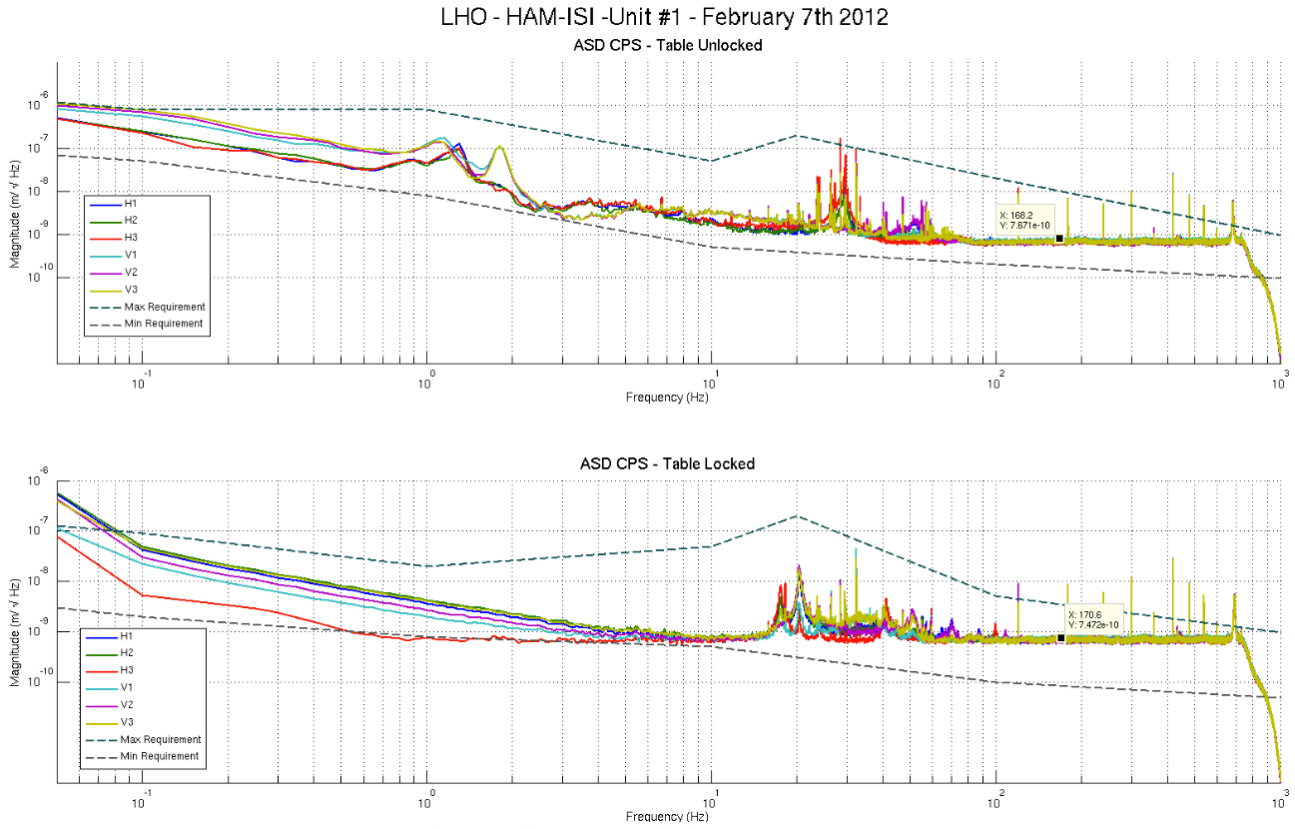
Failed because of standard deviation but a CPS set on a jig was measured and gave 4.3 counts, which is within specs. Hence, the high standard deviations measured are correlated to the 10Hz-100Hz peaks observed on the locked/unlocked GS13 and CPS ASDs (Cf. UNIT #3 testing phase 1 report, Document #E1000312–v3). As shown, these peaks are caused by ground motion. Hence, high standard deviations should not be associated with sensor noise.

Figure - Calibrated CPS power spectra

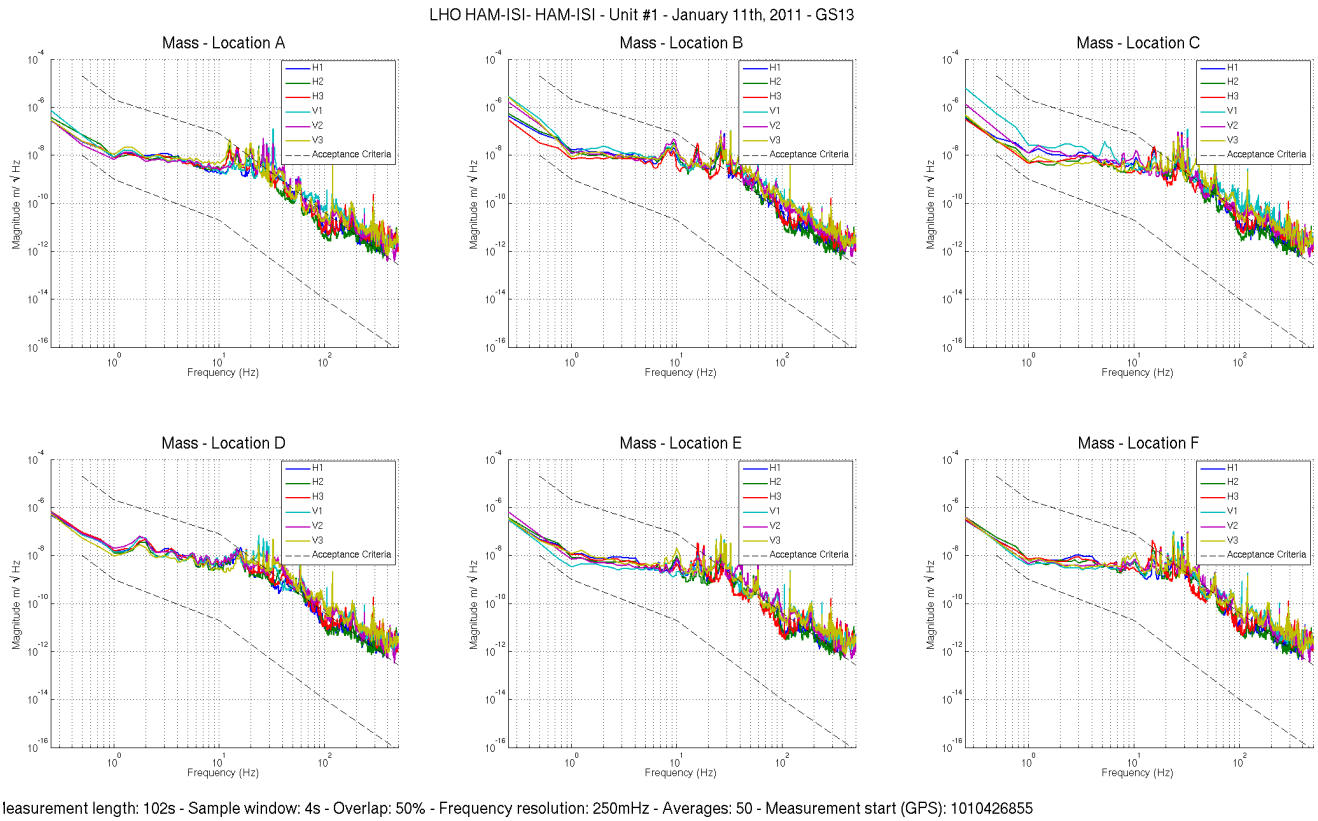
Figure – Power spectrum Calibrated GS13 with mass at corners A to F

Issues/difficulties/comments regarding this test:
- All PreFilters are OFF.
- Test GS13 are used, so borderline values are acceptable.

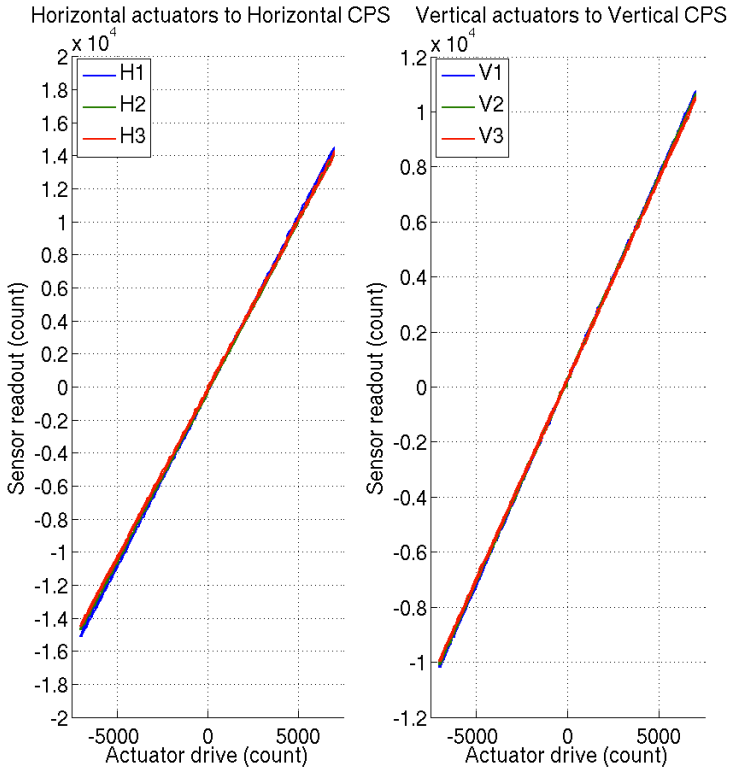
Figure - Linearity test on the triplet 'actuators - HAM-ISI – sensors' in both Horizontal and vertical directions

Step III.7: ASDs with table tilted are borderline. However the geophones will be replaced.
Step III.14: Deviation from average slope is out of spec. However this is associated with cable length. Make sure that linearity test results correlate with the final filed cables.

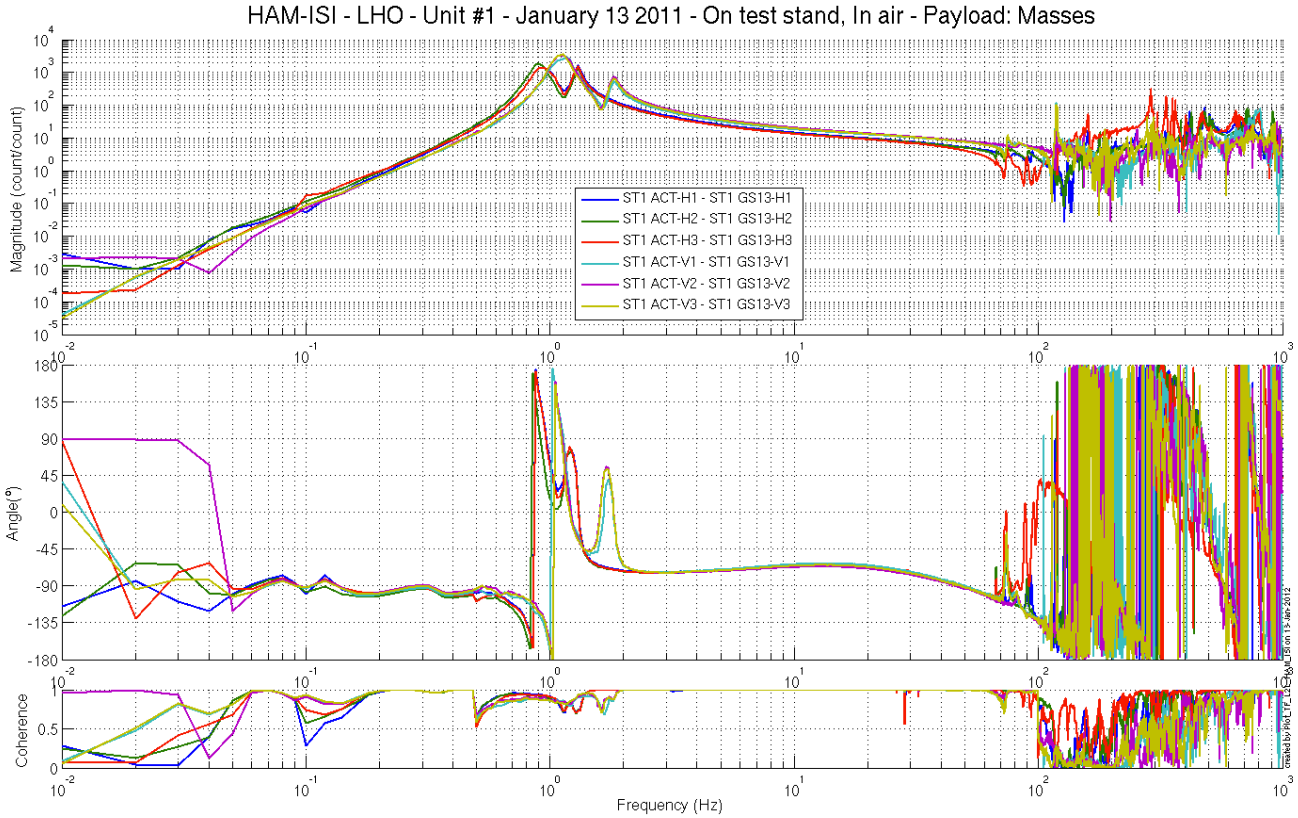
Figure - Local to Local Measurements – Inertial sensors – GS13 Doors partially bolted/torqued

Unusual resonances were initially observed a bit below 100Hz and above on LHO HAM-ISI Unit#1. It appeared, after inspection, that GS13 doors and their brackets were not fully bolted and torqued.

These mistakes were corrected, however, the resonances observed only disappeared when Viton pads were added under the ISI's Top Mass.

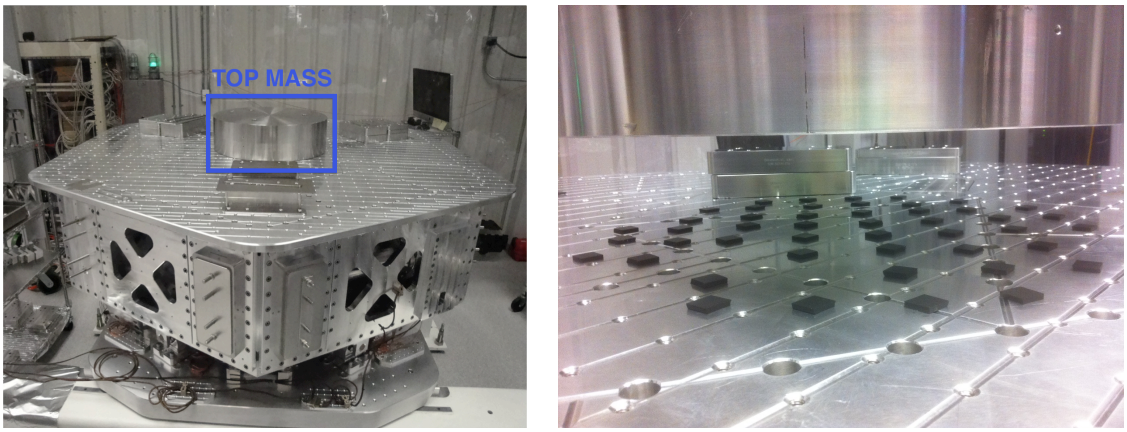
Figure – Top Mass and Viton pads checker

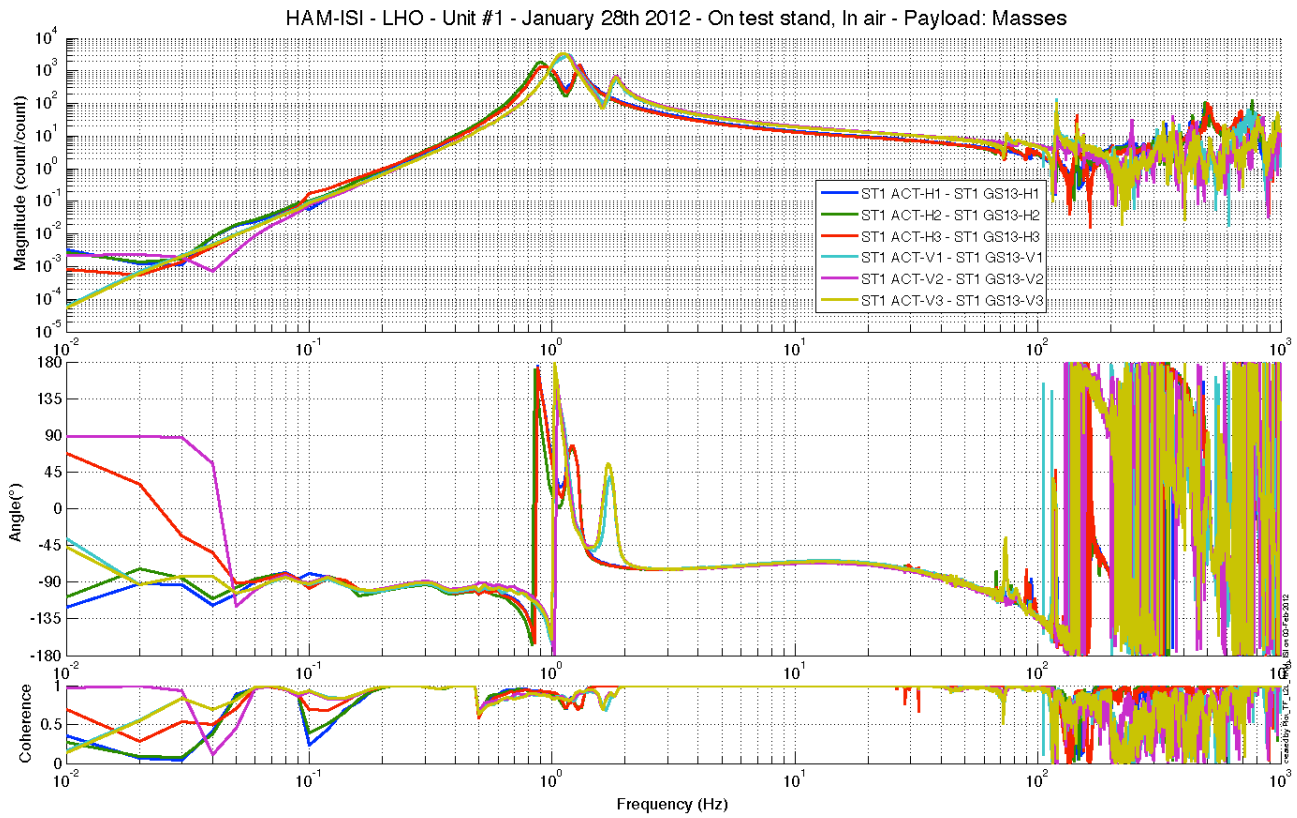
Figure - Local to Local Measurements – Inertial sensors – GS13 Doors fully bolted/torqued

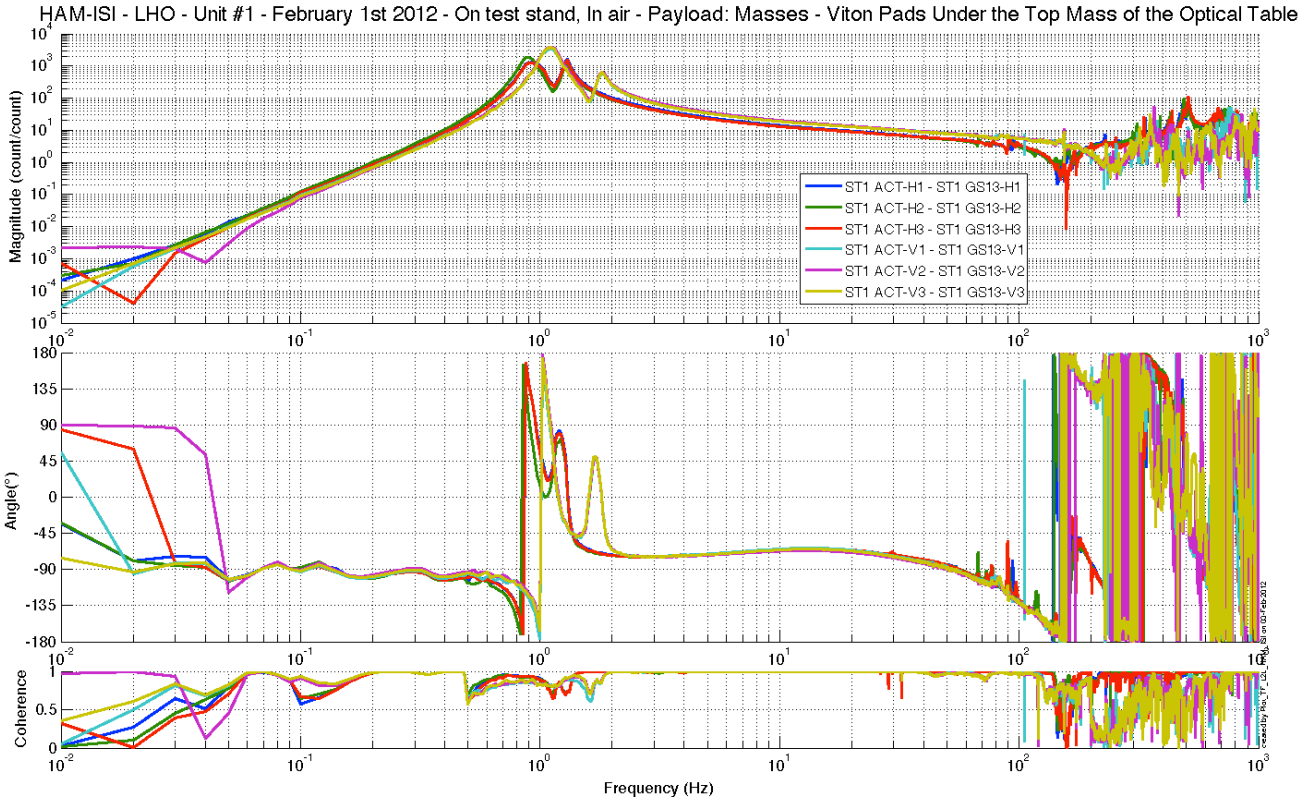
Figure - Local to Local Measurements – Inertial sensors – Top Mass on Viton pads

It is possible that the top mass/optical table boundary conditions were not constraining enough for the top mass, allowing the it to ring and perturbate measurements.

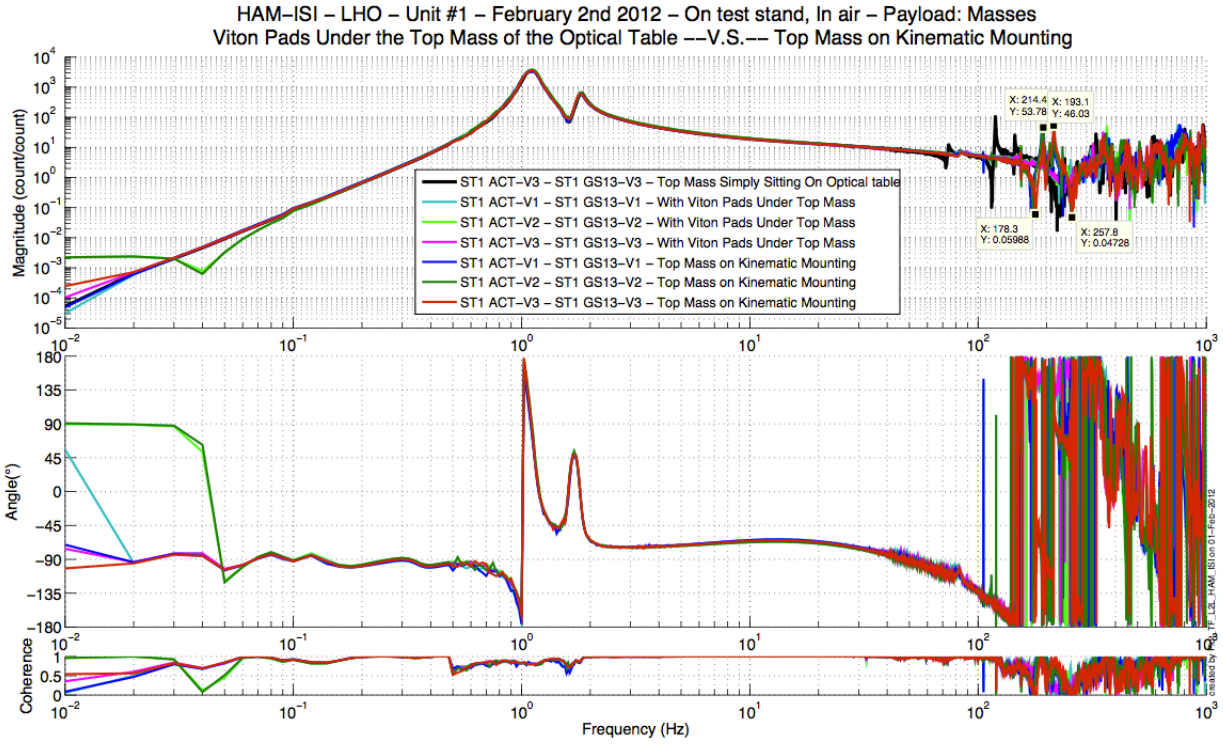
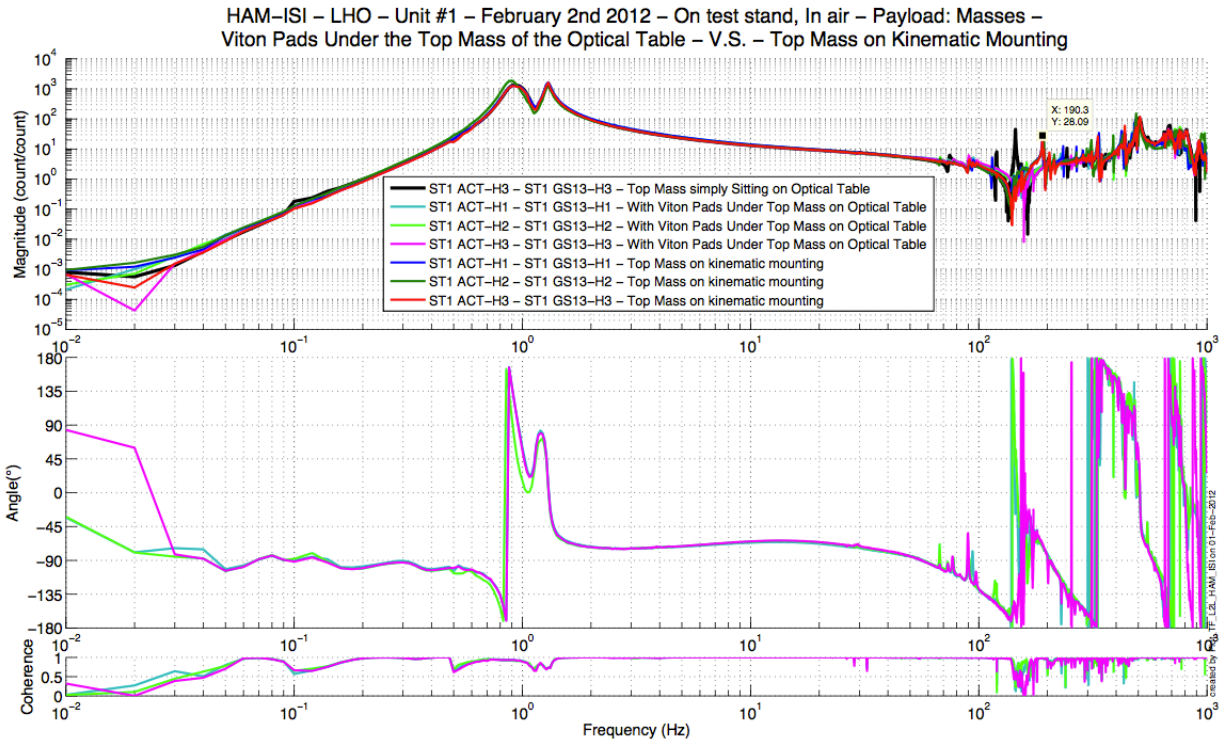
Transfer functions were then taken on HAM-ISI Unit #1 with its top mass sitting on a kinematic mounting. The unusual high Q resonances observed above 100Hz were also gone under this configuration. This result tends to confirm that the resonances observed came from the contact between the top mass and the optical table, and not from the ISI itself.

Resonances appeared between 170 and 260Hz when switching to kinematic mounting. They are mostly visible on vertical measurements. These resonances were not here initially, when the top mass was directly sitting on the optical table. They are caused by the changes applied on the boundary conditions of the Top Mass and shall not be associated with the ISI's mechanical response.
