Evaluation of three as-built aLigo optical levers at LHO: PR3, HAM2, ITMY

Cheryl Vorvick
Optical Lever Acceptance Review
LHO
6/6/2013
T1300651-v1

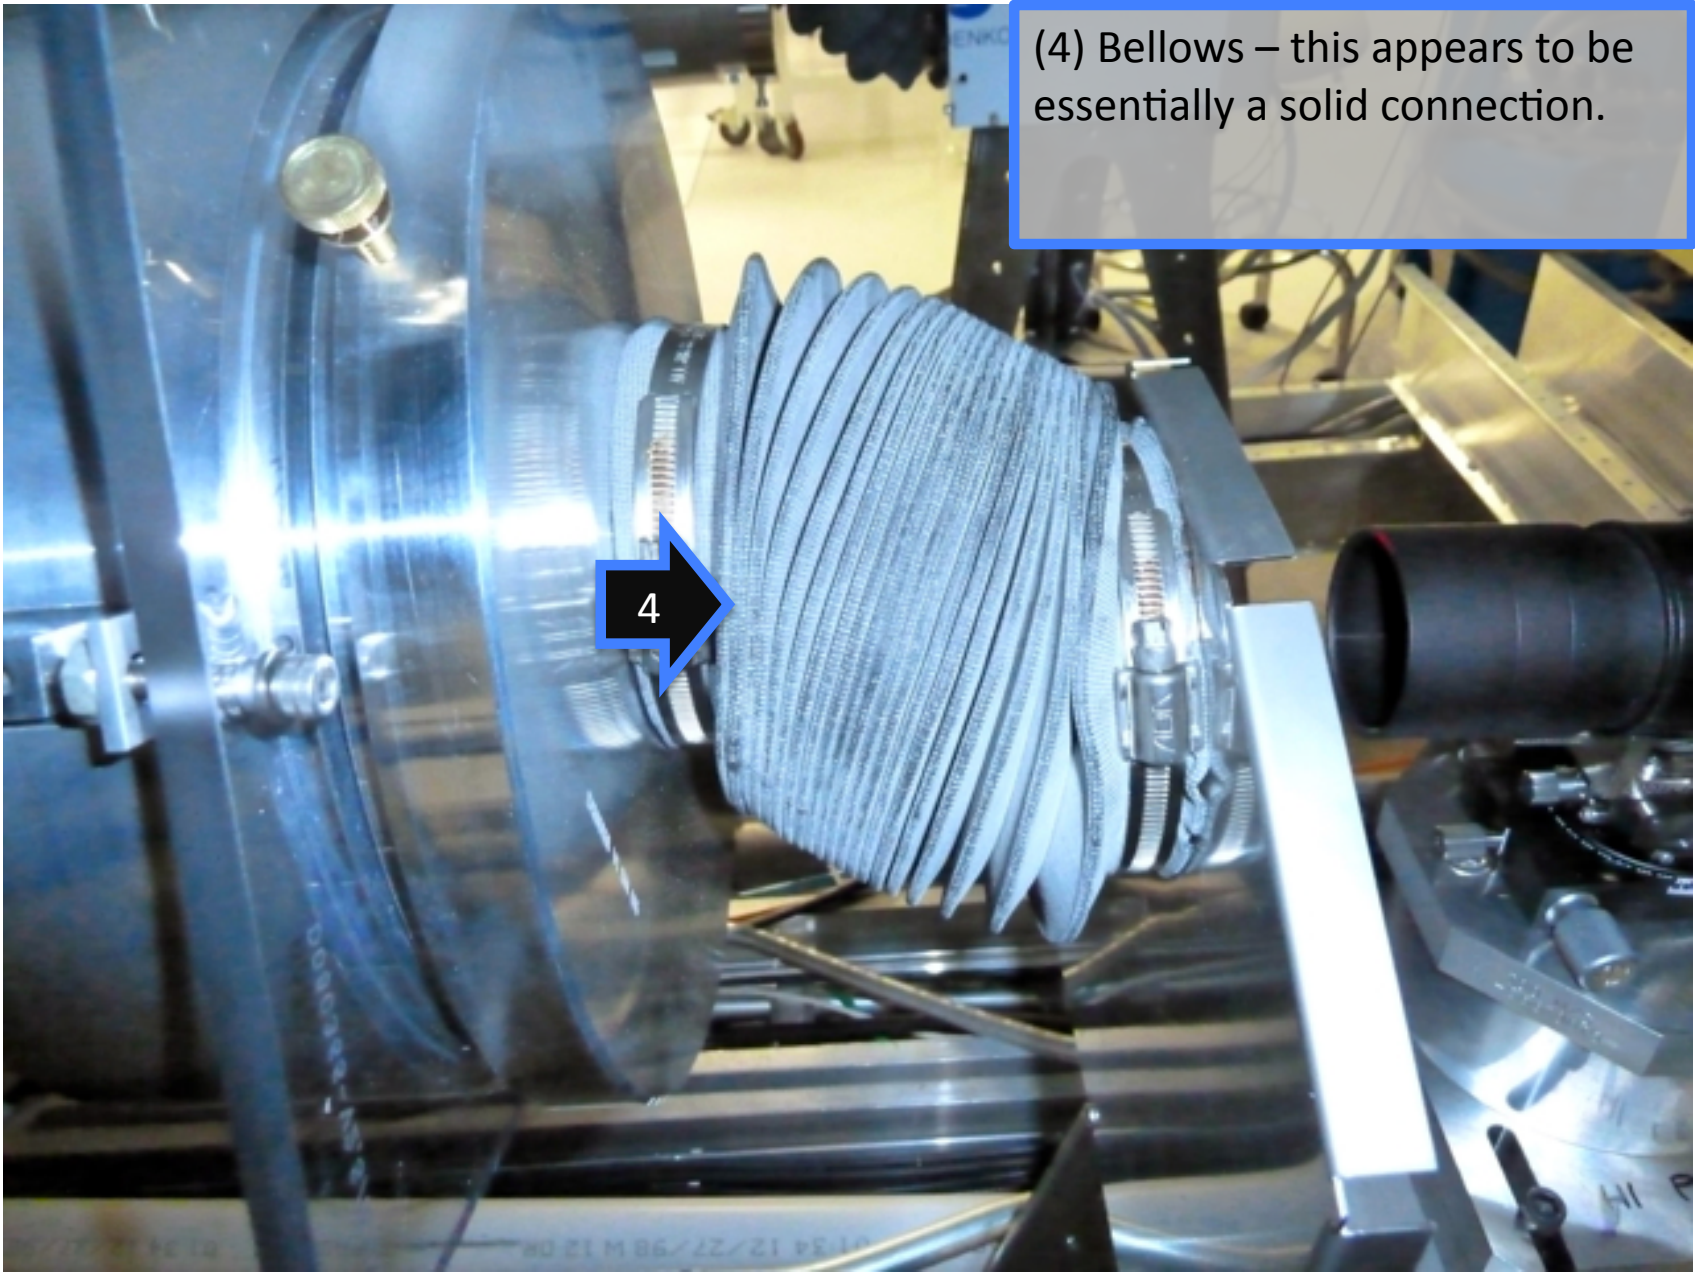
(4) Bellows – this appears to be essentially a solid connection.

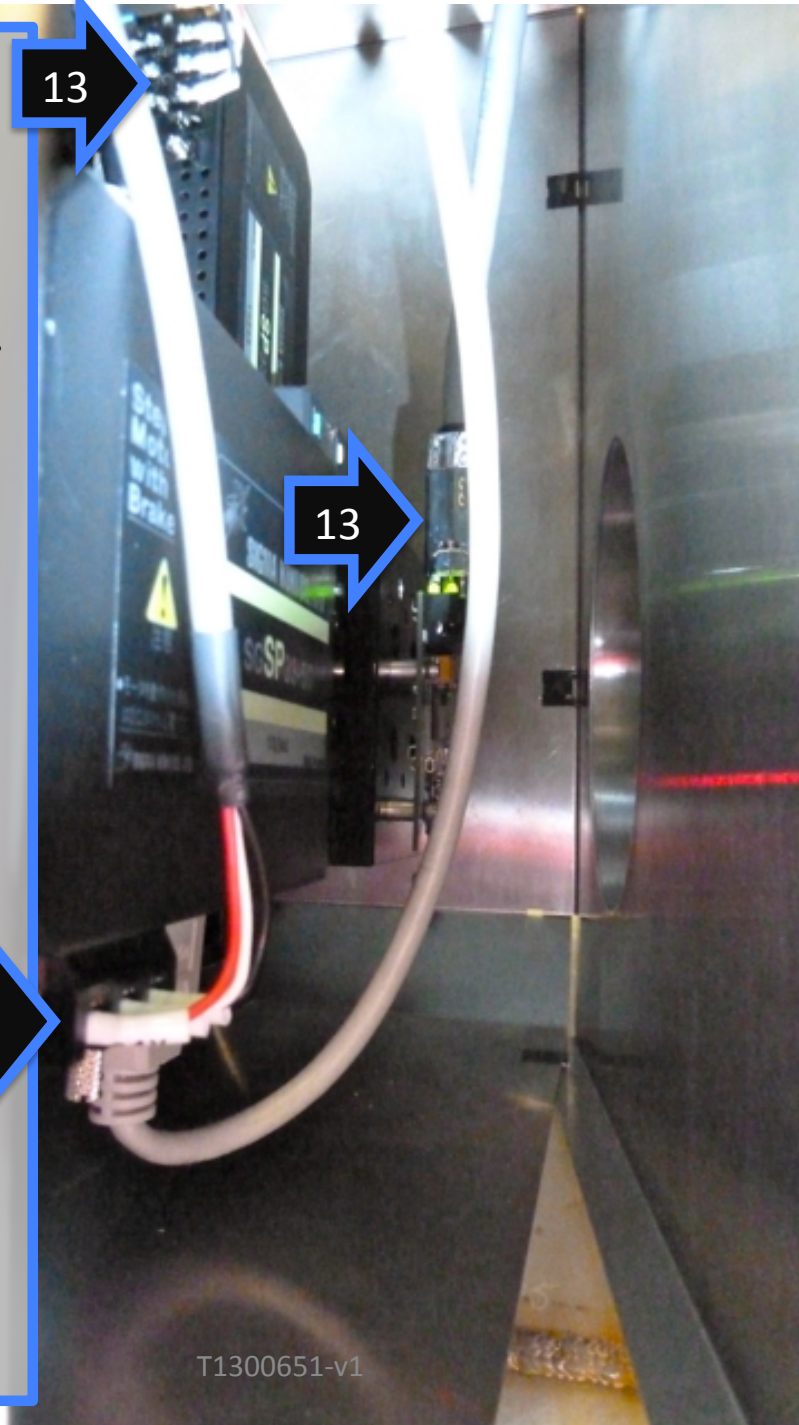
13

(13a) View through the slit.

Note the exposed raised circuit board, two sets of wires that come in at a 90 degree angle to the cable path, and a connector that is 180 degrees from the cable path. Contact with cables is unavoidable, which puts the cable connections at risk.

The cables make the back part of the box minimally accessible, and any attempt to work in the box means contact with the stepper motor and it's cables, which will change the alignment of the receiver.

The stepper motor cables themselves are a tether and alter the position of the receiver.
