DYP-2S Corrosion Investigation

Colin Campbell

7/16/04

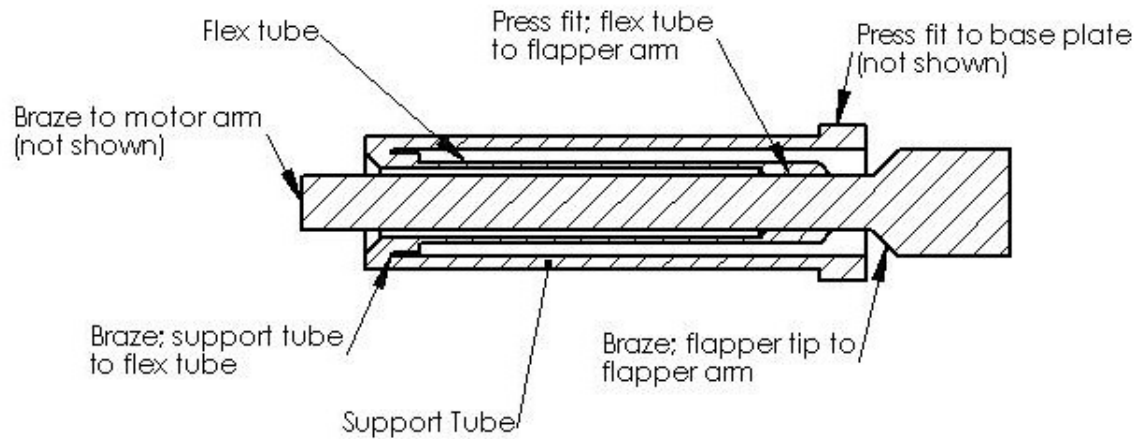
Figure 3. Schematic flapper assembly cross section.

Figure 3 shows a schematic view of the resulting cross section through the flex tube assembly. First, the brazed joints were photographed under an optical microscope, and then the assembly was pulled apart to allow us a clear view of the inside of the support tube and the back side of the flex tube, which are the principal surfaces exposed to the working fluid.
