Point absorbers in aLIGO coating

Slawek Gras, Kevin Kuns, and Peter Fritschel

MIT
December 2019

DCC: T1900838

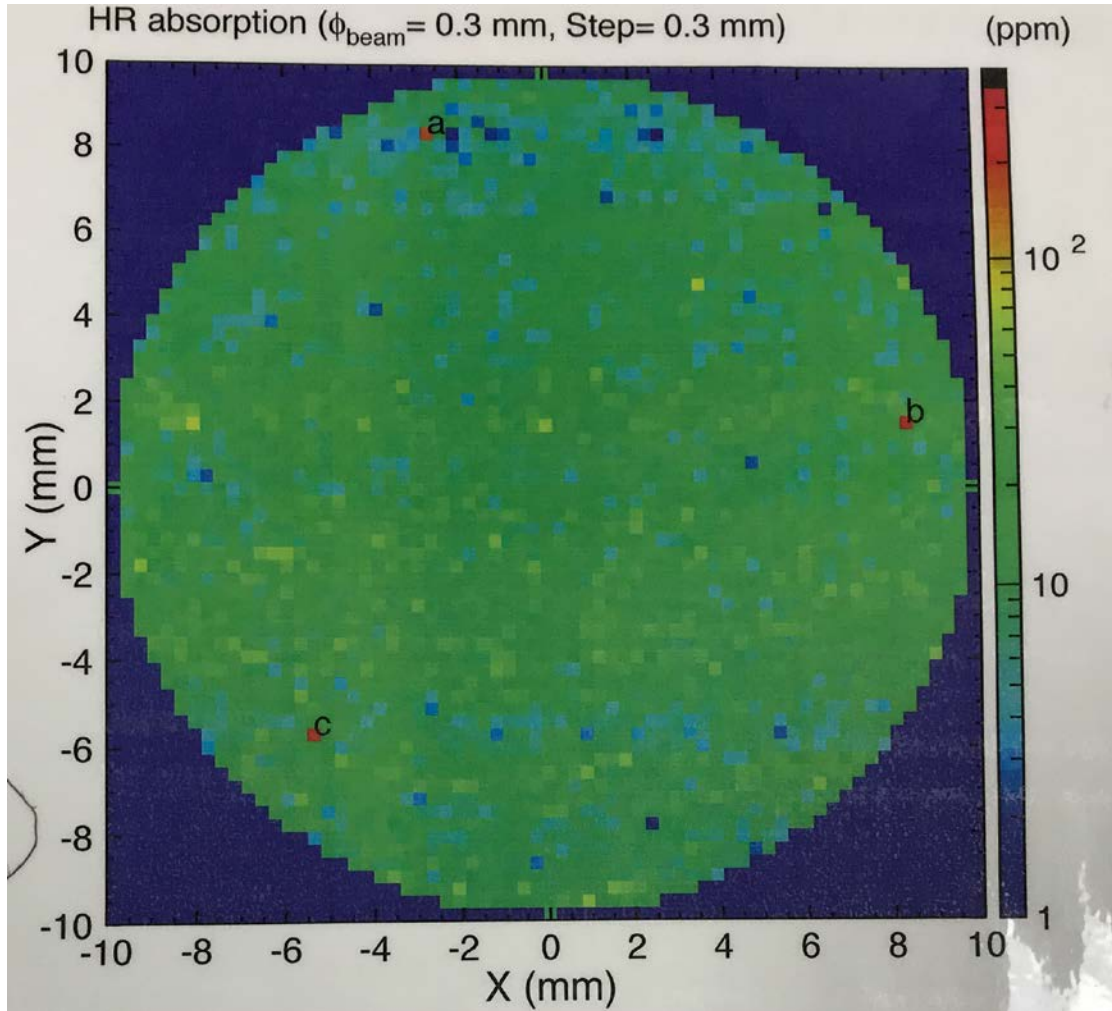
Absorption Map: Caltech

- Witness sample SN#13621 ETM07/09 AR coating
 - material: TiO_2 : Ta_2O_5 / SiO_2
 - total thickness: $\sim 1.6 \mu\text{m}$
- 3 high absorption points identified during abortion measurement :
 - a $\sim 180\text{ppm}$
 - b $\sim 270 \text{ppm}$
 - c $\sim 200 \text{ppm}$
- The origin of the point absorbers unknown until now
- Many absorber candidates identified from the optical inspection are in fact missing coating.
- SEM/EDS/WDS analysis revealed aluminum is a likely absorber candidate.

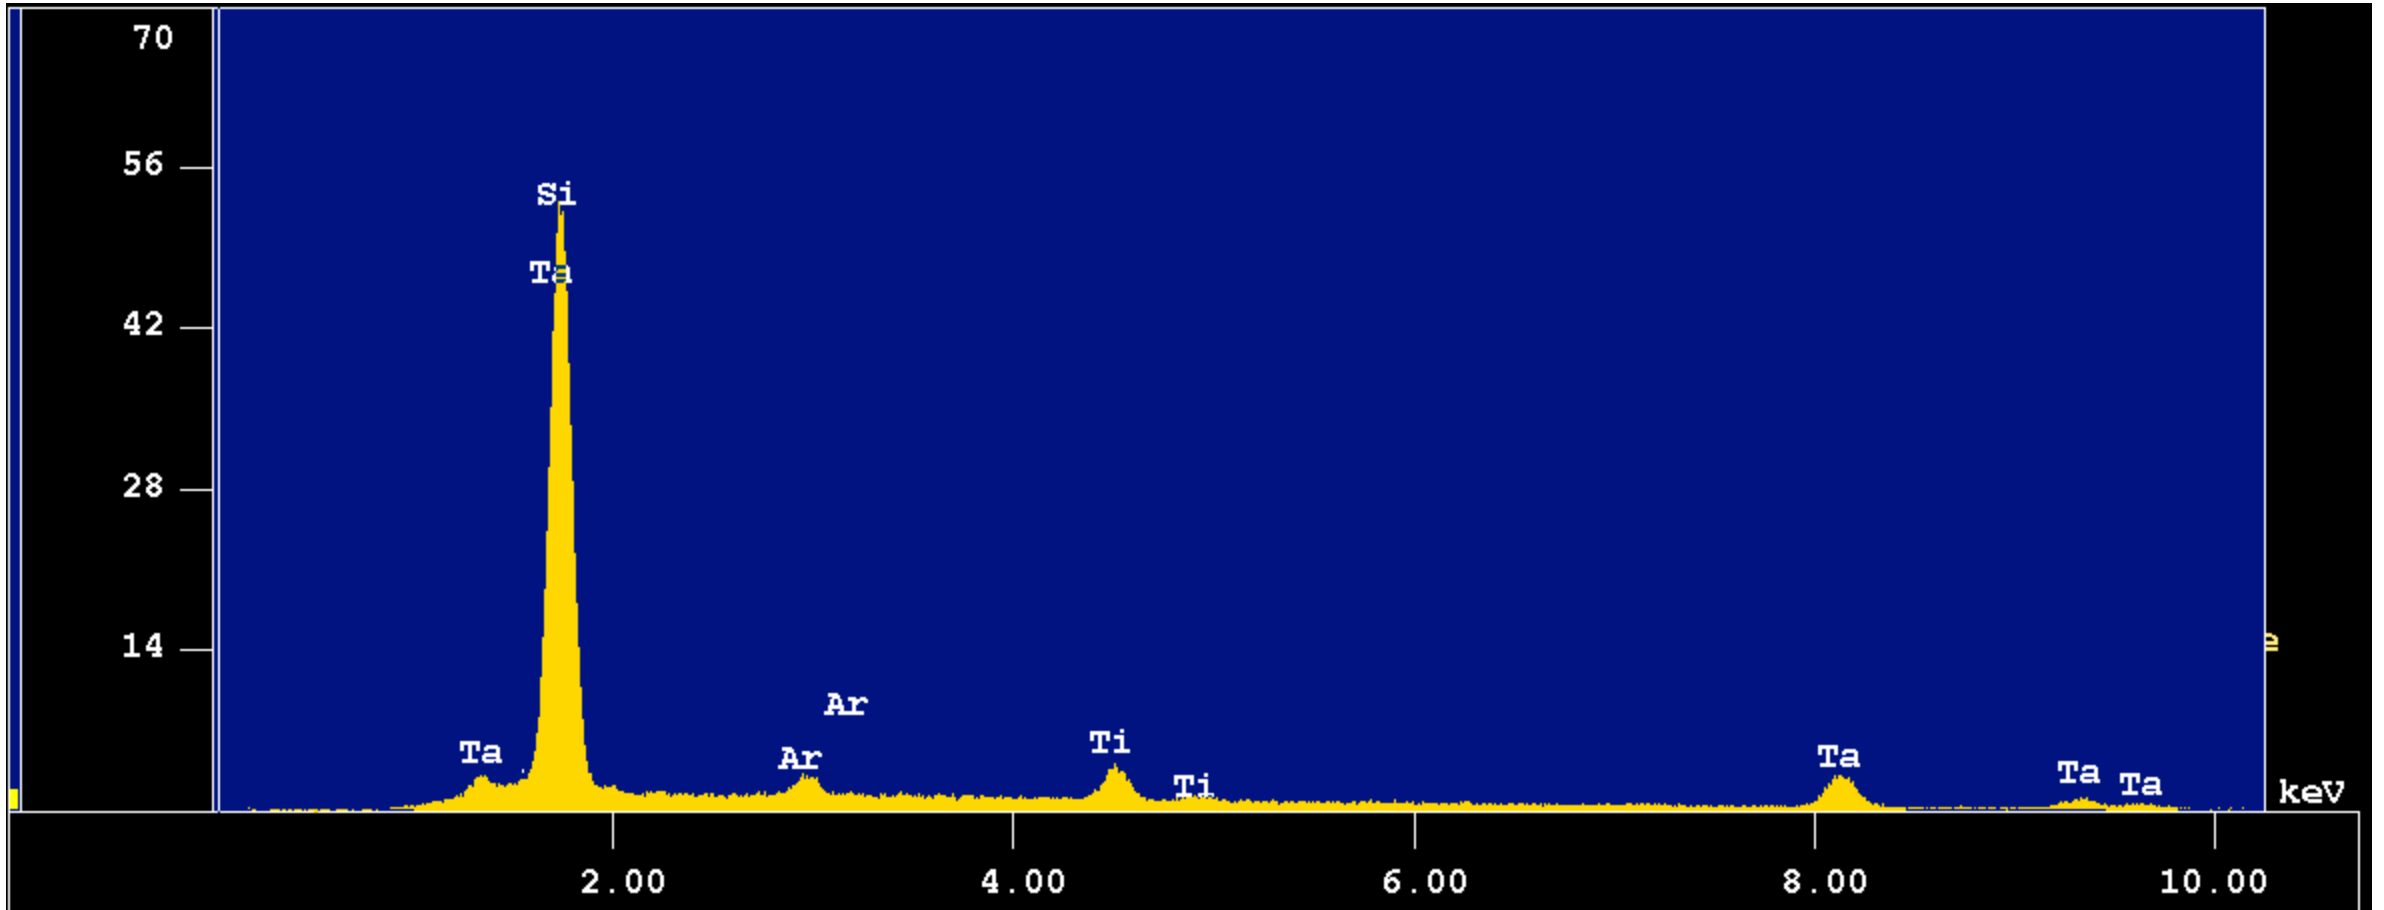
Spectrum of clean coating

- We see multiple Si, Ta, and Ti lines from the coating
- Trapped Ar lines from IBS plasma
- Oxygen from metal oxides is below 1 keV and too weak to measure with this instrument
- Based on WDS: $Ta/Ti = 78.9/21.1$

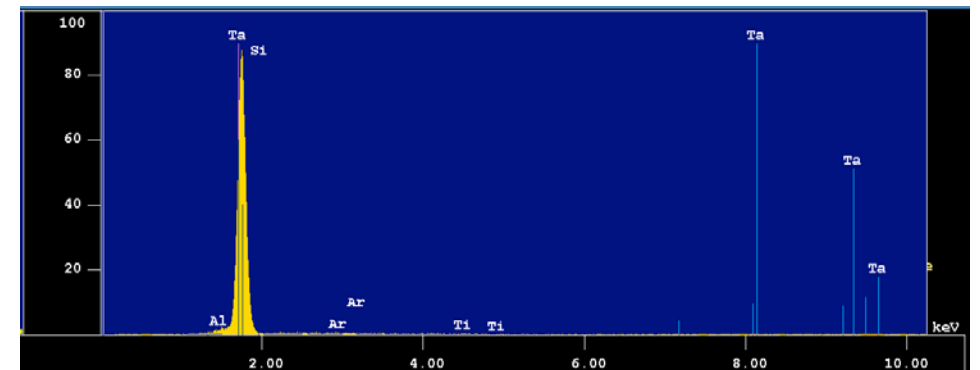
- The missing coating can be easily spotted on large contrast
- 5 places of missing coating with areas of various size, why?
- Conchoidal fractures due to the strain – burst during annealing process?
- Spectrum at M2, M3, and M4 show only Si above 1 keV – pure substrate, but... see next slide
