Ablation Evaluation

SN1535

[LIGO-T2100216](#)

Advanced LIGO Core Optic coating witness sample ETM 07/09

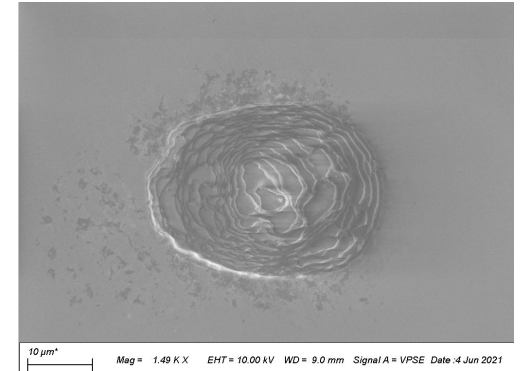
No Aluminum identified in most spectra measured near Feature D on SN1535 (or near Feature F, either).

Feature D - image ref. SN1535_d_01.tif

Typical spectrum comparing D (feature) to D1 (test ablation of clean coating) highlights absence of Al.

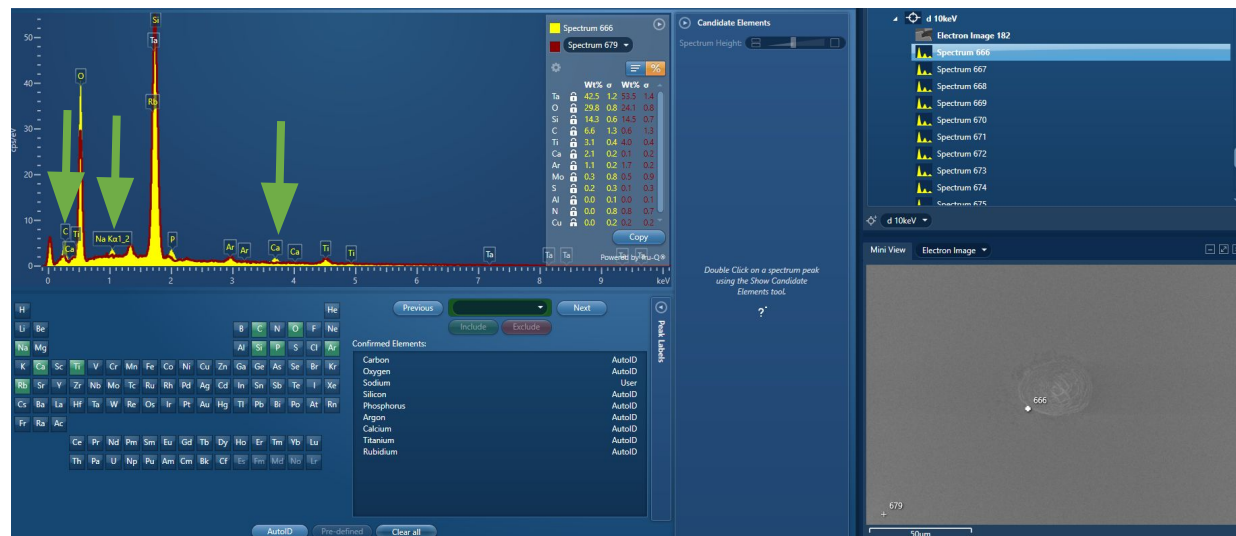
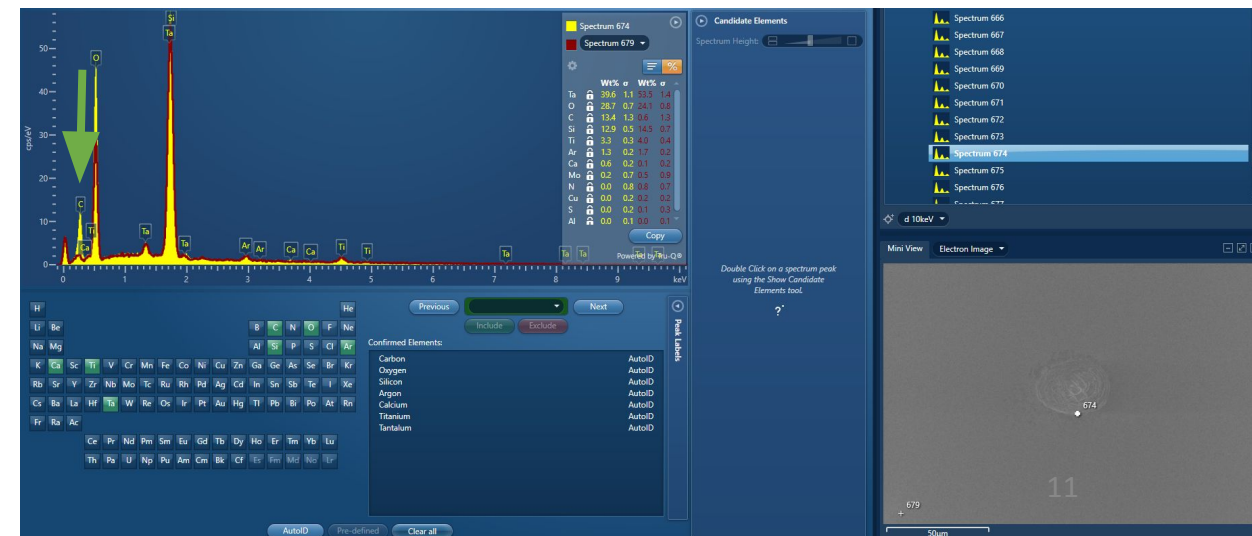
0.1% Aluminum (sigma 0.1%) in this particular point spectrum - is this meaningful?

small spike in C at nearby locations, not present in the rest of the spectra throughout the region - meaningful? also appears to include elevated Na, Ca, maybe P (though I think it could be misidentified Ta)

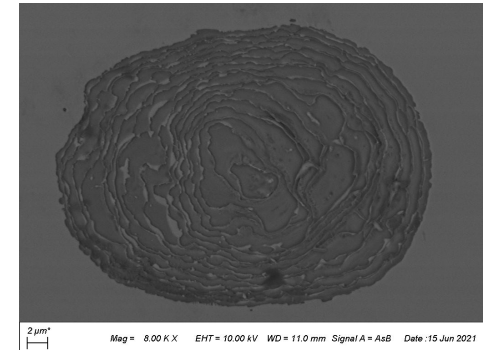
Feature D - Backscatter detector shows contrasting subregion at 6 o'clock at border. Also, uniform contrast suggests we may not have reached substrate.
image ref. SN1535_d_21.tif

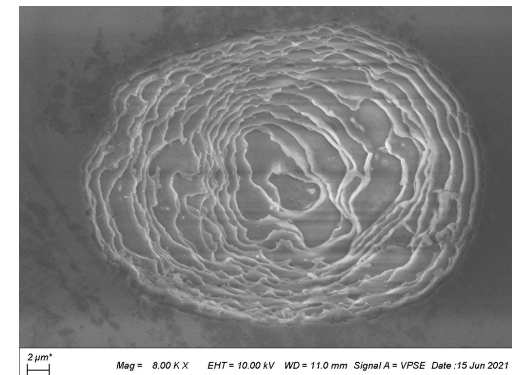
Feature D - standard detector, horizontal artifact lines due to charging at edges. image shows array of edges (layers?) (why apparently more than 8, per standard AR stack)
Image ref. SN1535_d_22.tif

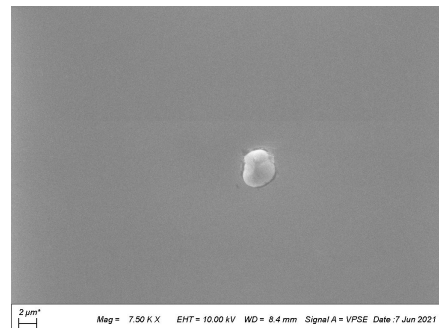
Top Right - spectrum showing typical scan, at center of 4 micron diameter feature. Red trace for comparison is adjacent “clean coating”. No signature of interest.

Bottom Right - spectrum showing localized Carbon peak (7.6% wt. compared to 1.3% wt.).

Localized Carbon signature warrants additional backscatter imaging to try to understand the extents of a potential subregion including Carbon.

SEM Image of the apparent absorbing feature in region F.
ref. image SN1535_f1c_01.tif

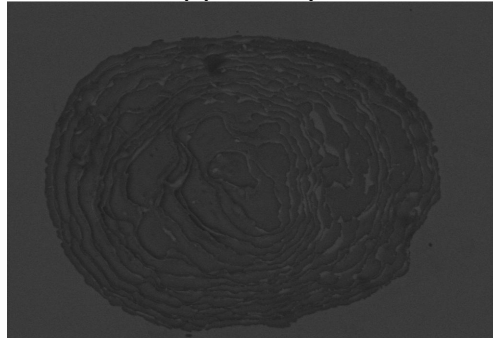
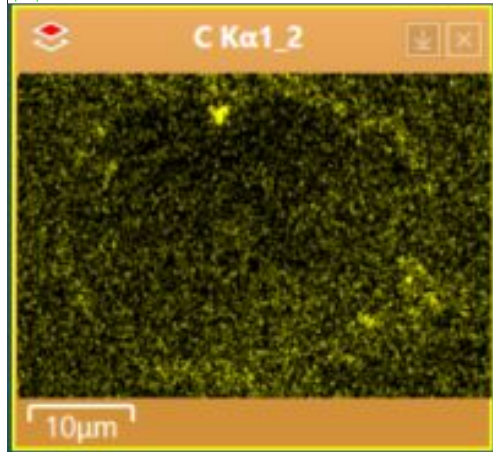
D
2.6% C, sum over area

High resolution mapping shows presence of **Carbon** present in all ablations, around the border.

Carbon is more prominent in Feature D (including strong localized feature). Current speculation is that this could be related to conductive polymer coating applied by MIT. These results are consistent with this speculation, as all features show pretty similar C signature.

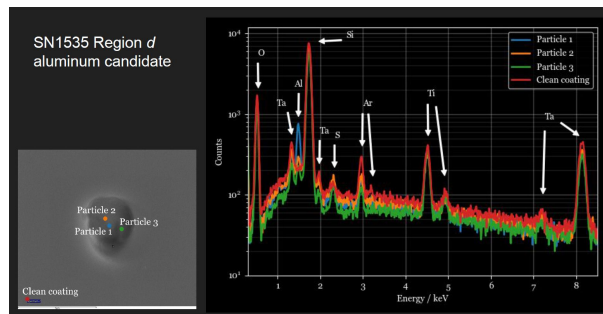
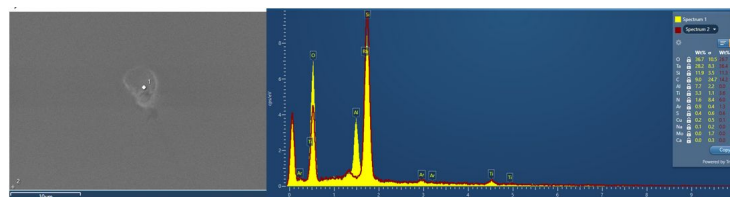
Kevin found local,
small aluminum signal
(ref. his slide 5)

Stephen's found the
aluminum signal (data
not posted yet)

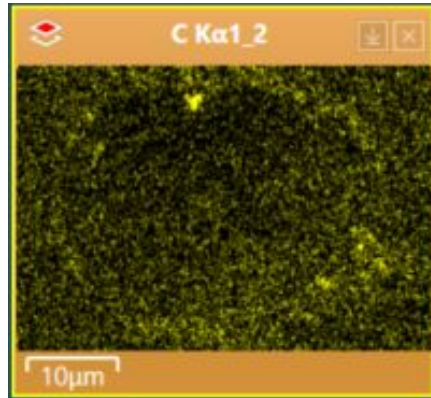
D

To address 1), the witness sample was cleaned using an O₂ plasma. After, the concentrations of carbon were no longer present, with C levels reduced and now on par with “clean coating” areas. Absorption scan next, to attempt to address question 2).

2.6% C (0.3%) before

→ 3.0% (1.6%) (larger error, smaller peak by eye)

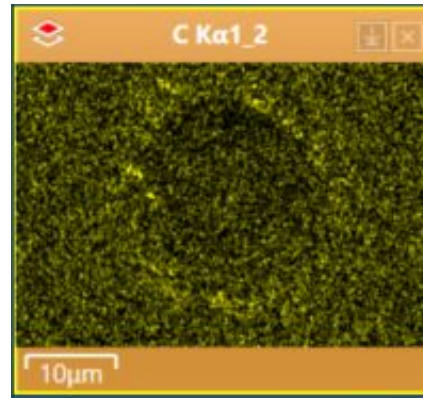
D1 (clean coating)

2.1% (0.2%) before

→ 1.8% (0.7%)

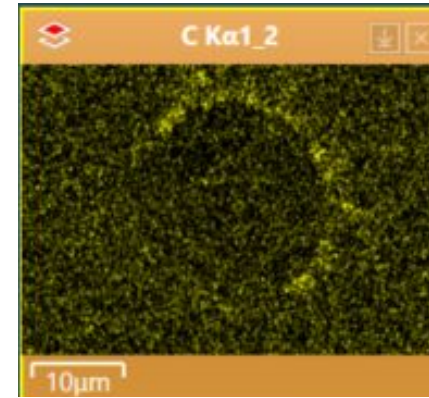
F1A

2.2% (0.3%) before

→ 1.6% (0.5%)

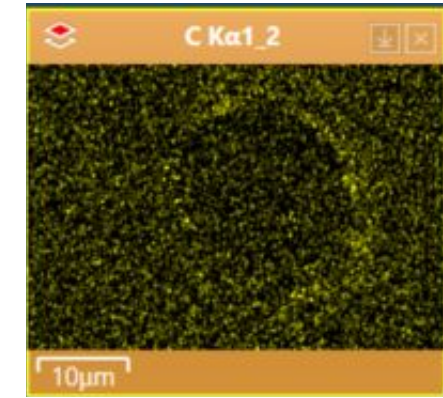
F1B

2.2% (0.3%) before

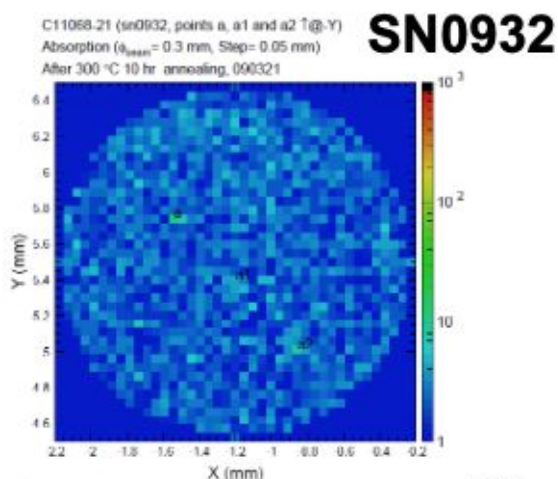
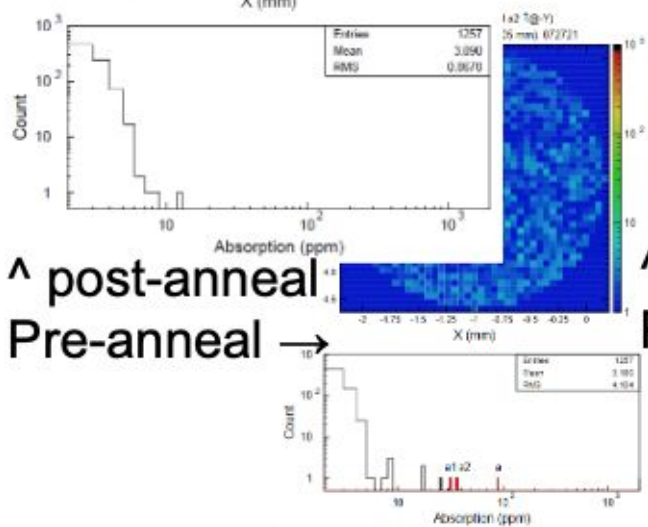
SN0932

- Ref. E2000107
- Pre: 50-100 ppm
- Post: below noise floor

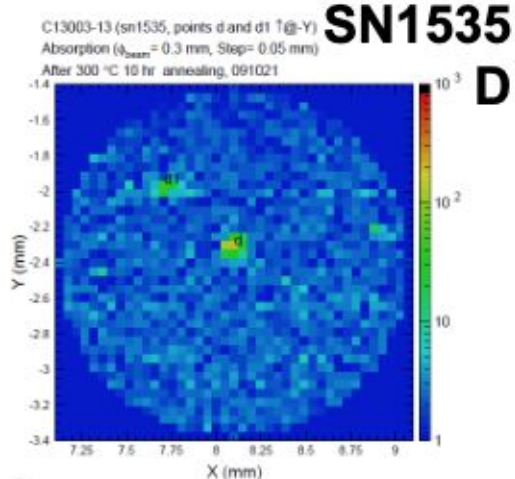
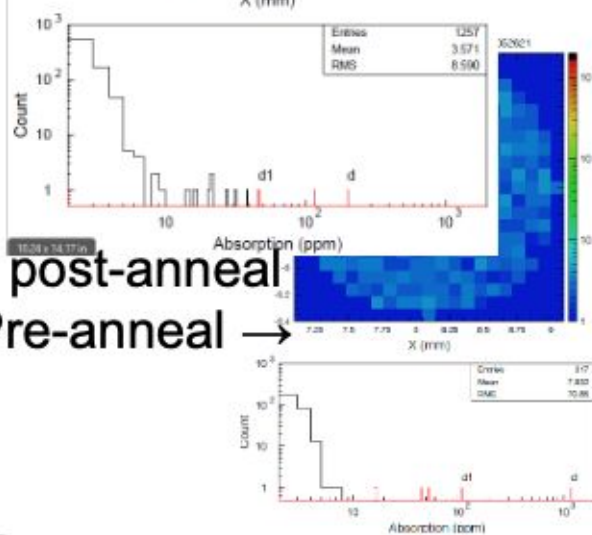
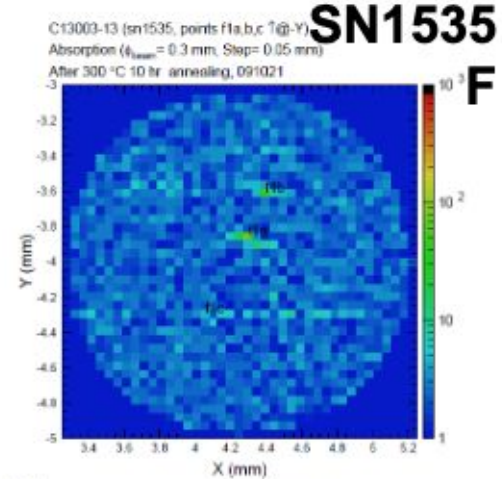
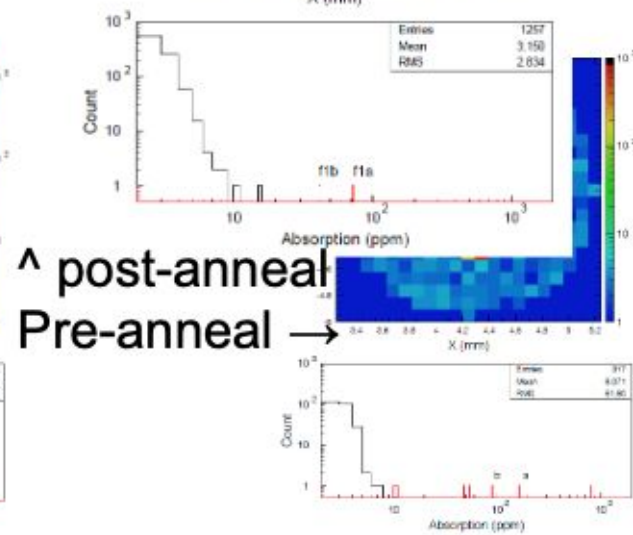
SN1535

- Ref. E2000023
- Ref. T2100216
- ~5.9x drop at d
- ~3.6x drop at f1a and f1b

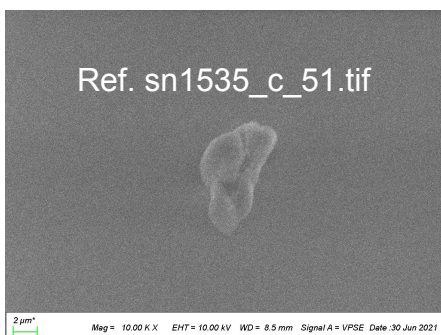
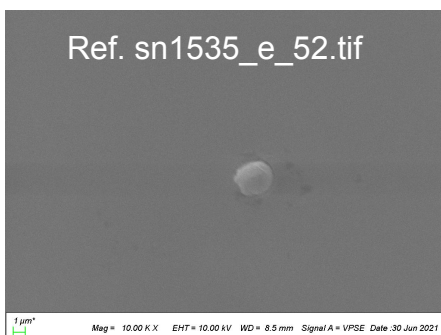
SN 1535 original d1?

Original spot d “od” is now 2 spots: od1, od2

No	X _{optic} (mm)	Y _{optic} (mm)	Absorption (ppm)	Comment /Original ID
1	-8.014	-3.787	4546	oc?
2	-6.547	-5.239	1582	od1?
3	-5.345	-5.288	1648	oe?
4	-6.768	-5.439	1039	od2?
M1	11.067	-0.807		
M2	0.591	-12.108		next to ^
M3	-11.326	-2.102

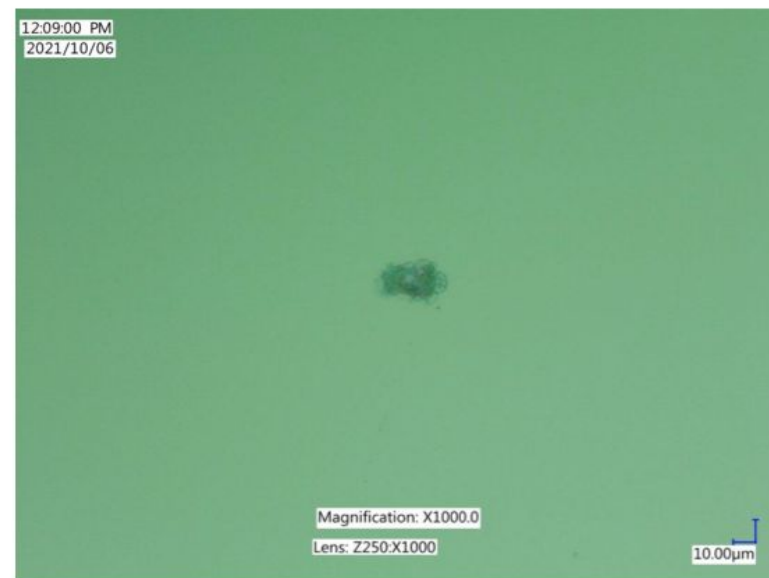
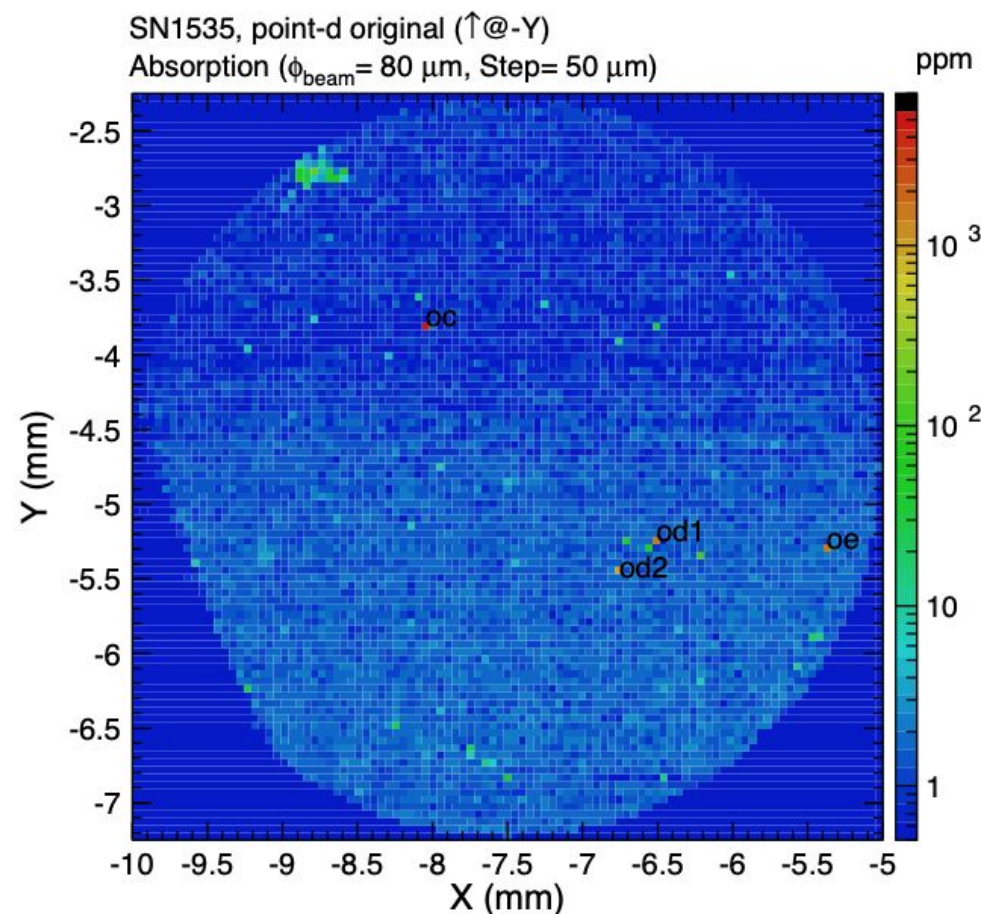
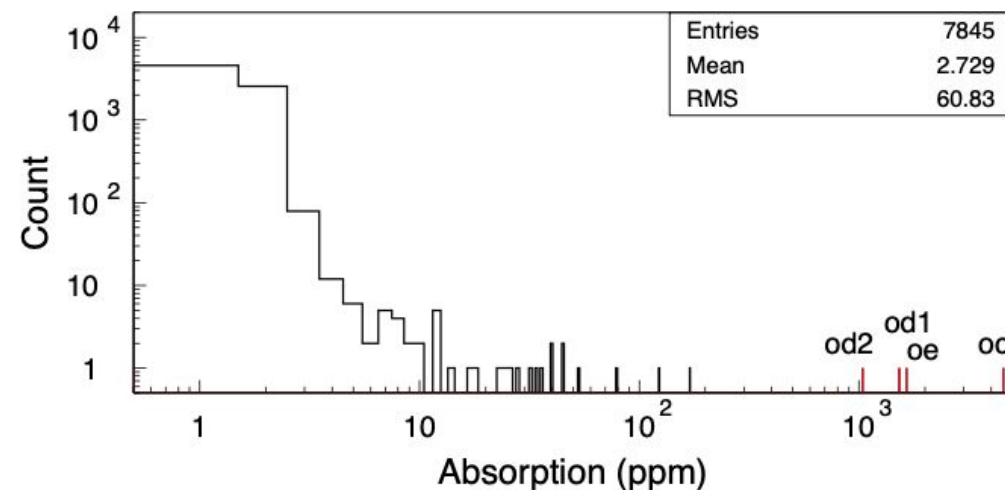
od after plasma clean then annealing (green background) from most recent [RTS scan](#) does not compare well to SEM images?

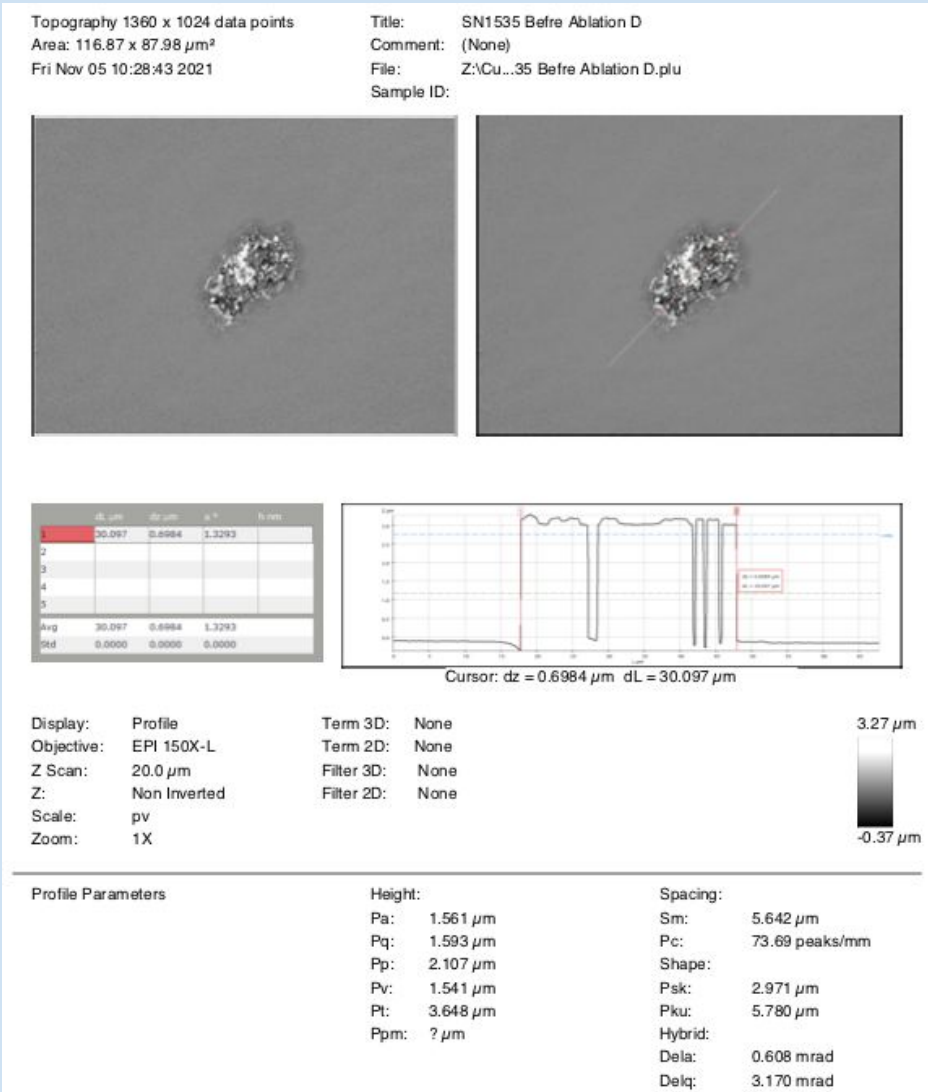
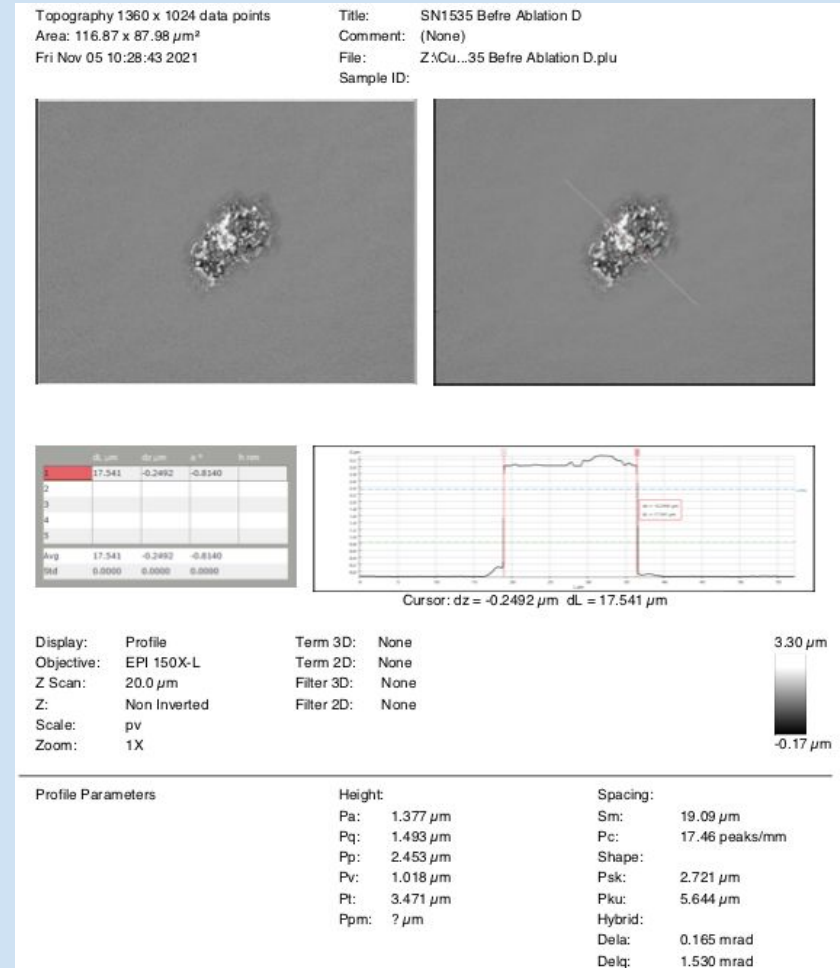
SN1535, od, before ablation

Before Ablation, feature 'od'

SN1535, od, after ablation: 8 pulses, 7 uJ each, in 2 partially overlapping spots

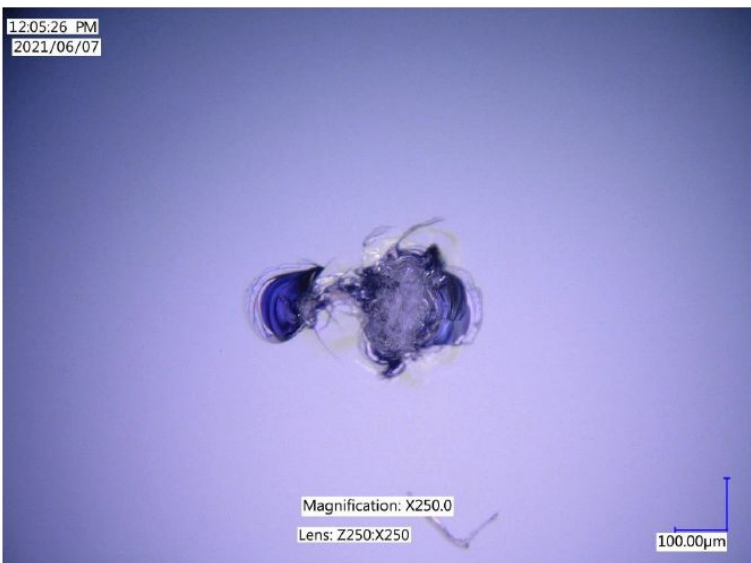
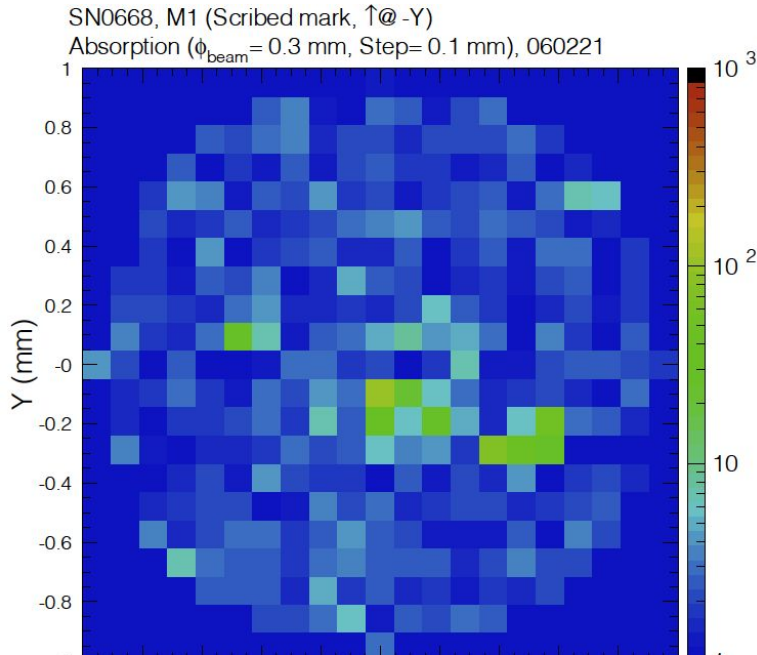
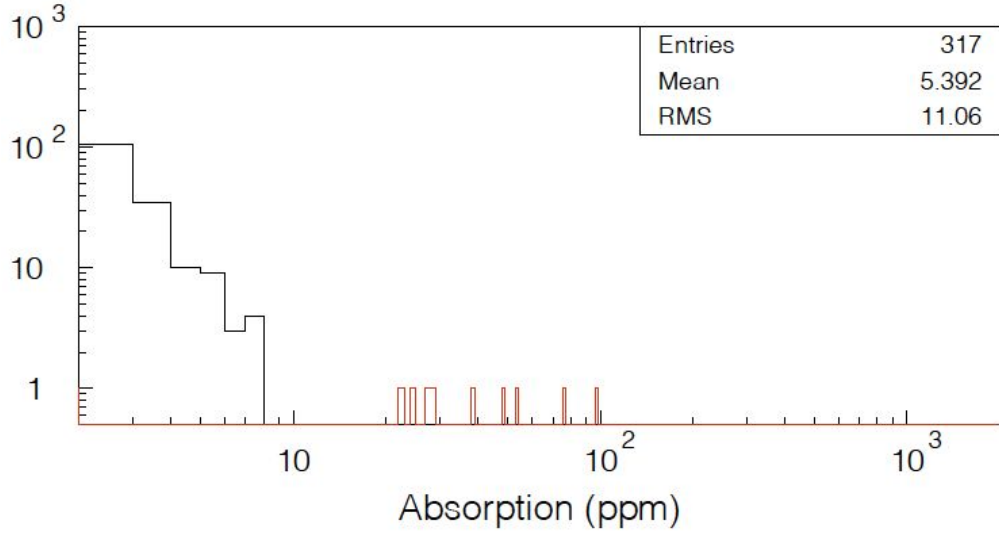
SN0668, M1, scribed mark

Ink does absorb see [T2000526](#)
