LIGO-T1200385-v2

ADVANCED LIGO

18 Oct 2013

LLO BS Prism Gluing Issue and Resolution

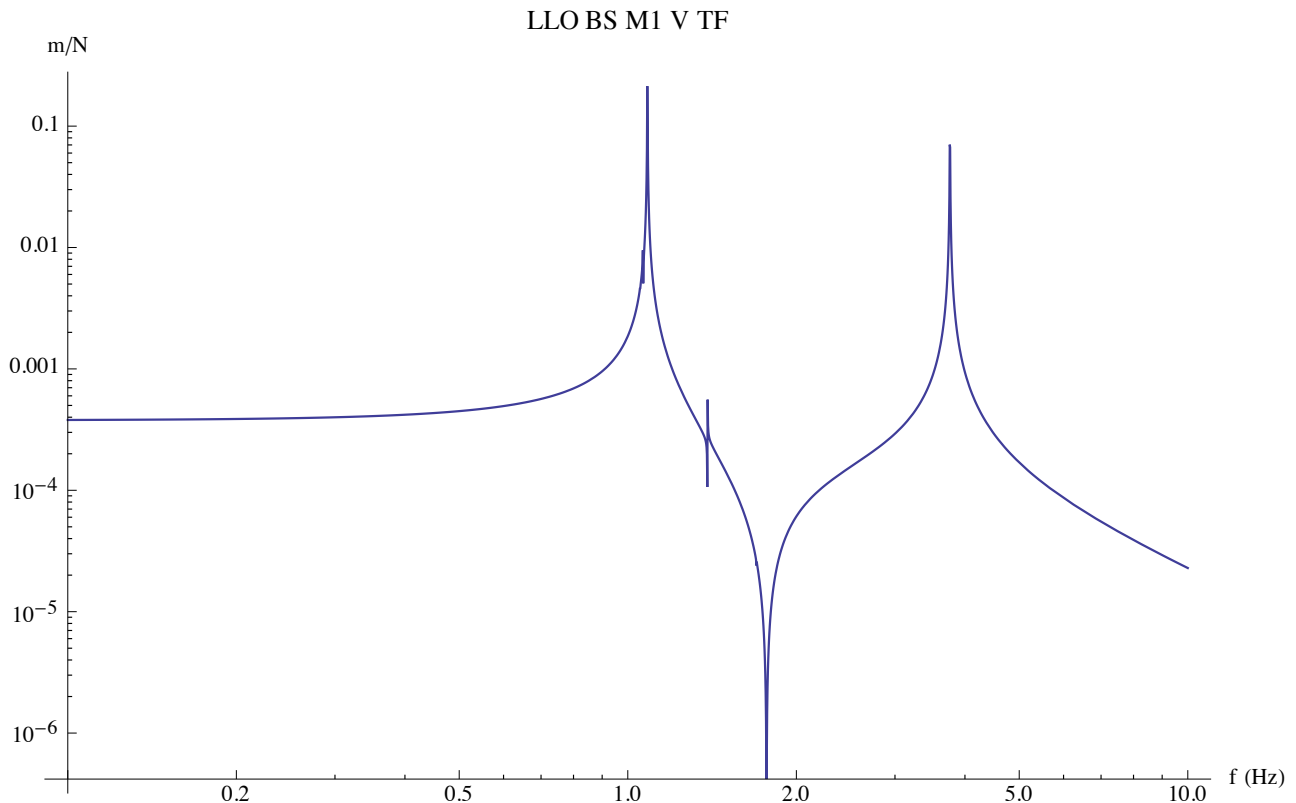
The rebalancing fix was applied at LLO and the M1 transfer functions were fairly normal with the exception of a small 1.4 pitch mode and a small 2.2 Hz roll mode that appeared in the vertical transfer function (see LLO alog 8534). The pitch mode is predicted by the Mathematica - see Figure 8, generated from case 20120712bsglassfix2) and is well-suppressed by normal damping. The roll mode is still under investigation but is also well-suppressed by normal damping.

Figure 9: Vertical transfer function at top mass showing extra pitch mode peak at 1.4 Hz.

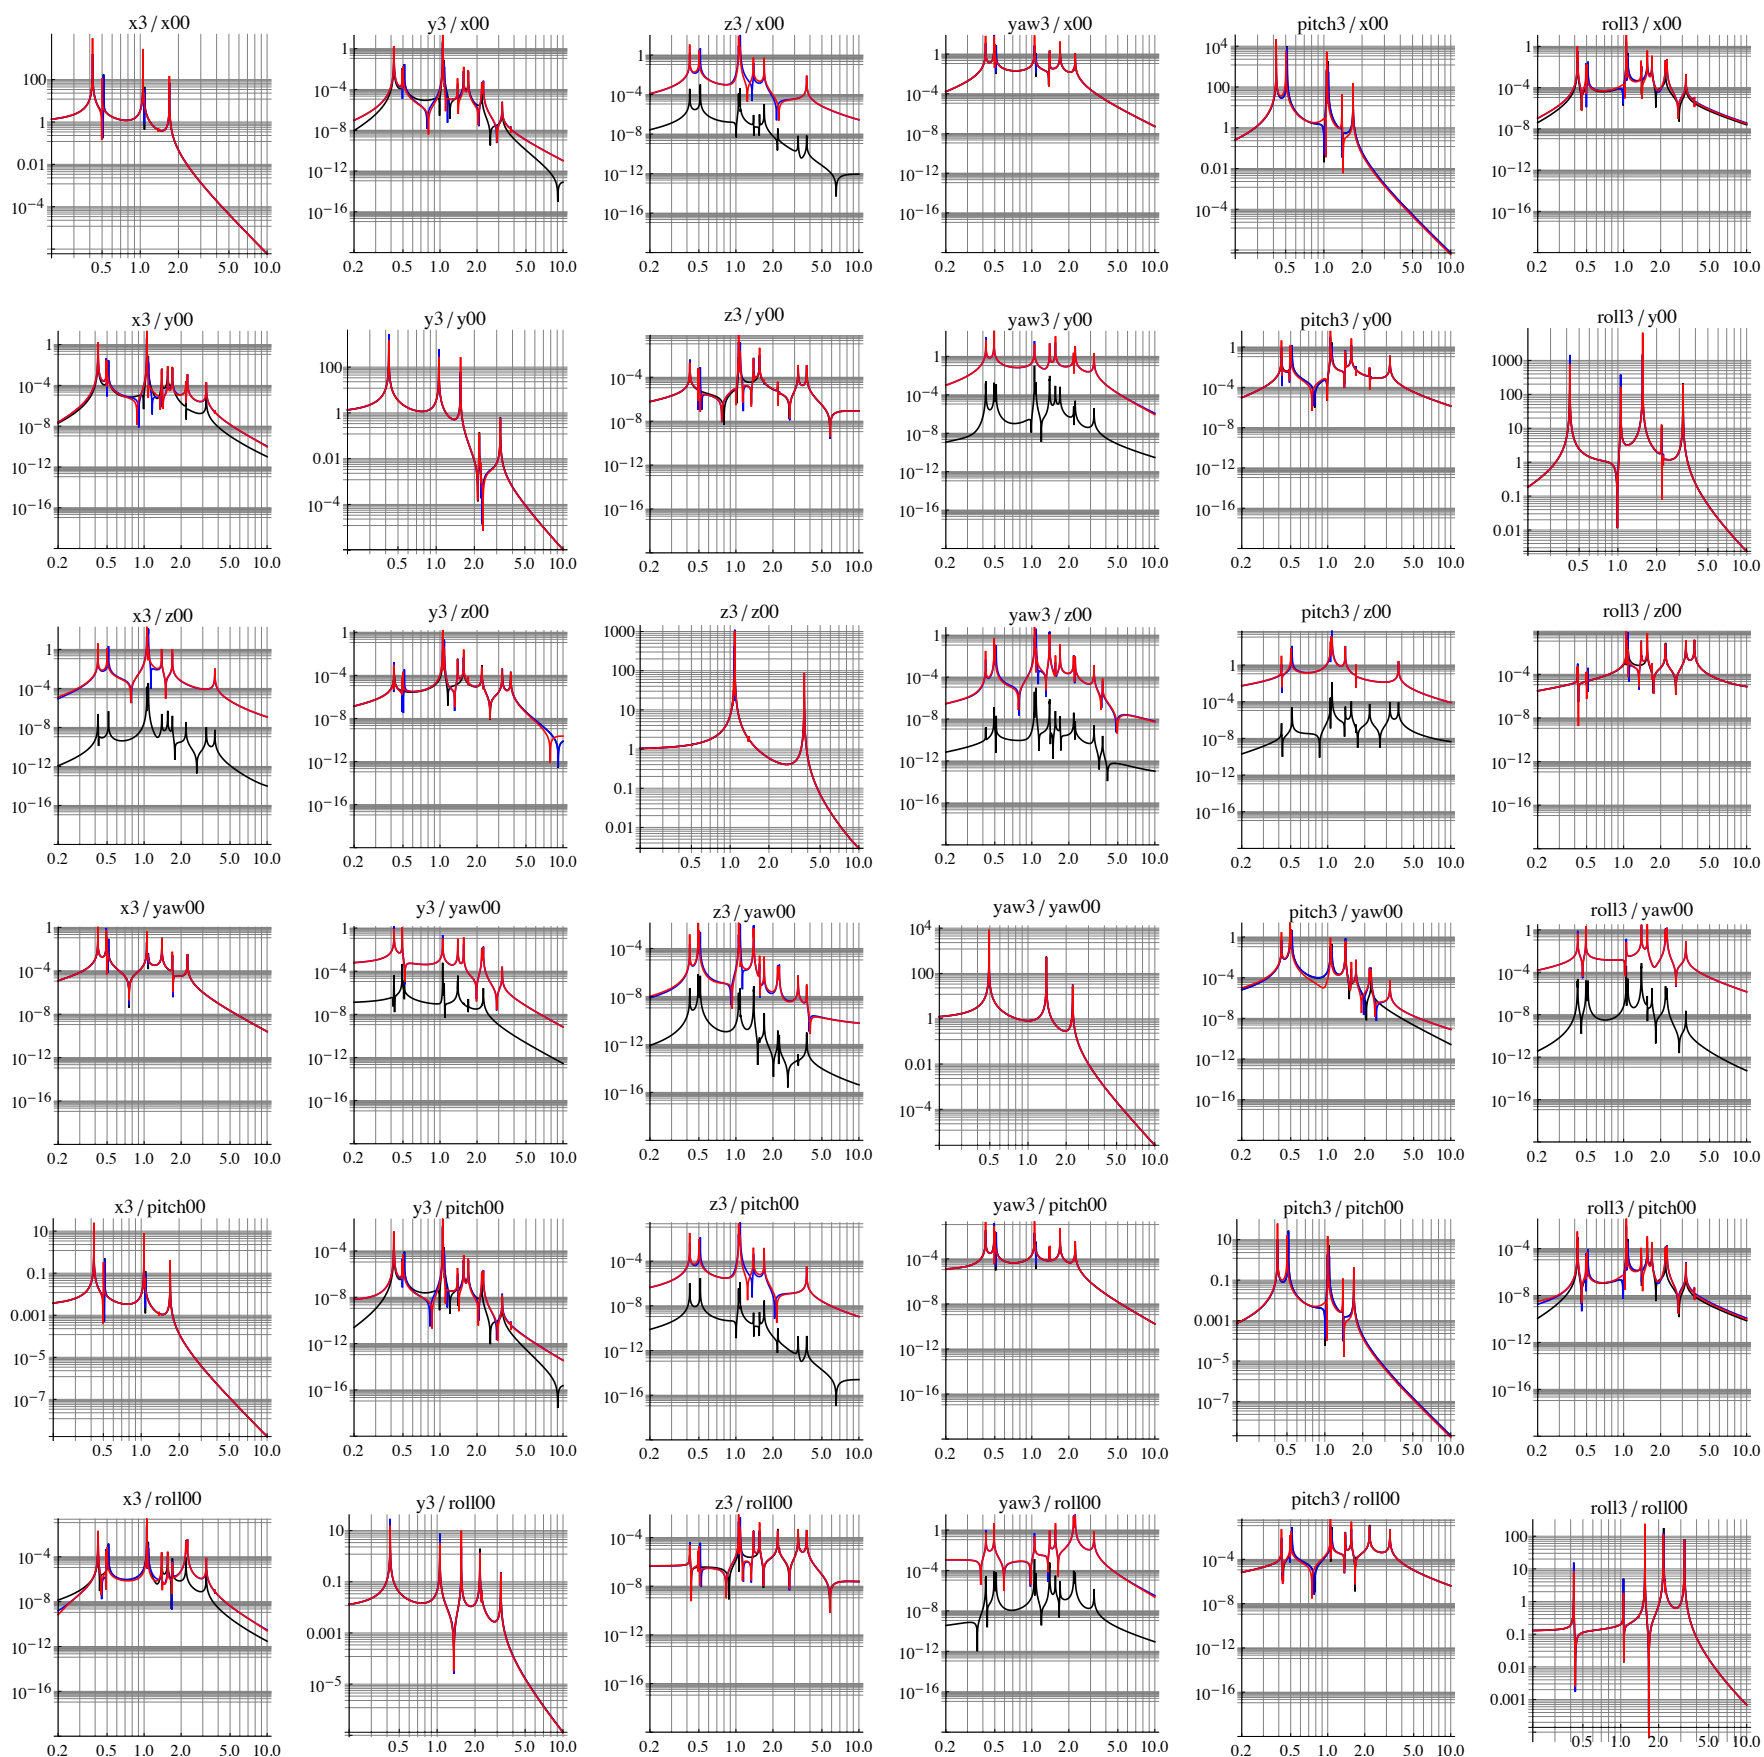
To check for untoward effects on the dynamics, all 36 transfer functions from structure coordinates to optic coordinates were plotted for the base model and the two modified models described above (Figure 10 - final section of this document, best printed on 11"x17" paper). As expected, the error and fix introduced cross-couplings between pairs of coordinates that had been independent, for example structure longitudinal (x00) to optic vertical (z3). However there are no new couplings that are obviously problematic. Also it turns out that it is the horizontal component of the trim mass

adjustment that drives the effect - adding the vertical component doesn't significantly increase any of the couplings further.

Figure 10: TFs from structure coordinates (x00 etc) to those of the optic (x0 etc)

Key: black = no error or fix, blue = error and fix with horizontal movement of trim, red = error and fix with diagonal movement of trim
